Bloedel Conservatory

Spectrum Skyworks is replacing the domes at the Bloedel Conservatory in Vancouver, British Columbia

By Paul Griffin, Construction Manager, Westcan Scaffolding

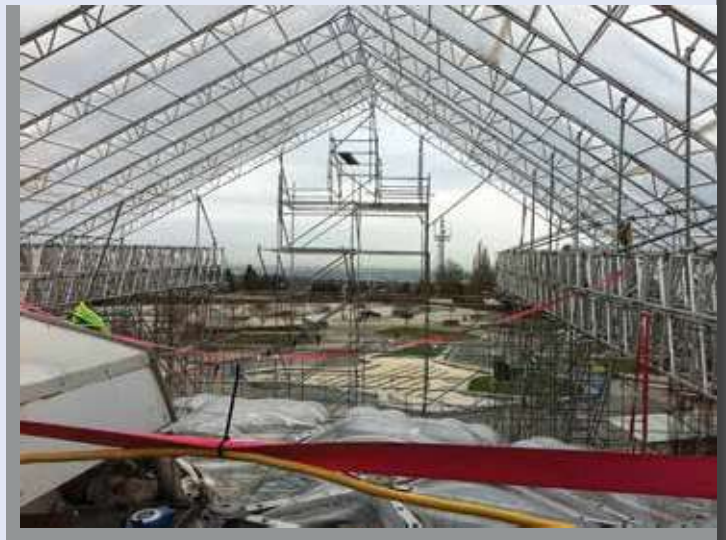
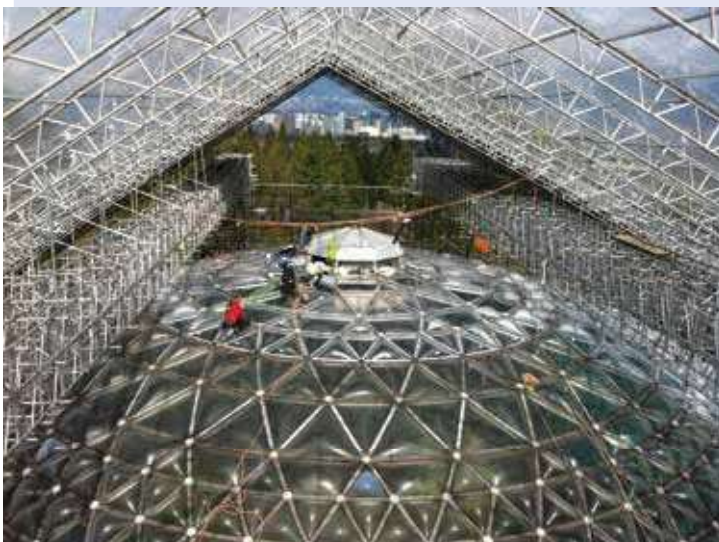
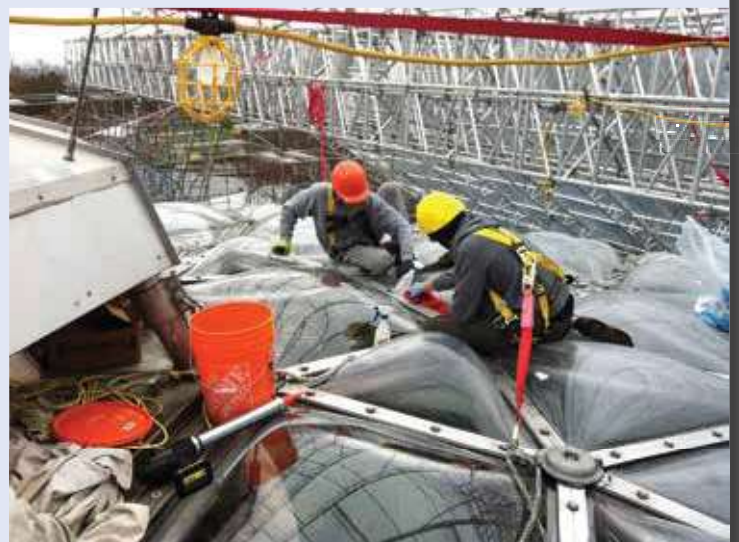
This is a large and unique project as the dome structure has more than 1,400 individual “bubble” panels of 32 different sizes. While the conservatory roof is strong, it is more than 40 years old. Some individual roof panels need replacing because they have cracked and now leak.

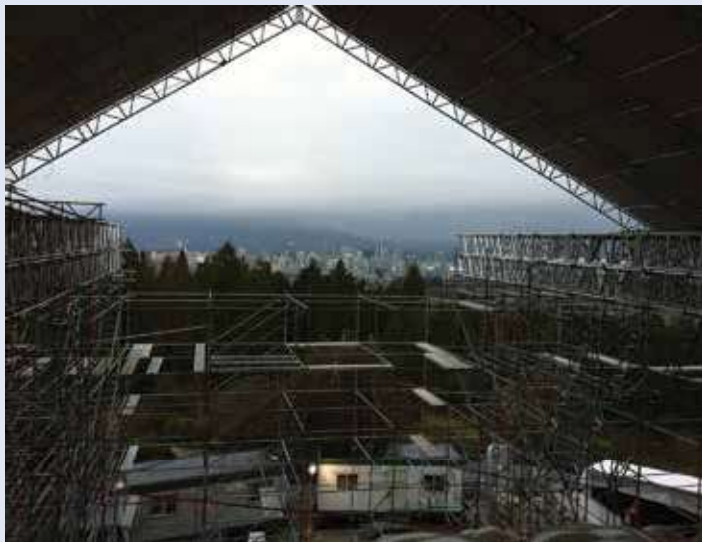
Bloedel Conservatory scaffolding drawing

Scaffolding will cover the entire dome, as shown in the cross-section diagram. Due to the unique structure, special scaffolding will be used to cover – but not touch – the dome. A protective cover will wrap around the scaffolding.

- Westcan has used clear scaffolding as opposed to solid scaffolding in this unique project due to the nature of the building
- Includes 2 X 180 FT Spine Beams.

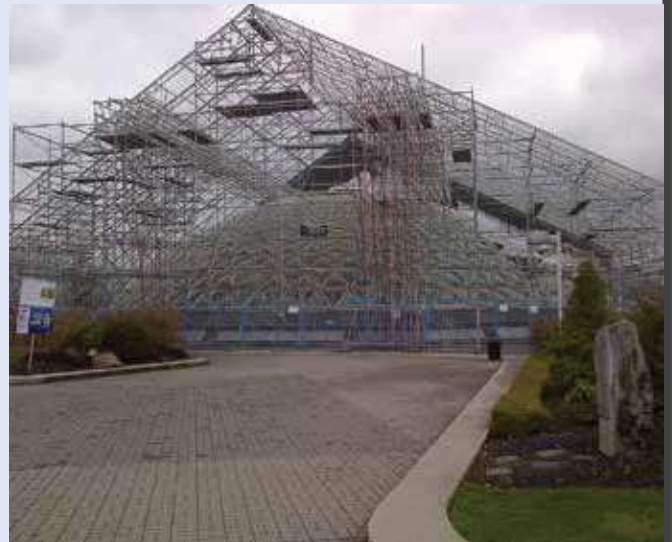
Keeping birds, plants, and visitors safe. Special care and attention will be paid to protecting the conservatory's beautiful birds, exotic plants, and visitors during construction. Protective netting will be used inside the dome to ensure no birds escape and no outside birds can enter, and to catch any falling debris.

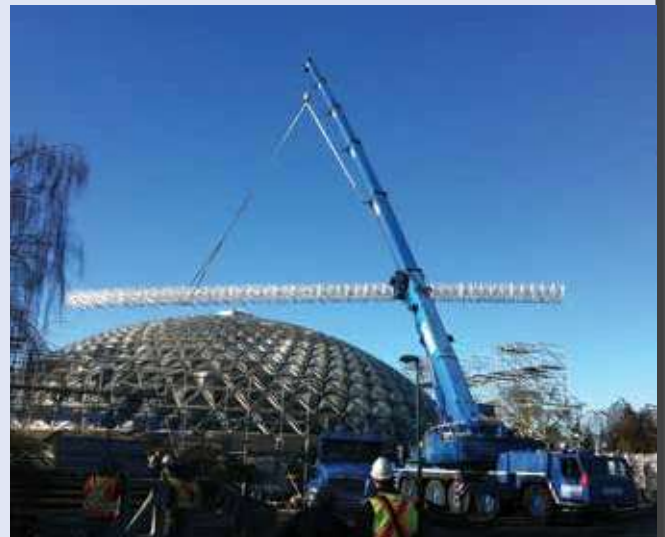
Some other details:
