# GPR TESTENC RESULTS

## October 19, 2022

#### <u>New Rambler Operation,</u> <u>Historical Map.</u>

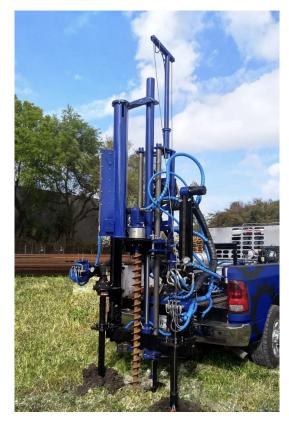
MB-23 Rotary Drill with depth capacity of 50 - 75 feet.

For the steps ahead Buyer Group will be exploring the necessary drill rig needed to reach a depth of 65 - 75ft. The goal being punching a 4" hole thru to the old workings below (the 67 foot level) and descending LED equipped cameras for further inspection and confirmation. If necessary, tracked and tethered bots with mounted GoPros can also be utilized to explore a few hundred feet in either direction from the drill hole. This will allow Buyer Group to map out the underground workings with the intent of then matching it up to the available historical maps.
