MMOCC Newsletter –

OCTOBER 2023

1925 Franklin 11A Babcock bodied coupe

(A project I'm calling 'The Phoenix')

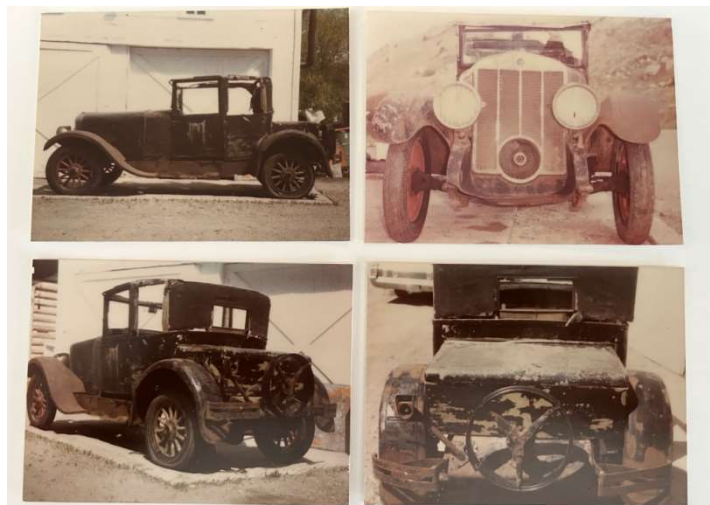
Caption: 1925 Franklin 11A, Babcock Bodied Coupe (pictures circa 1979 before it was disassembled)

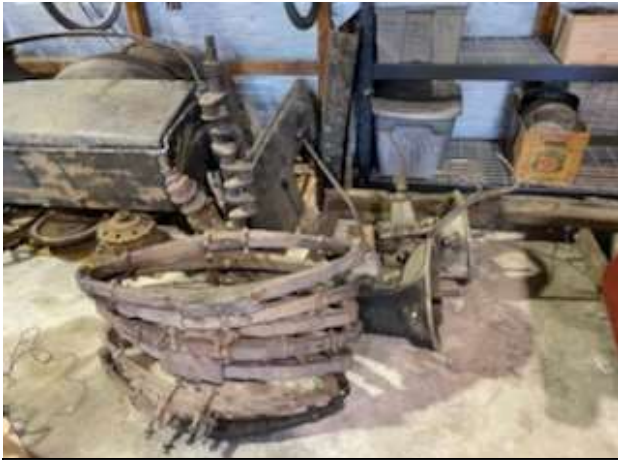
Caption: Various Franklin parts: Leaf springs, rear trunk, crank shaft, clutches, flywheels, two transmissions, rear fenders...

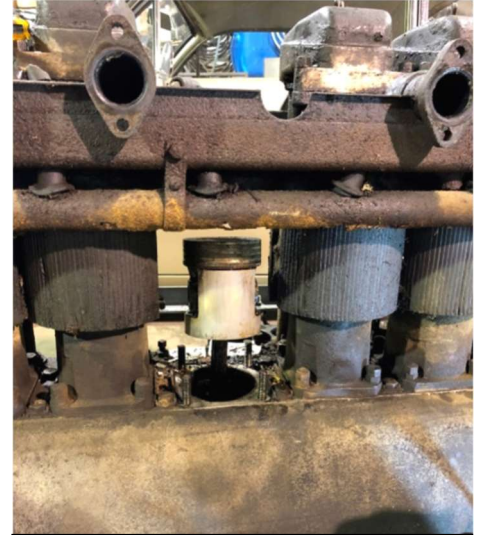
Caption: Franklin Air Cooled Engine, one cylinder jug removed.

25.3 horse power 6 cylinder air cooled engine with 3-1/4" bore and 4" stroke. Crankshaft main and rod journals are 2" diameter. At first I thought I might be able to free the engine cylinders by soaking liberally in penetrating fluid. That proved fruitless so I decided to start taking the cylinders off one-by-one to see which was hanging things up from rotating. Franklin cylinders of this model are made of one casting (a true 'jug' no separate cylinder head which has advantages and disadvantages). The major advantage is no possibility of 'head gasket' leaks. The major disadvantage is if the piston is stuck you have to

leave the rod on the crank to give you leverage to pull the cylinder up & down to free the piston from the cylinder since there is no easy way to access the piston from the top side. Well... six cylinders later I discovered that not only were the

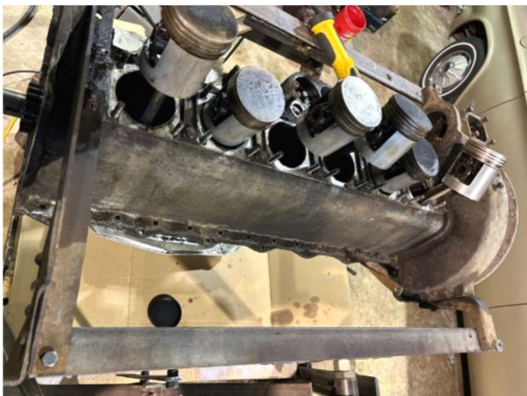
Caption: Air Cooled Engine, all cylinder assemblies removed

cylinder/piston assemblies pretty much stuck, the crank was still stuck. I removed the oil pan and began to free the connecting rods one-by-one. Each rod was fairly snugly adhering to its respective crankshaft journals. I was able to get 5 rods out without damaging the babbitt bearings on most, but one babbitt bearing did break on the bearing cap side. Franklin used solid die cast babbitt insert bearings (no steel or bronze backing) for the connecting rods and the main bearings. More on the babbitt bearings shortly...

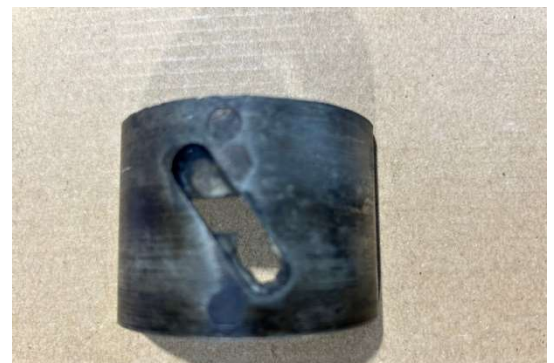
The issue Franklin faced was the oil gallery could not be drilled directly on center to the bearing or it would interfere with the bolts that secure the lower main bearing caps, so Franklin drilled the oil gallery offset to the side of the bearing cradle bore. Franklin designed a relief on the back side of the upper babbitt bearing 5/16" wide at 35 degrees diagonal to direct oil to the center of the bearing where there is an oil groove cut

Caption: Center main bearing-solid babbitt (die cast). Note: Oil gallery relief 'cut/cast' diagonally on the back side to allow oil from the oil gallery supply in the crankcase at the edge of the bearing to the center of the bearing.

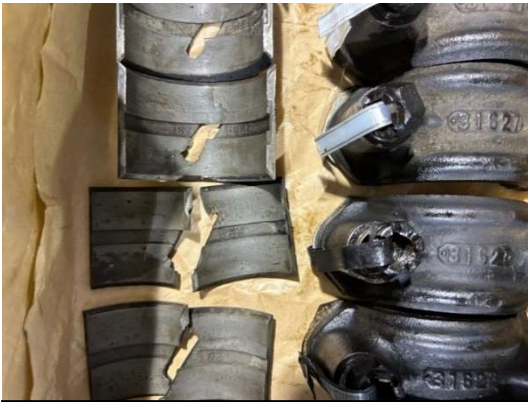
bearing caps and discovered the reason for the stuck crank... rust from years of condensation cycles had slowly grown to penetrate into the babbitt bearing surfaces preventing any chance of movement. Only slight pitting on the babbitt was evident though, so not so much of a problem. The real problem was that three of the inner 5 main bearings (7 total) were cracked on the upper half shells due to a design flaw in the oiling system. Franklins use an all aluminum crankcase that's cast in two halves. The upper half holds the crank and camshaft and the lower half is a solid cast aluminum oil pan with an integral sump, oil pump and oil gallery distribution system to cooper distribution lines. The main bearing caps are fastened by two long bolts that straddle the bearing cavities in the center of the crankshaft bore.

Caption: Main bearings. Note damage to upper babbitt bearing shells due to the weakness of the oil gallery relief.

concentrically around for the oil gallery that feeds oil to the connecting rod journals through a rifle bored port in the crankshaft between the main and rod journals. Franklin cut the relief in the upper main bearing long enough so that during assembly a person could not install the bearing inserts backward and block the oil supply. This is good from an foolproof manufacturing assembly design perspective, but the long relief left only about 0.150" of babbitt bearing over most of the length of the bearing leaving the bearing susceptible to breakage over long term abuse from crankshaft vibrations. I

noticed in the Franklin drawing for the insert bearing in change "O", Franklin removed the relief on the back side of the bearing on November 30, 1928, presumably realizing the design flaw. The change incorporated a note indicating consult assembly instructions for repairs (presumably a note that instructed the service person to install the relief so the oil gallery hole lines up and is not installed backward and block the oil supply since the design change would mean the bearing can only be installed one way and work correctly!)

So, the next step in the engine project is deciding between several options to address the main bearing situation.

1. Find used babbitt bearing inserts that are still good, use those, polish the crank and reassemble.
2. Grind the crank, pour babbitt main bearings in the block & caps, and then align bore to the crank size.
3. Purchase custom made babbitt inserts, align bore to the crank size.
4. Use the crank and block from latter 1926 engine that has poured main bearings and crankshaft that was ground 0.015" undersize in the past.

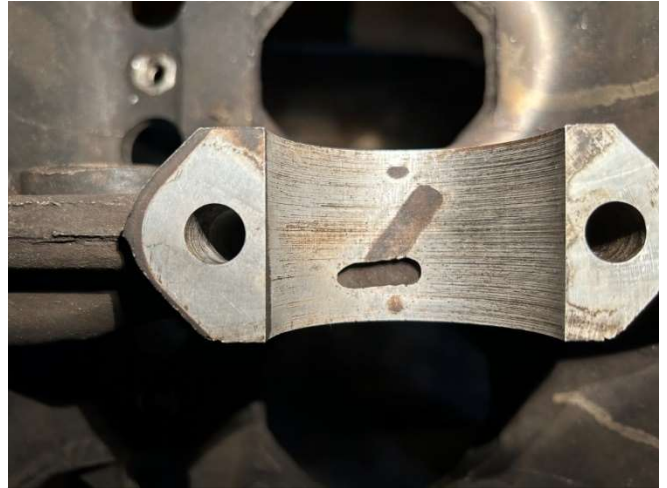
Caption: Upper crankcase main bearing cradle. Note offset oil gallery port and oil staining behind where the bearing oil passage relief is cast in the bearing shell.

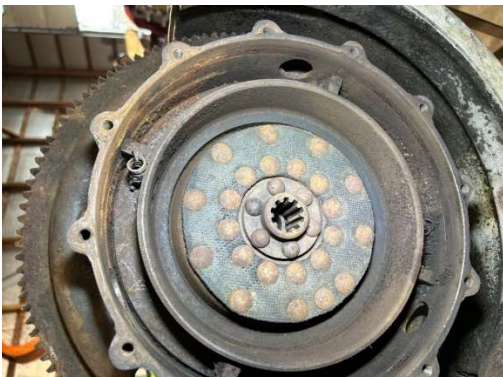
Caption: Clutch thrust ring in flywheel housing- Note the four centralizers rusted to the flywheel housing and broken release spring.

Now that I realized the crank had to come out, it was time to start working on removing the clutch from the flywheel which is necessary to obtain access to the bolts that hold the flywheel on the crankshaft. The flywheel has to be removed to access the bolts that fasten the rear main aluminum labyrinth style oil seal half castings to the block. Franklin used a Brown-Lipe 'pull' release type clutch design where the pressure plate assembly slides into the cast flywheel housing. There are four precision hard cast steel centralizers that hold the pressure plate assembly true in the housing. The problem was... you guessed it... the four centralizer blocks were rusted to the flywheel housing and they are not accessible when assembled. Again, using the tried and true penetrating oil

applications and heat I was able to free the pressure plate assembly but sacrificed a spring that holds the steel pressure plate friction disk retracted when the clutch is released. With the pressure plate assembly out, I could access the pressure plate friction ring and centralizers. With a little heat (Wes's rosebud torch) and Wes's vice grip slide hammer tool I was able to slowly and carefully pull, little-by-little, each of the four centralizers with the puller symmetrically moving the puller to each of the centralizers until the assembly pulled out. Nothing broke which was good since where can you find parts?!?

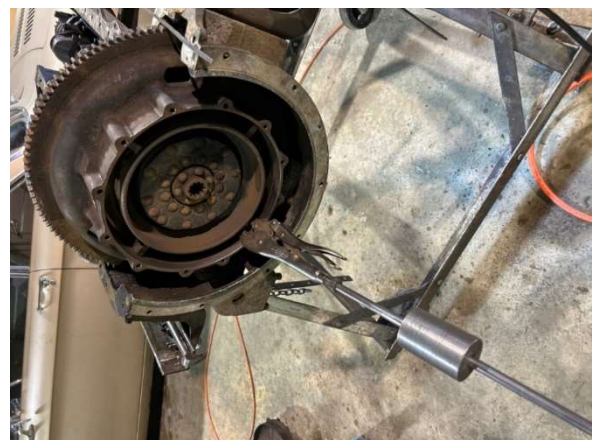
Caption: Pulling thrust ring out of flywheel housing.

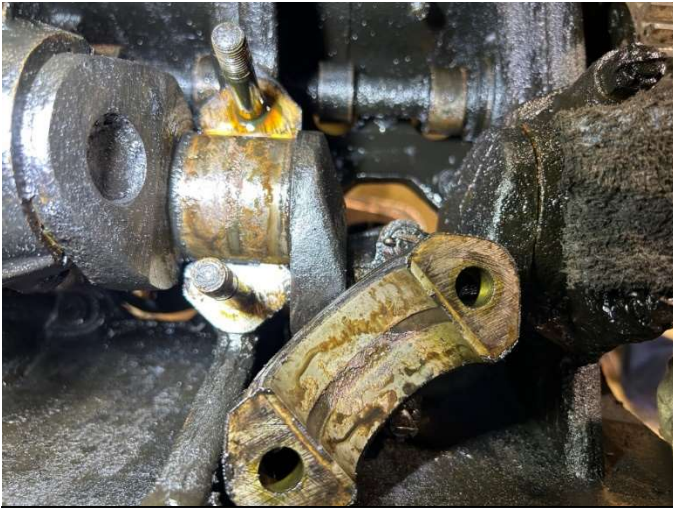
Caption: Years of condensation cycles rusted the surface of all the main journals.
