Stormwater Construction Site Inspection Report

Rattlesnake Creek Substation and Transmission Line

Substation: Steel erection. T-Line: foundation construction

Post-Storm Event

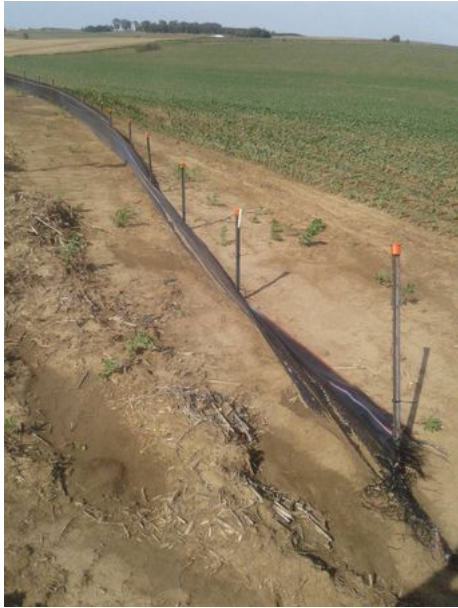
Appendix 1

Question	Response	Details
Add BMP		
BMP 1		
BMP Number	Silt Fence	
Is BMP Installed?	Yes	
BMP Maintenance Required?	Yes

<p style="text-align: center;">Appendix 1</p>		
Corrective action needed, Notes	Fix at entrance to Substation. Remove excess silt behind silt fence on west side approximately 320ft north of entrance and reattach to tee posts. Fix outstanding issues from Burns and McDonnell report and last SWPPP inspection 6/9/18	
BMP 2		
BMP Number	Concrete Washout: Substation	
Is BMP Installed?	Yes	
BMP Maintenance Required?	Yes

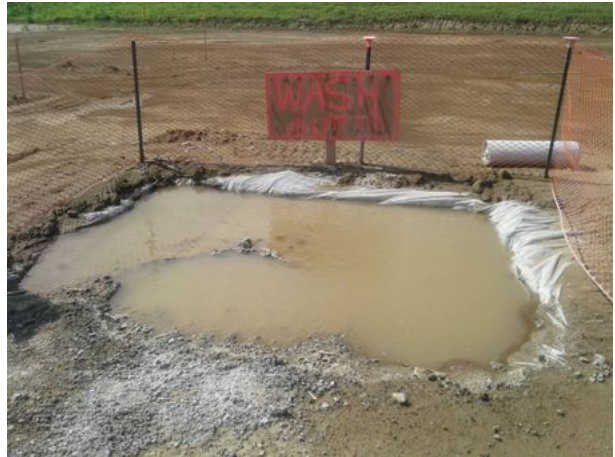
Appendix 2

<p style="text-align: center;">Appendix 2</p>		
Corrective action needed, Notes	Washout at substation is full of water. Cannot be used until water is removed or it evaporates.	
BMP 3		
BMP Number	Concrete Washout: T-line

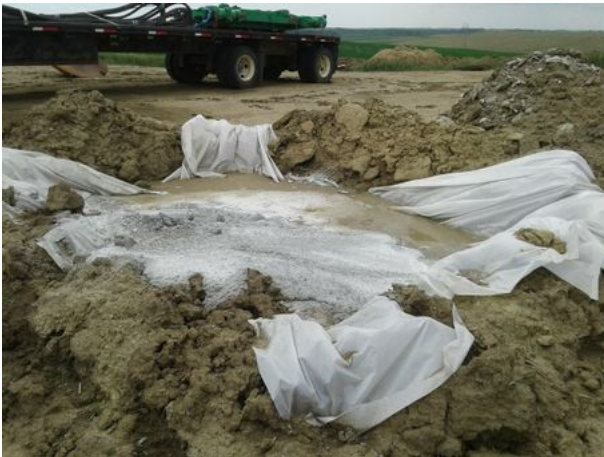
Appendix 3

</div> <div>Appendix 3</div>			
Corrective action needed, Notes		Washout at t-line is full, sides are down, can no longer be used and needs to be removed. Second washout at t-line needs to be removed. Both washout are now out of service.	
BMP 4			
BMP Number		Erosion control: wattles	
Is BMP Installed?		Yes	
BMP Maintenance Required?		Yes	
<div>

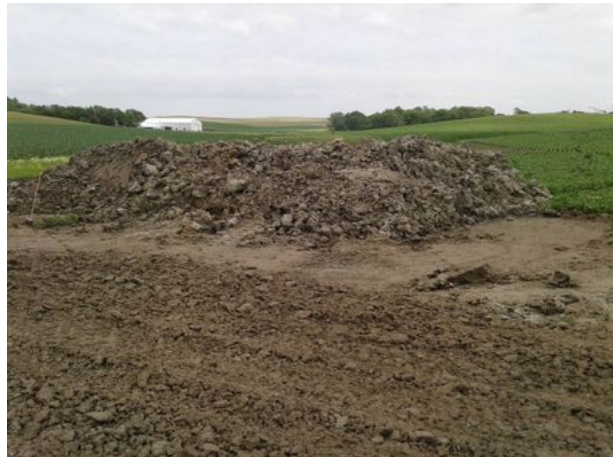
Appendix 4

</div> <div>Appendix 4</div>			
Corrective action needed, Notes		Wattles around concrete washout need to be staked to the ground. Spoil piles at structure 2 and structure 4 do not have wattles. Wattles are required to prevent erosion. Per SWPPP all spoil piles must be stabilized with mulch, soil tackifier, silt fence or other applicable BMP if in place for more than 14 days.
