Stormwater Construction Site Inspection Report

Rattlesnake Creek Substation and Transmission Line

CWS-201802602

Post-Storm Event

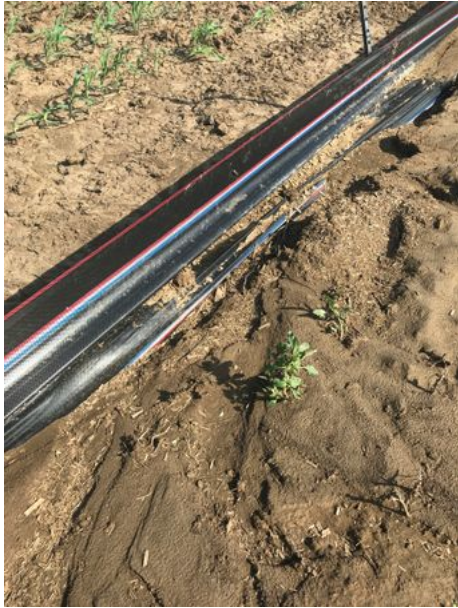
Appendix 1

Question	Response	Details
Add BMP		
BMP 1		
BMP Number	Silt Fence	
Is BMP Installed?	Yes	
BMP Maintenance Required?	Yes	
<div style="display: flex; justify-content: space-around; align-items: flex-end;"> <div style="text-align: center;">

<p>Appendix 3</p> </div> </div>		
Corrective action needed, Notes	Fix silt fence per Burns and McDonnell report. Recover silt fence on west side approximately 300ft north of entrance. Silt fence is ripped on the east side of the O&M pad, south end.	
BMP 2		
BMP Number	Concrete washout: Substation	
Is BMP Installed?	Yes	
BMP Maintenance Required?	No	
BMP 3		
BMP Number	Concrete washout: T-line	
Is BMP Installed?	Yes	
BMP Maintenance Required?	No	
<div style="display: flex; justify-content: space-around; align-items: flex-end;"> <div style="text-align: center;">
