Stormwater Construction Site Inspection Report

Rattlesnake Creek Substation and Transmission Line

CWS-201802602

07 Aug 2018 09:07 AM

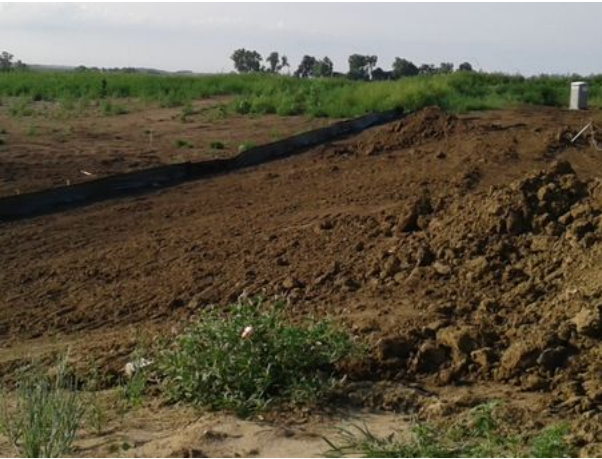
Appendix 1

Question	Response	Details
Question 1		
Are all slopes and disturbed areas not actively being worked properly stabilized?	Yes	
Maintenance Required?	Yes	Photos show silt fence prior to getting cut.
<div style="display: flex; justify-content: space-around; align-items: flex-end;"> <div style="text-align: center;">

Question	Response	Details
Add BMP		
BMP 1		
BMP Number	Substation: Silt Fence	
Is BMP Installed?	Yes	
BMP Maintenance Required?	Yes	
Corrective action needed, Notes	A Mortenson contractor cut the silt fence on east side of substation and repair is required. Silt fence is uncovered on west side of substation approximately 500 ft south of entrance.	
BMP 2		
BMP Number	Substation: Dumpster	
Is BMP Installed?	Yes	
BMP Maintenance Required?	Yes	
Corrective action needed, Notes	Dumpster is covered but it is full. Pickup is scheduled on 8/8/2018	
BMP 3		
BMP Number	Substation: Temporary Seeding	
Is BMP Installed?	Yes	
BMP Maintenance Required?	Yes	
Corrective action needed, Notes	Mortenson disturbed slopes on east side of substation on 8/7/2018 to install substation cabling. Re-seeding is required.	
BMP 4		
BMP Number	Substation: Wattle (S/E/C)	
Is BMP Installed?	Yes	
BMP Maintenance Required?	No	
BMP 5		
BMP Number	T-line: Dumpster

<p>Appendix 3</p> </div> </div>		
Corrective Action Needed, Notes	Substation slopes require re-seeding
