← SCAN TO LOAD THIS LOCATION

106304 RATTLESNAKE CREEK MONITORING

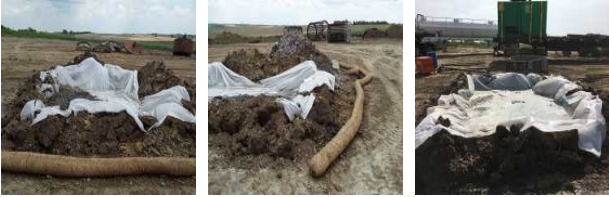
ID	Location	Issue Description	Assigned to	Due	Status
37	RATTLESNAKE CREEK MONITORING (T-line)	Measures & Controls: Substation - Concrete washouts need to be of an adequate volume capacity and design so they completely contain all concrete washout water. Exposed berms under the plastic can erode as they are not stabilized, resulting in failure of the concrete washout.	Not assigned		Closed

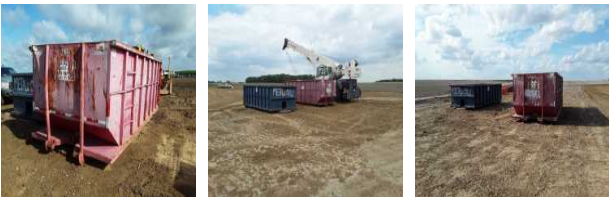
23	RATTLESNAKE CREEK MONITORING (Substation)	Measures & Controls: Substation - Trash receptacles must be covered with netting or equivalent control to avoid trash from blowing offsite, in compliance with the SWPPP/General Permit. Assigned To: SCS	Not assigned		Open
