Dermoid Sinus

Overview

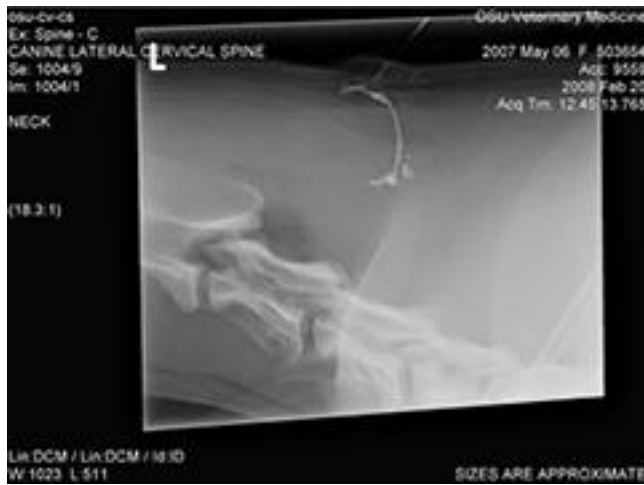
Figure 1. Contrast fistulogram. Contrast material has been injected into the sinus.

Your primary care veterinarian may probe the sinus by placing a catheter into the opening. A contrast fistulogram (Figure 1) can be performed by injecting contrast material into the sinus and then taking a radiograph. Because the depth of the sinus is often filled with hair or keratin debris, probing and contrast fistulography may underestimate the depth of the sinus. In this case or when connection to the lining of the spinal cord is suspected, advanced imaging may be recommended, such as:
