November 2024
SAFETY ALERT 03/24

Critical Failures in Lifeboat Release Gear Cables

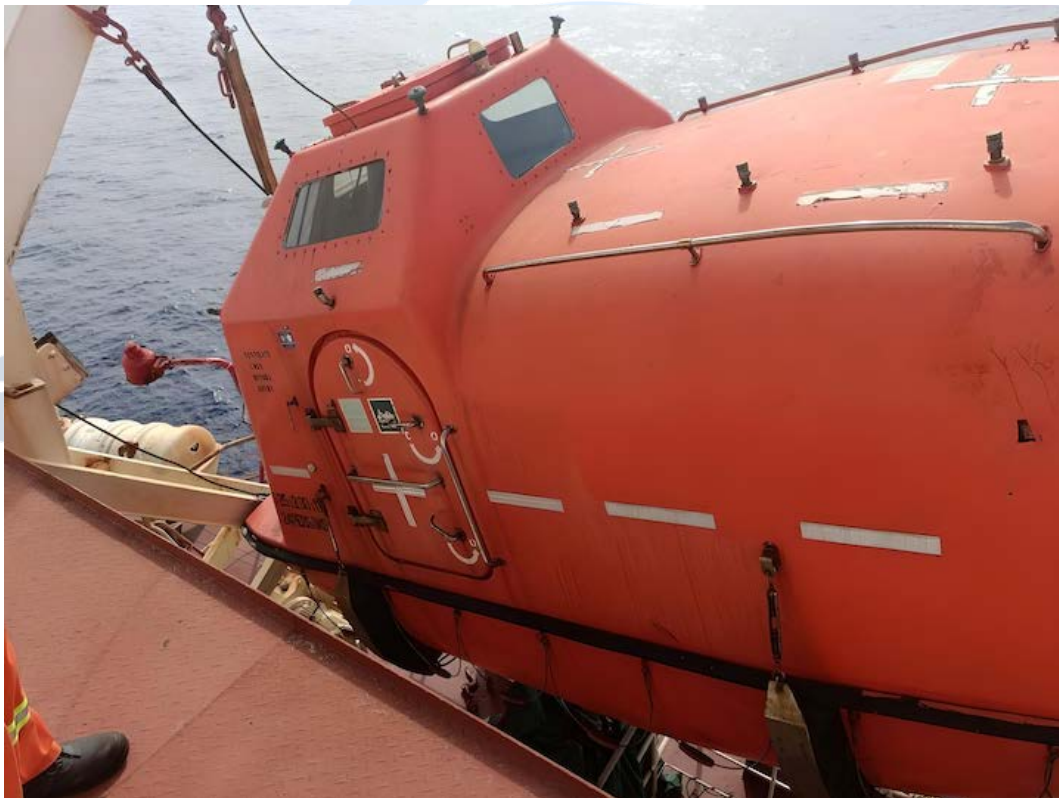
- In one incident, the aft hook of a lifeboat opened unexpectedly during a routine monthly lowering exercise. A serious accident was avoided only because Fall Preventer Devices (FPDs) were fitted. The hook design had been previously modified to meet new LSA Code requirements, but this incident raises concerns about the effectiveness of such modifications on older hook systems, particularly as the hook did not fail to safe when the cable failed

Figure 1: The port lifeboat suspended by FPD following opening of the aft hook due to a failed release gear cable. Note the angle of the boat indicating fwd hook is still properly engaged.

6. **Questionable Hook Modifications:** The inability of a lifeboat hook system to fail to safe, as designed, following a component failure raises questions about the effectiveness of modifying old non-compliant hook systems to comply with sections 4.4.7.6.4 to 4.4.7.6.6 of the LSA Code.

- **Immediately remove the lifeboat from service:** Secure the lifeboat with maintenance pendants to prevent any operational use until repairs are completed.

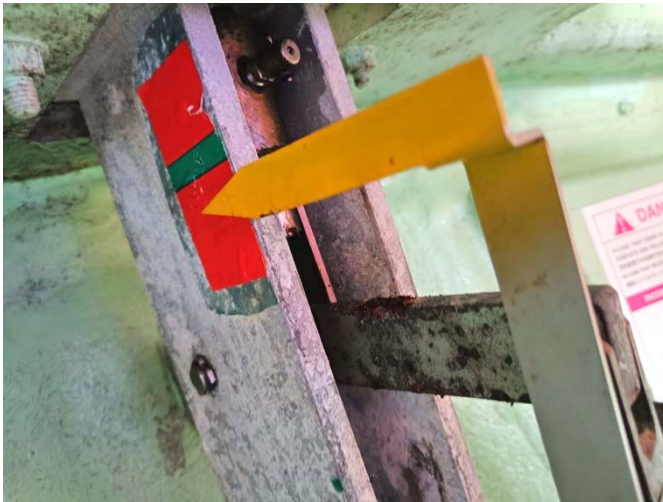
- In another incident, excessive paint on the hook units restricted their movement, with paint intrusion into critical areas such as the main hook pin, bushes, and locking pin further hampering functionality. During resetting, the aft hook failed to return to its locking position, and the locking pin could not close. The crew applied excessive force on the release handle, ultimately breaking the cable.

Figure 2: Aft hook indicator shows the hook is not properly reset. Despite which, the crew continued to force the system to close

4. **Excessive Paint:** Over-painting of hook units inhibits movement, contaminates key components (such as pins and bushes), and leads to seizing or malfunction.

5. **Improper Resetting Practices:** Application of excessive force on release handles during hook resetting when components are fouled, ultimately causing cable damage.

8. **Lack of knowledge on correct operation:** The crew did not abort resetting when visual indicators showed a hook was not fully reset. This suggests inadequate training or disregard for the risks of excessive force beyond the hook system's design limits, resulting in cable failure.

- If excessive force is needed to reset or release a hook, abort the operation and investigate.
- Ensure forces required for release and reset are within design criteria (100N to 300N for fully loaded systems).

- Replace release gear cables every 5 years or sooner if signs of deterioration appear.
- Avoid over-painting hook units, as they are designed to operate without additional coatings.

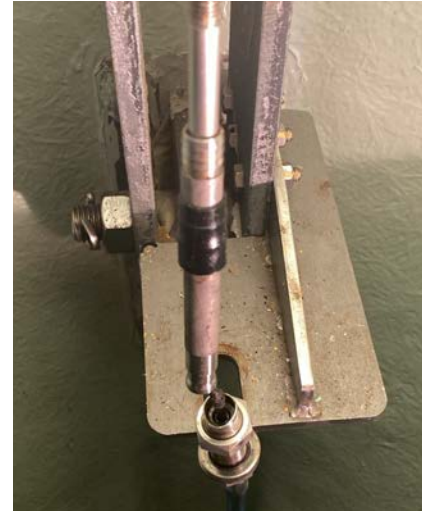
Figure 3: The aft hook cable failed

1. **Substandard Cable Quality:** Failure caused by the use of push-pull cables not designed for the compressive and tensile forces required in lifeboat operations.

2. **Improper Installation:** Issues arising from improper bend radii that exceed cable design specifications, leading to lower efficiency, mechanical stress and eventual failure.

3. **Corrosion:** Gradual degradation due to water ingress at cable connections, often caused by insufficient sealing and exposure to marine environments.

- Use push-pull cables that are suited for lifeboat release gear operations rated for the necessary push and pull load requirements with suitable bend radii and efficiency rating.
- Ensure all exposed cable fittings are marine-grade stainless steel (LSA Code 4.4.7.6.9).
- Engage manufacturers or approved service providers, such as Watercraft Marine, for guidance on appropriate cable specifications.

- **Notify flag state and classification society:** Seek guidance for dispensation requirements and ensure compliance with applicable regulations.
- **Avoid temporary repairs:** Under no circumstances should temporary repairs be attempted on lifeboat cables or other critical components. Such measures compromise safety and do not restore the system to its required operational standards.
