## TEST REPORT

Report No.: HLB0310A/2021

Product Description: S-102 Twist-to-Break Nylon Cable Tie

<u>Test Requested:</u> Refer to IEC 62275:2019 Clause 6.2.1 loop tensile strength for cable ties

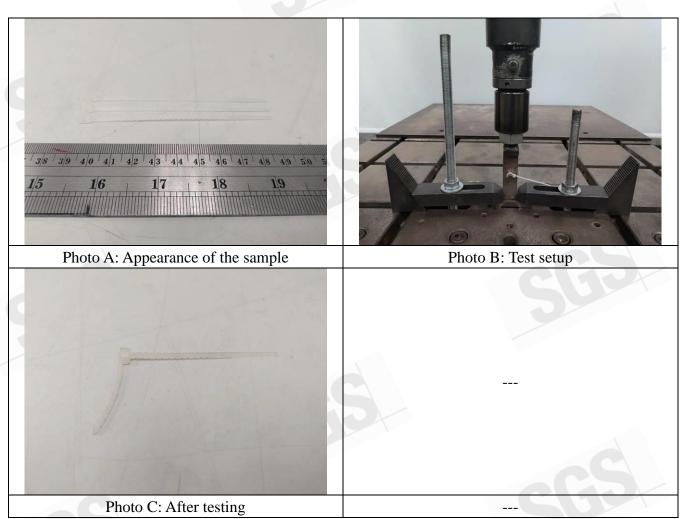
## – Picture(s) –

(a). Secure the sample on the testing machine. (See photo B)

Sample	Max. force	Client Declare Requirement Force	Remark
S-102 Twist-to-Break Nylon Cable Tie	10.69 kgf	8 kgf	The sample was damaged after testing. (See photo C)
