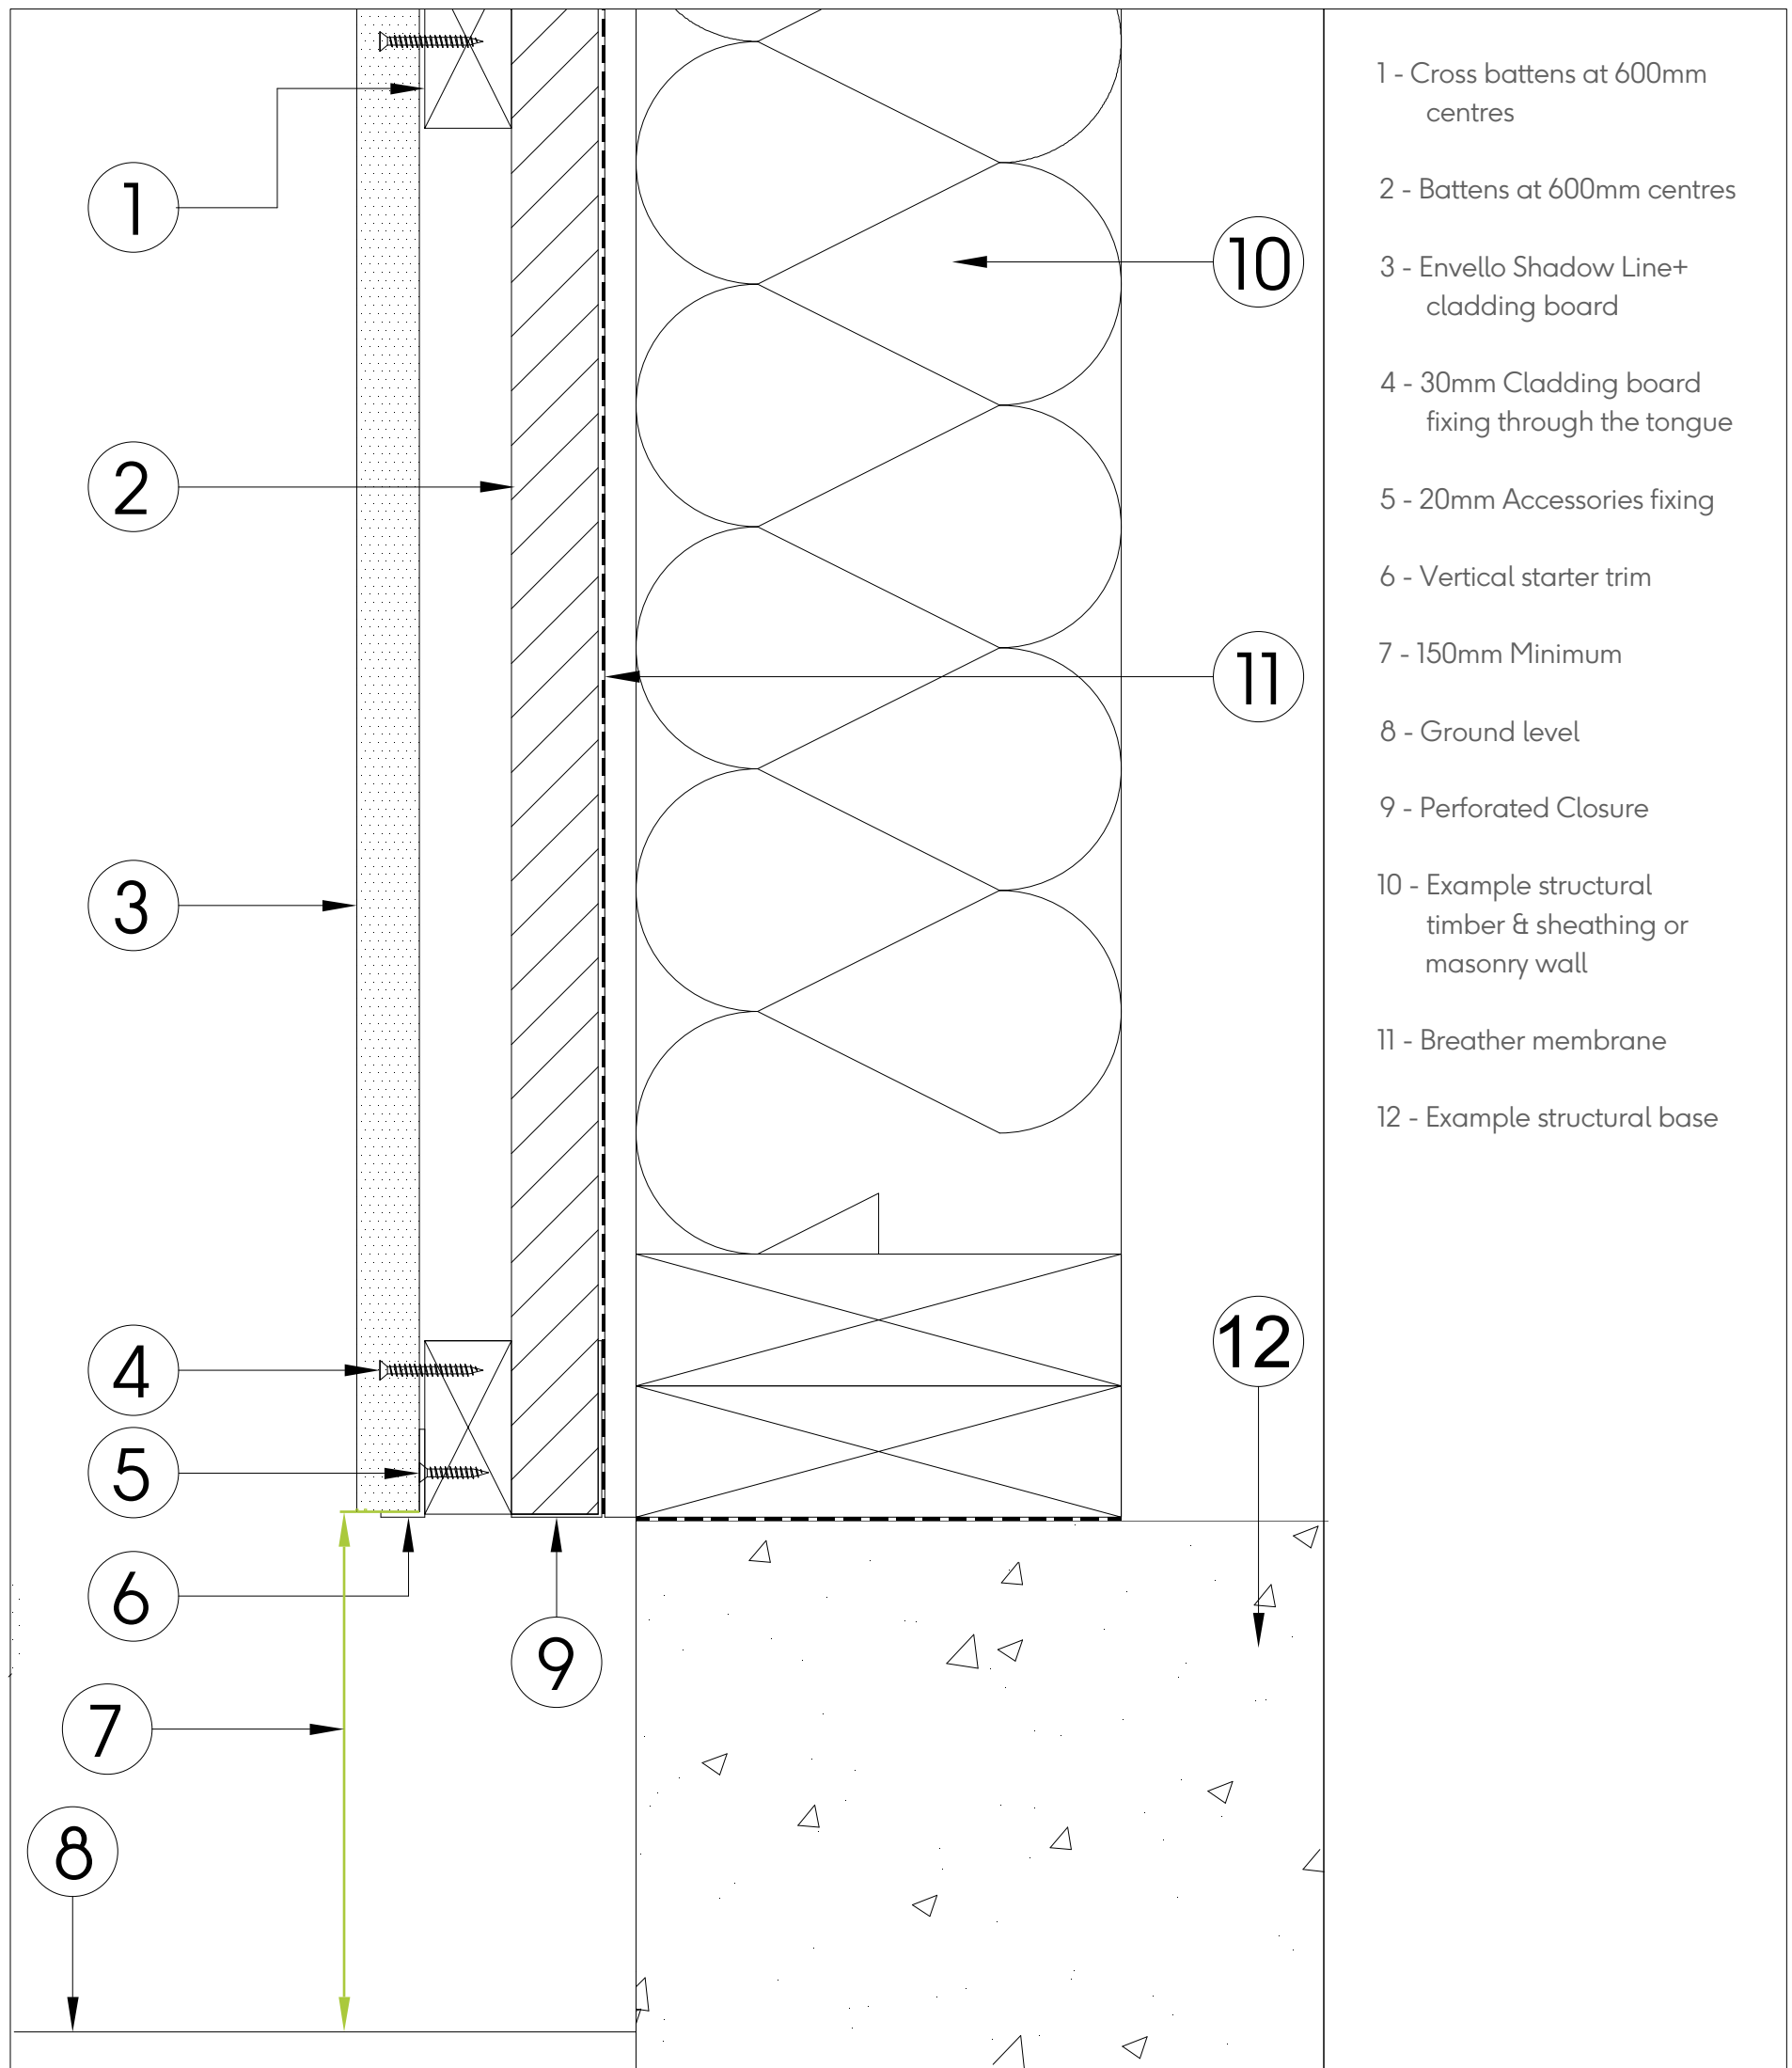
#101.22.01

Bottom of cladding detail

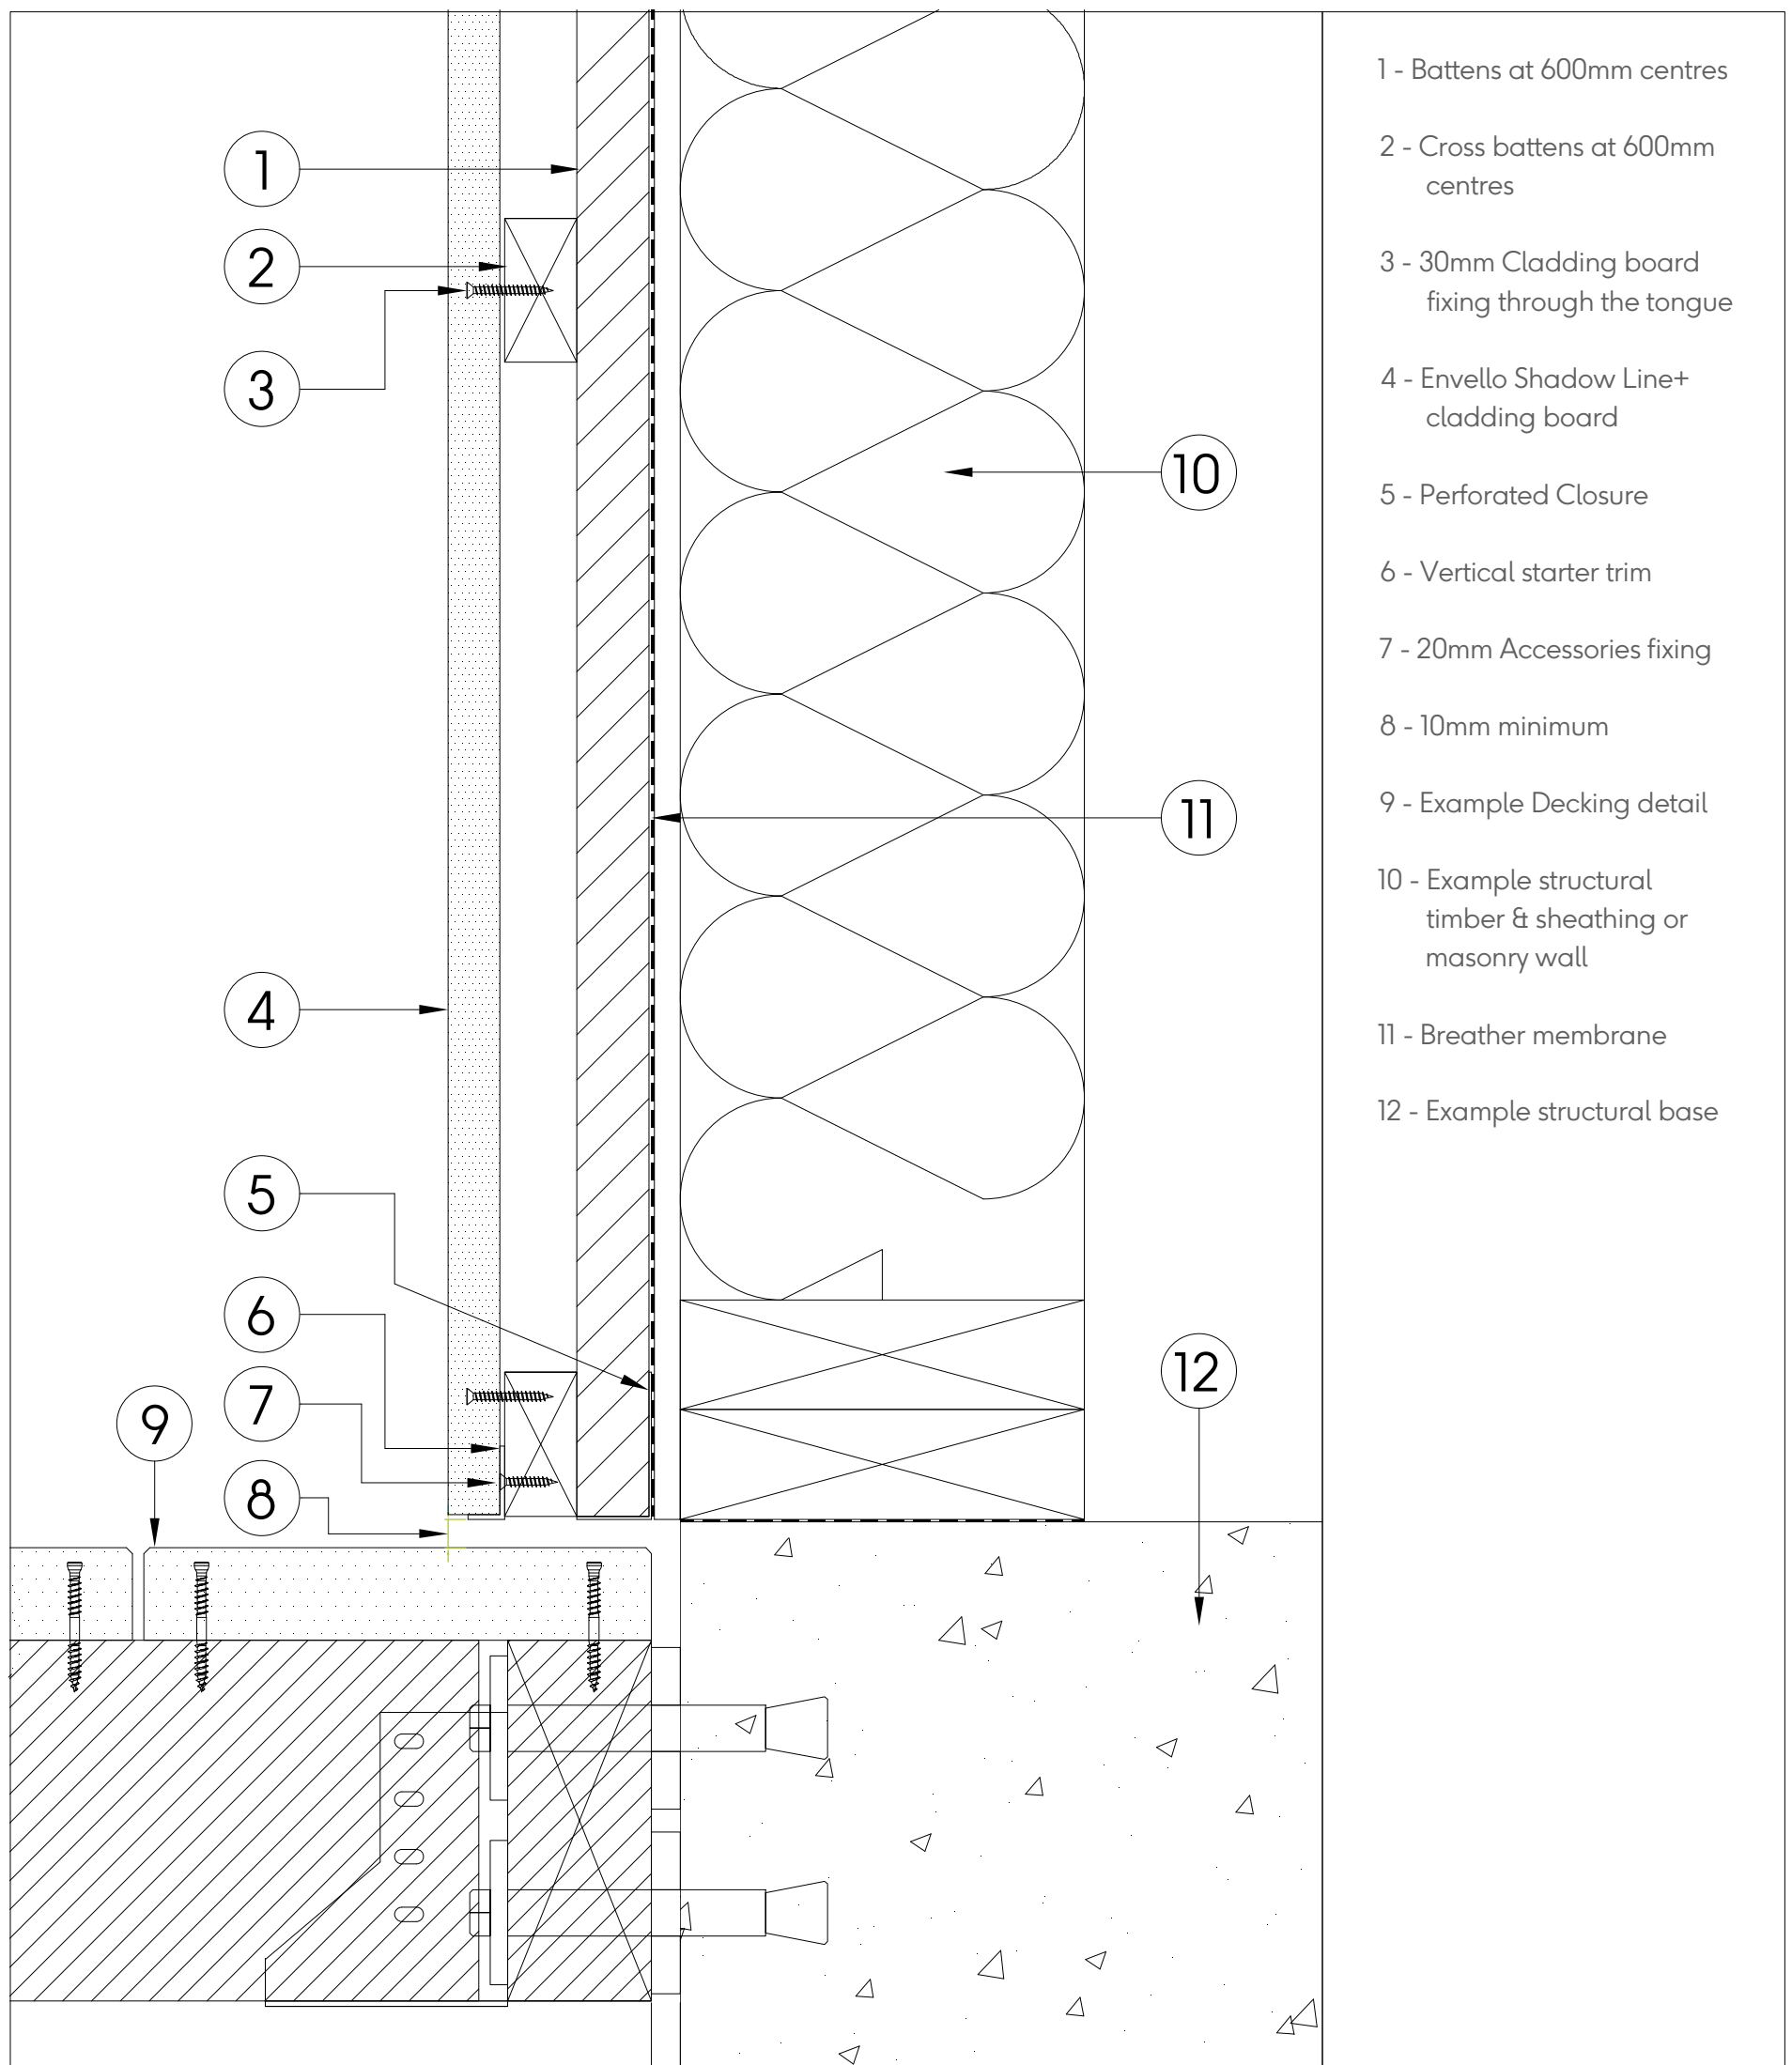
#102.22.01

Cladding to decking junction

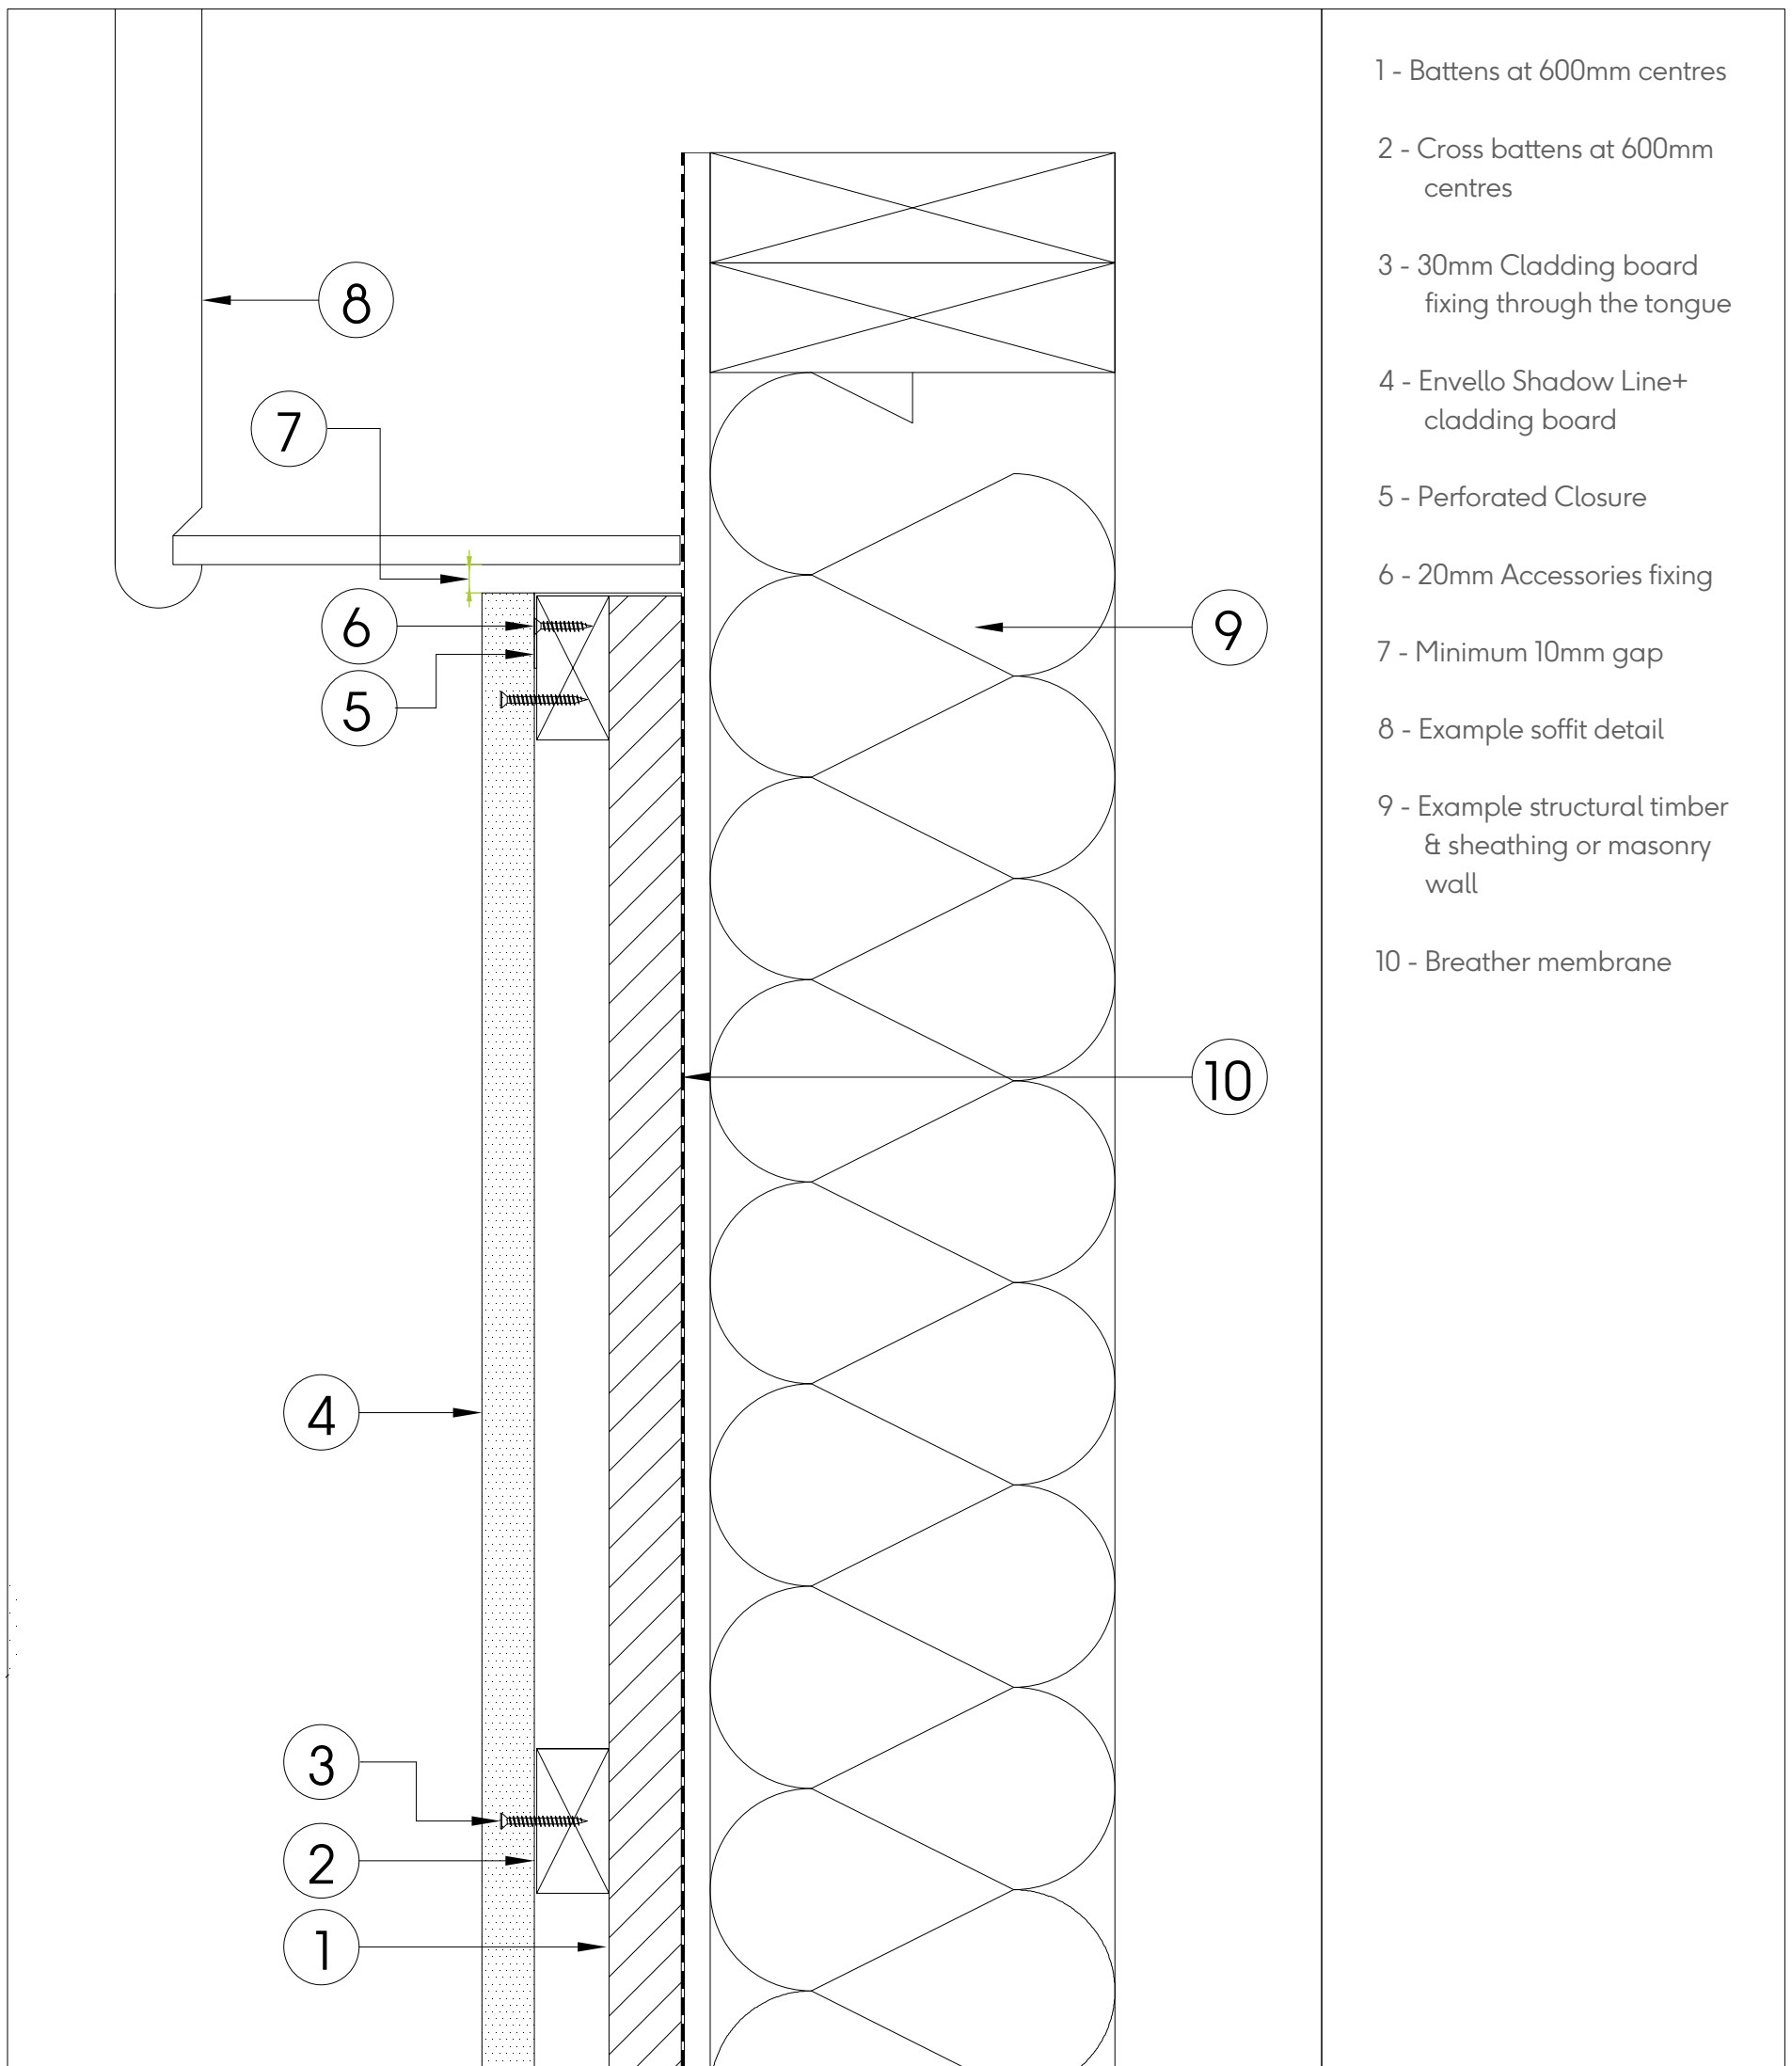
#103.22.01

Soffit junction detail

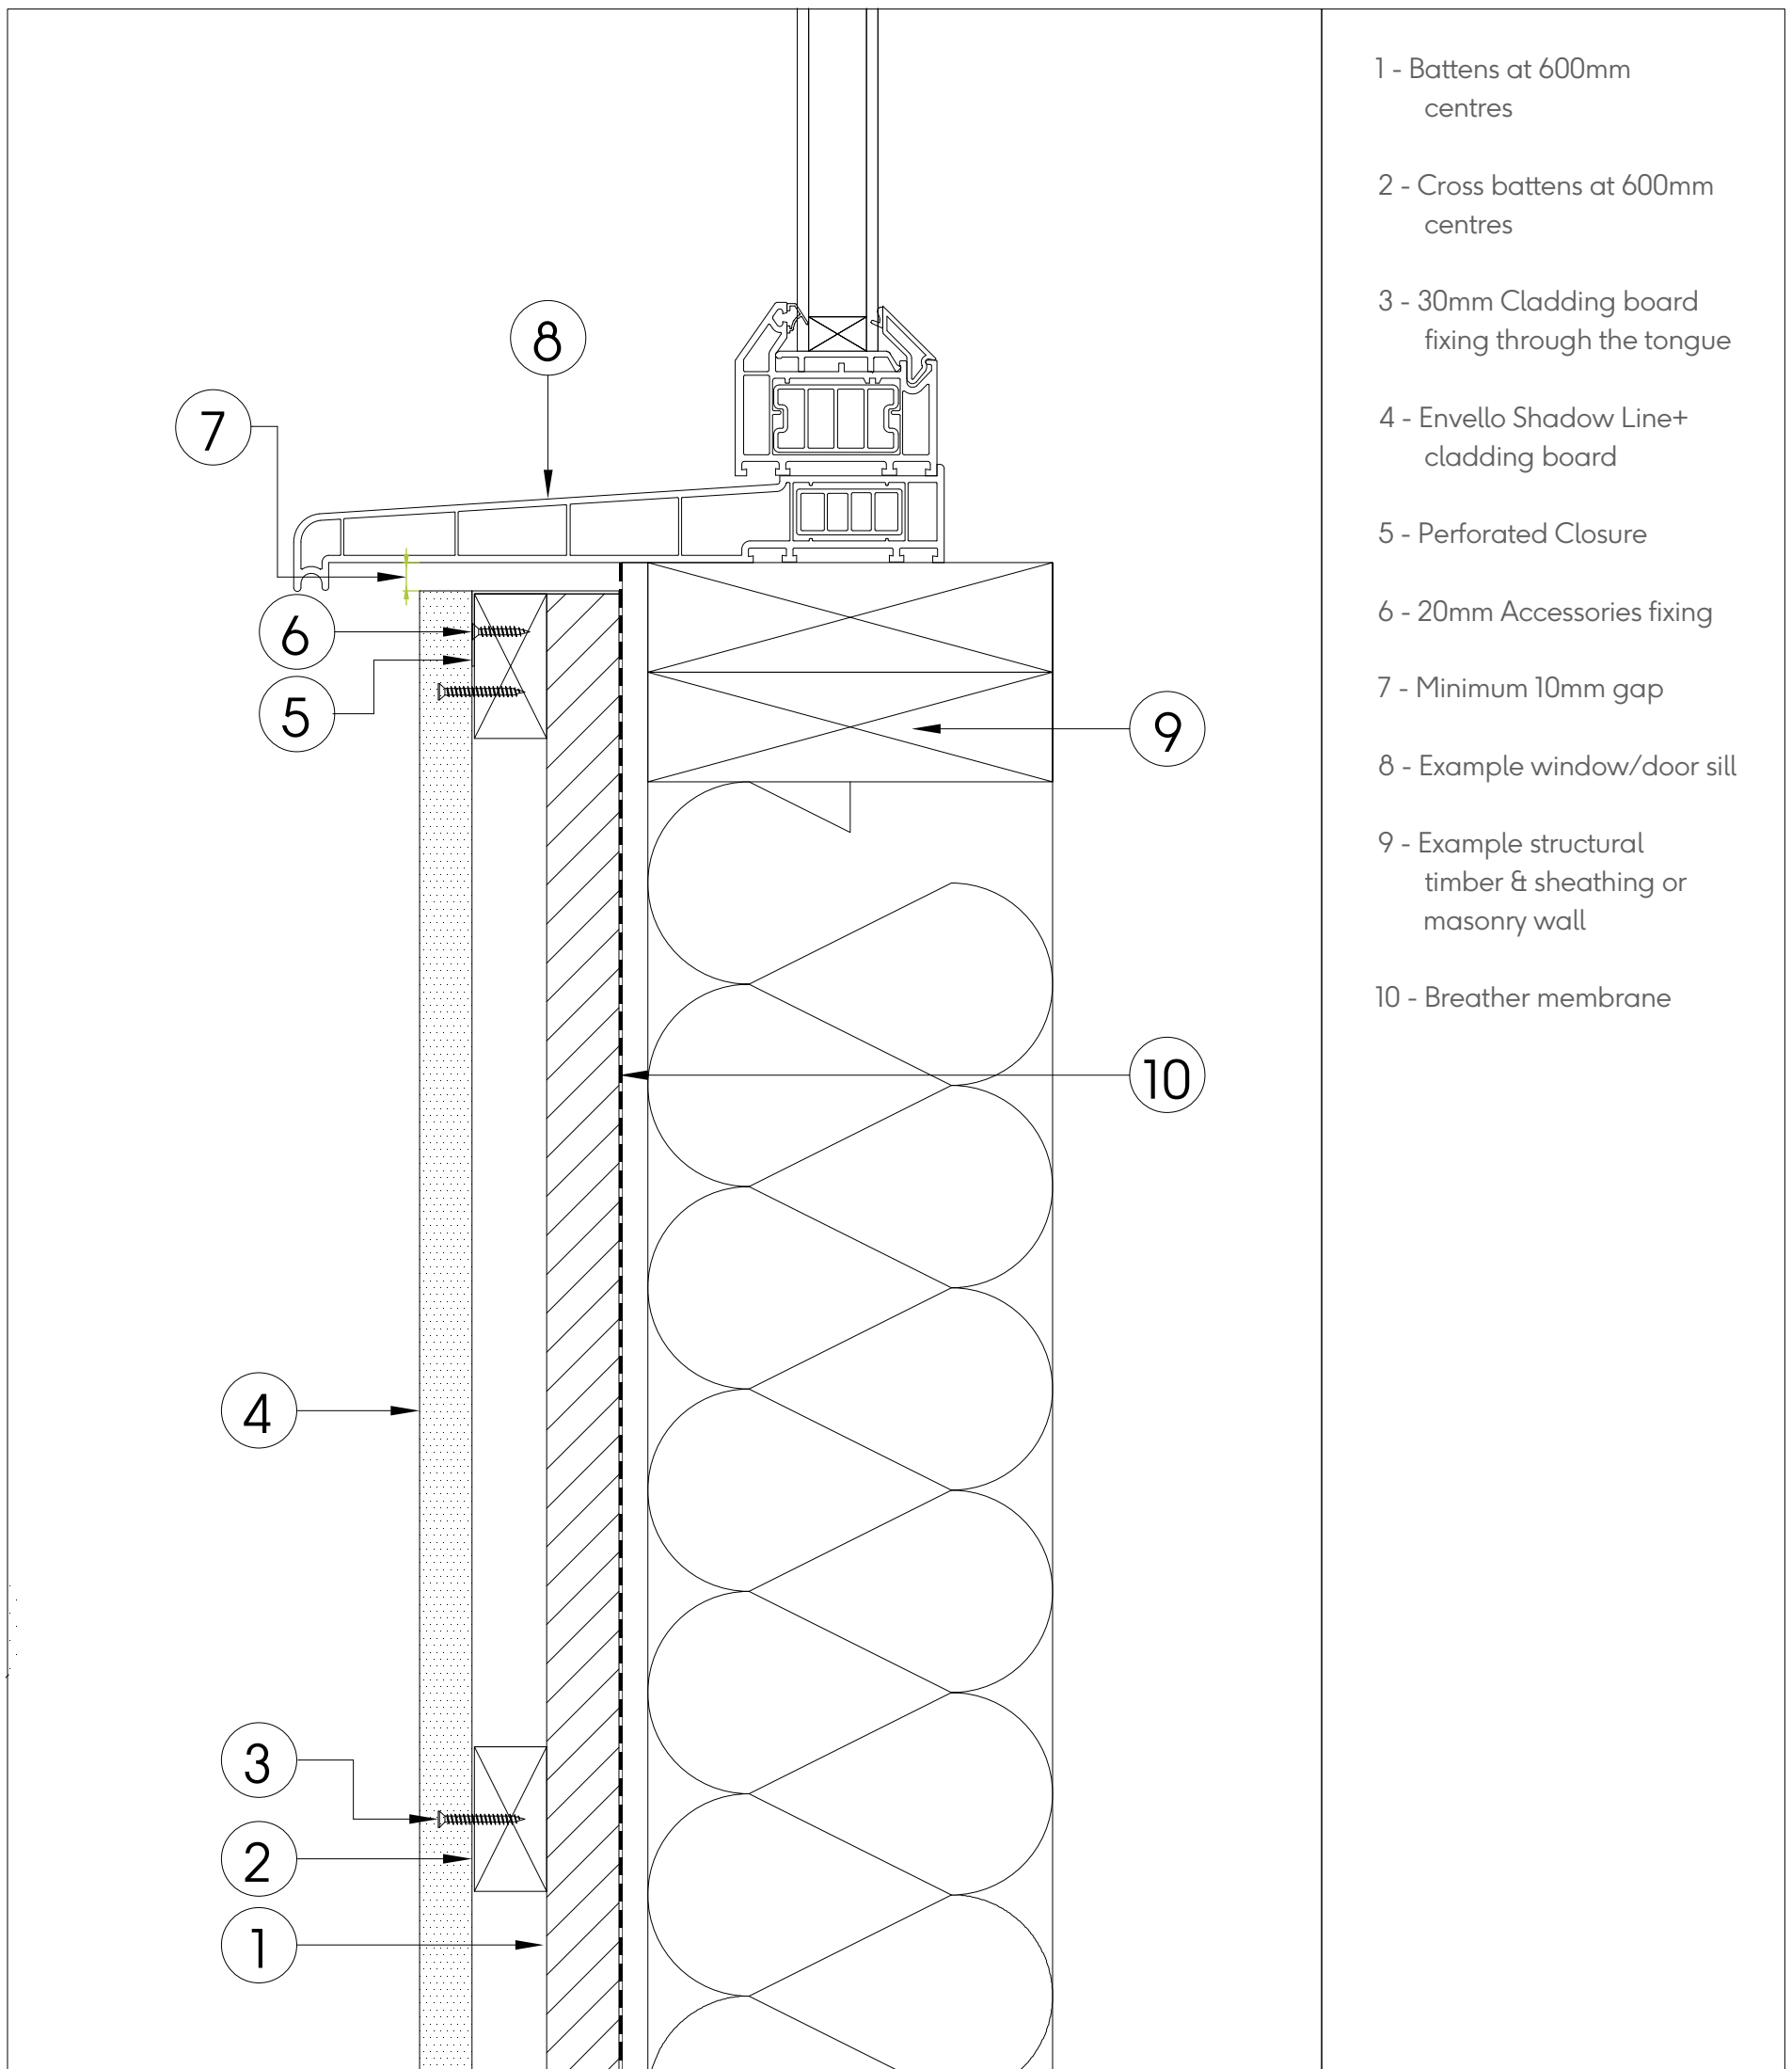
#104.22.01

Window/Door sill junction

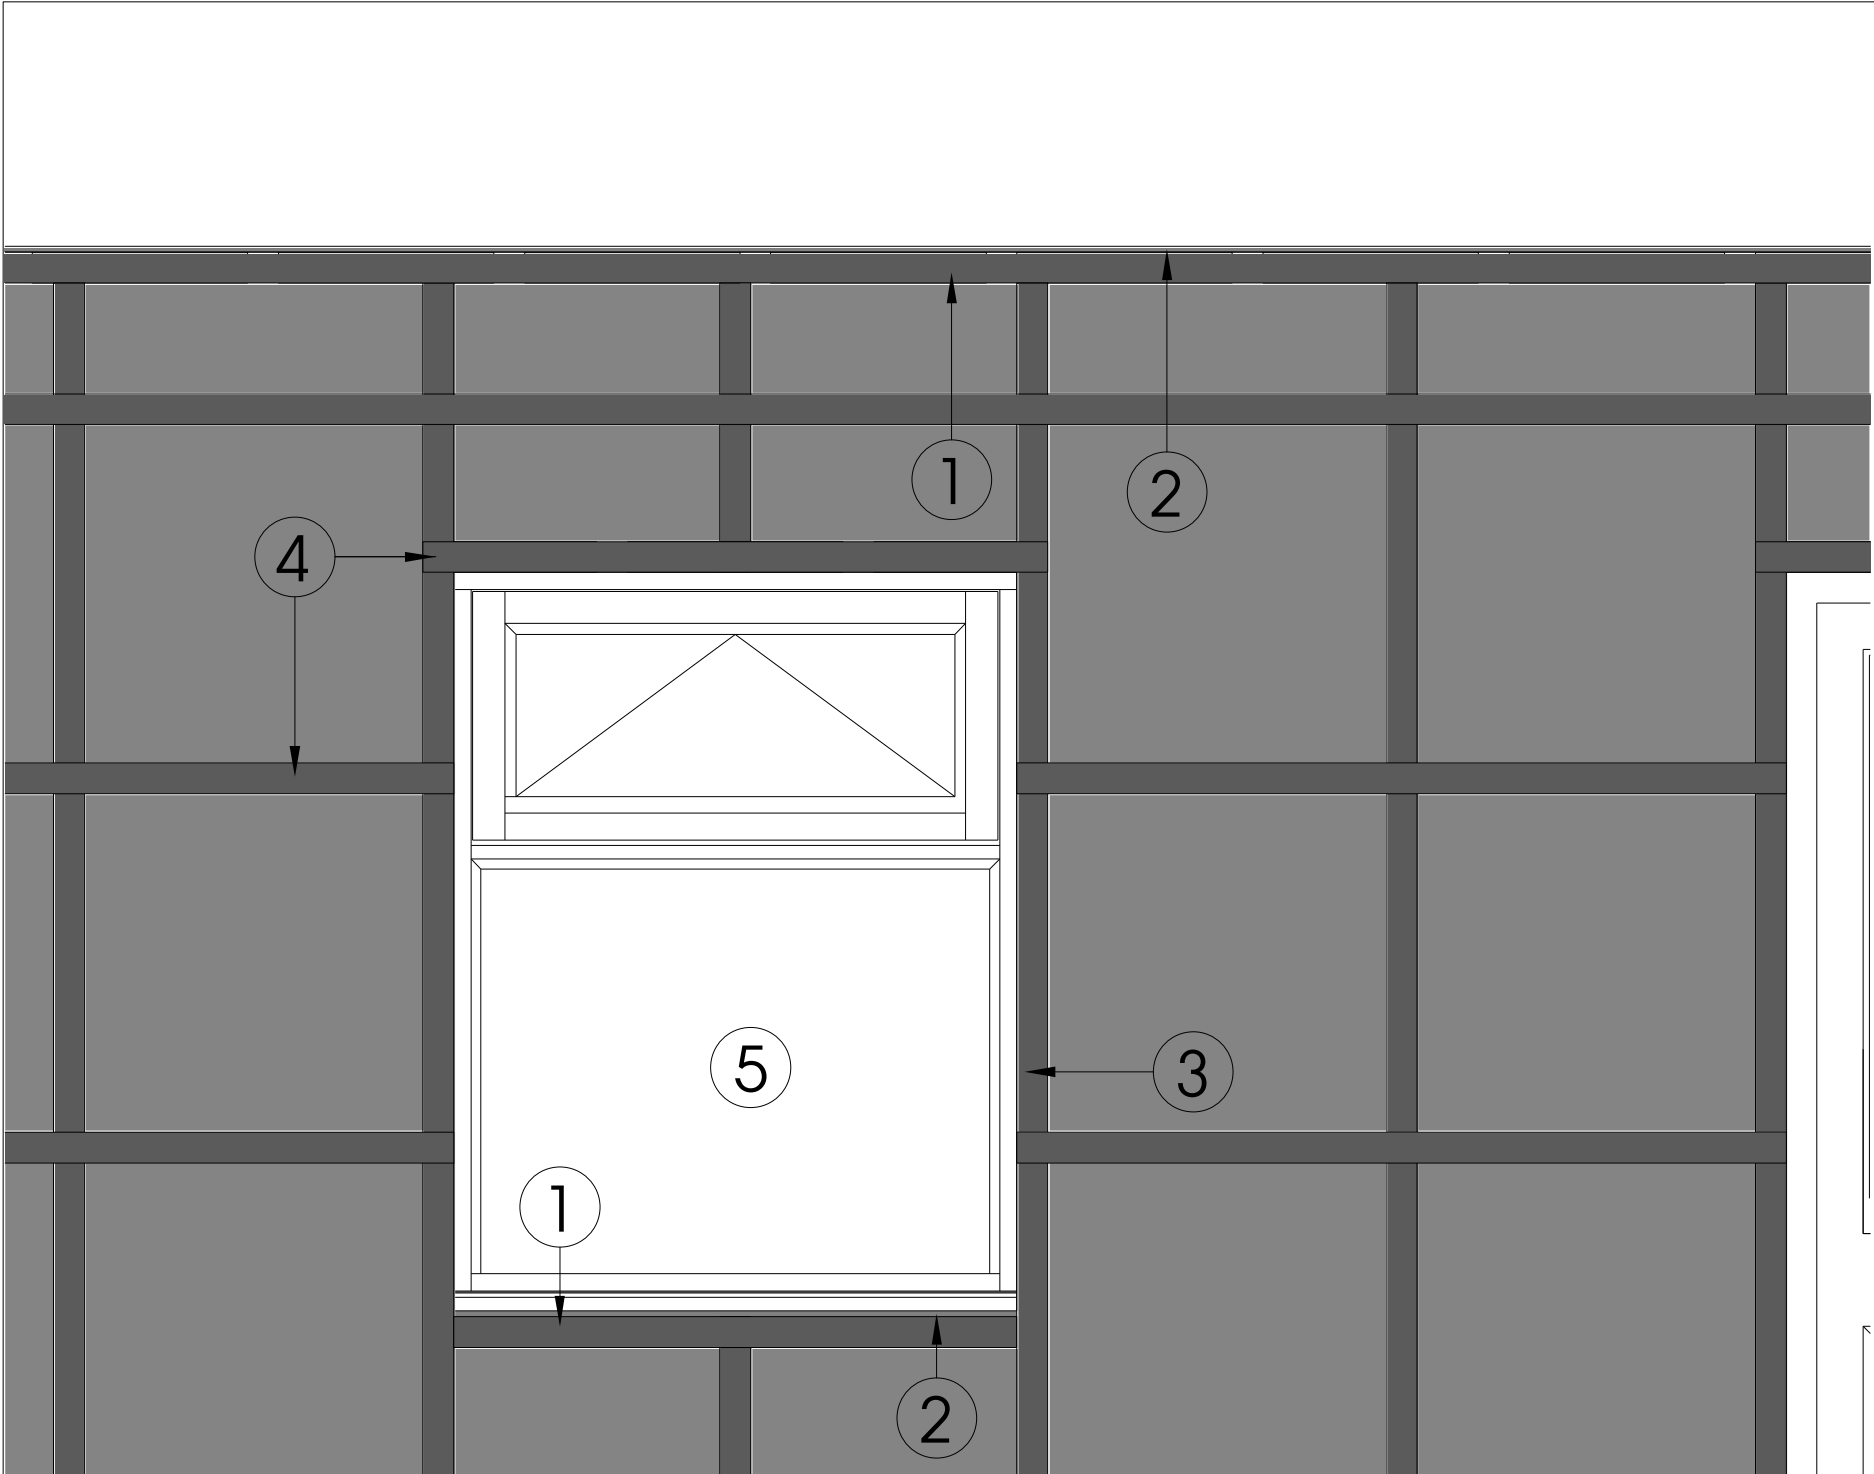
#107.22.01

Batten Layout - around an opening

- 1 - Perforated Closure
(behind batten)
- 2 - 10mm Gap
- 3 - Battens at 600mm
centres
- 4 - Cross battens at 600mm
centres
- 5 - Example window

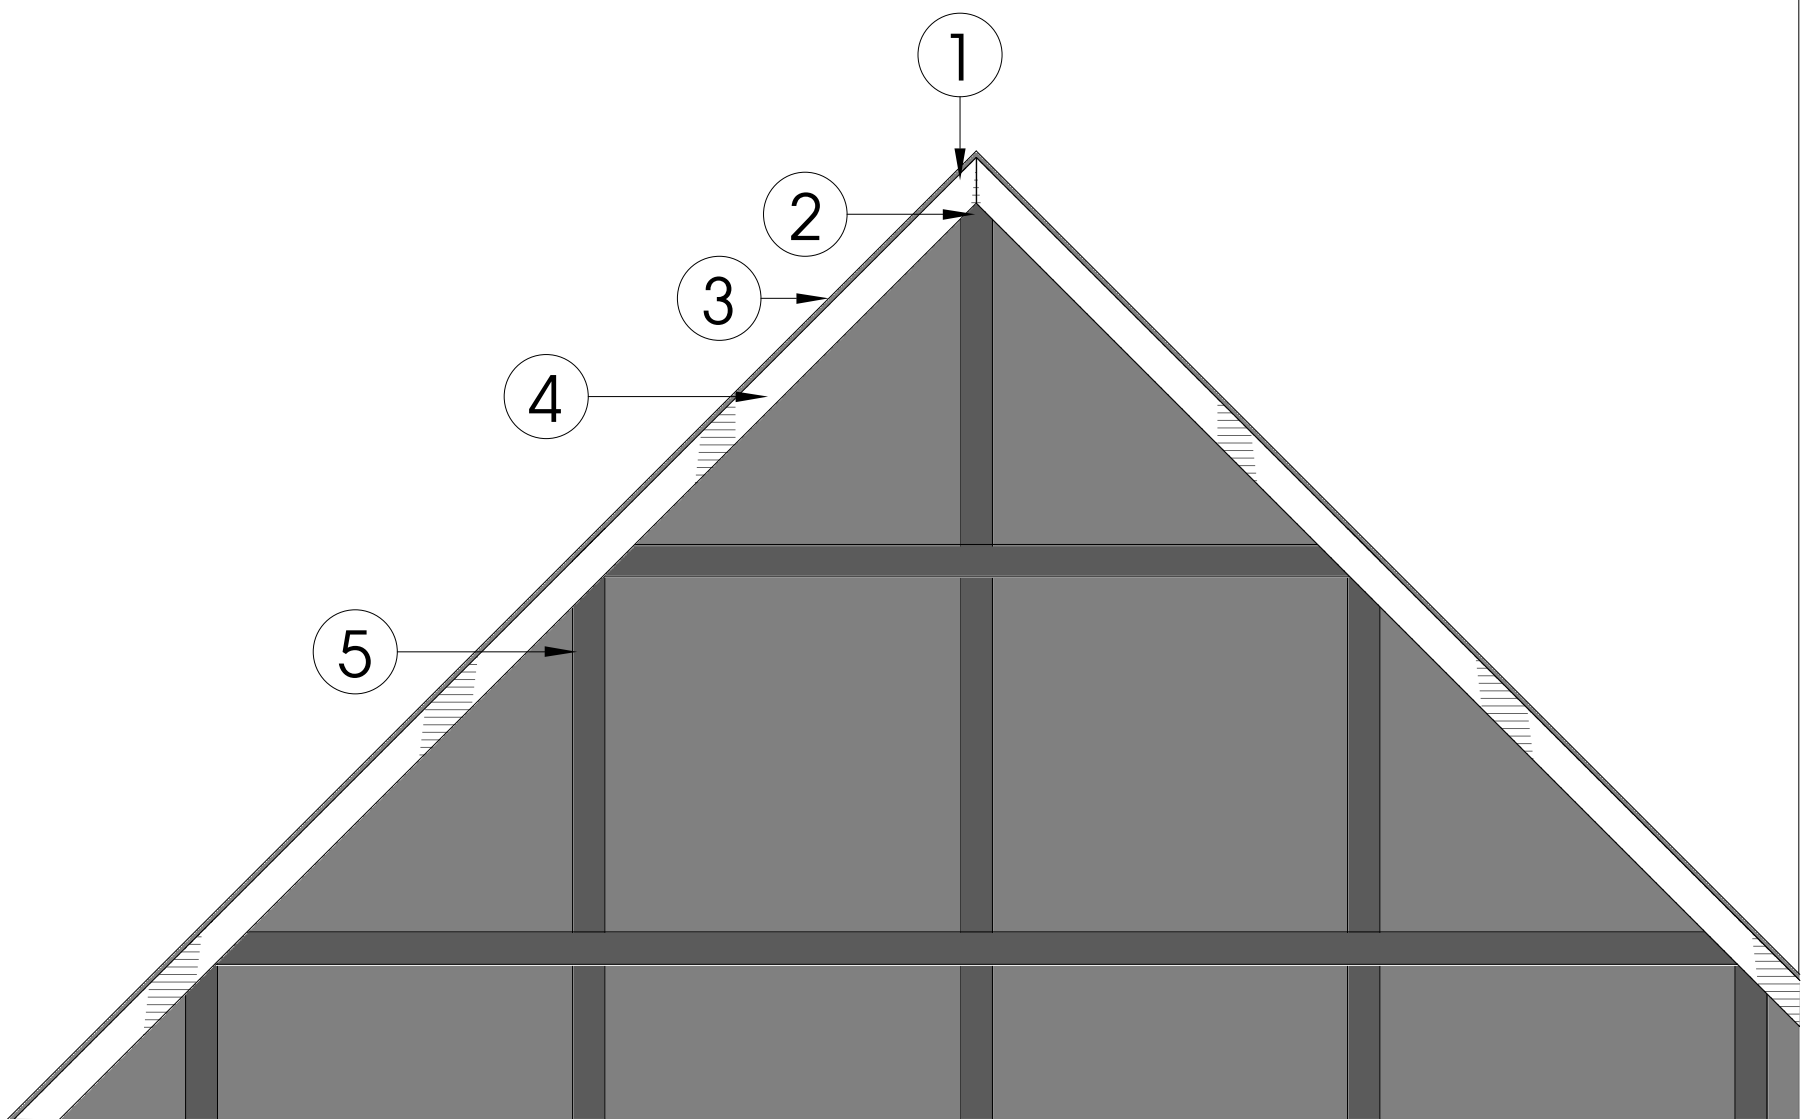
#108.22.01

Batten Layout - Gable end

- 1 - Perforated Closure (behind top batten)
- 2 - Battens at 600mm centres
- 3 - 10mm Gap

- 4 - Batten running up the edges to support the board ends
- 5 - Cross battens at 600mm centres
