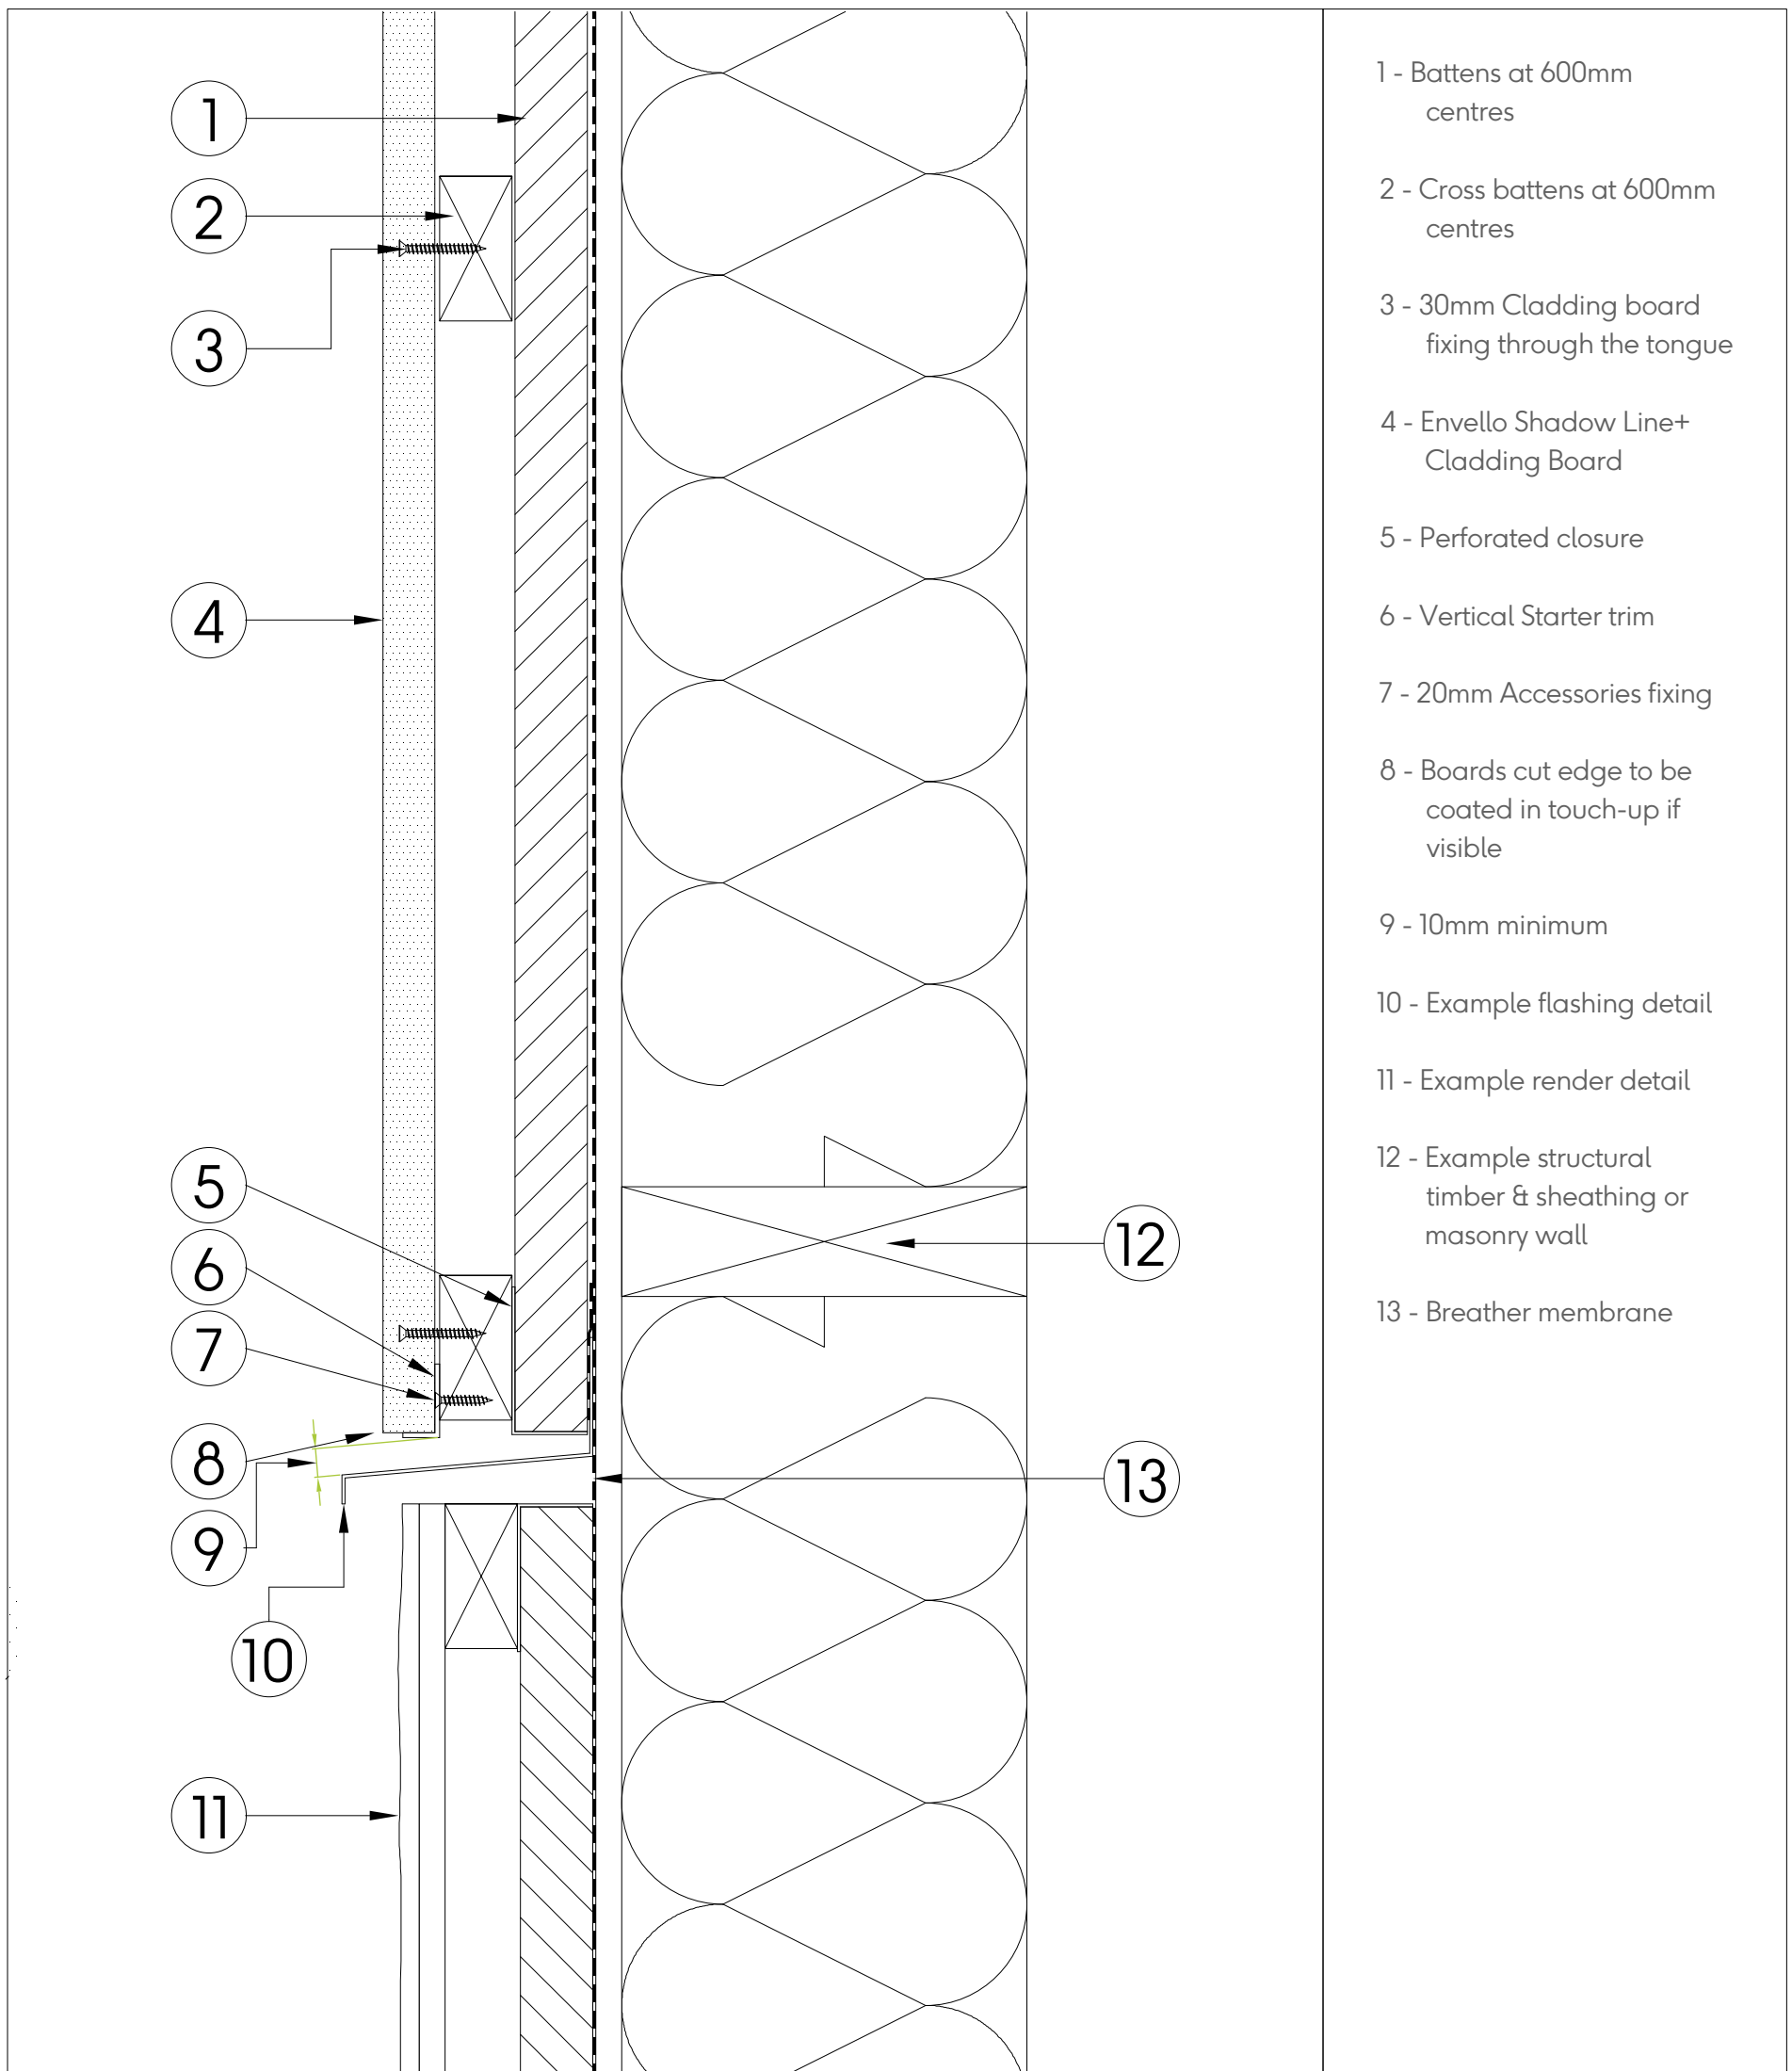
#109.22.01

Joining render detail

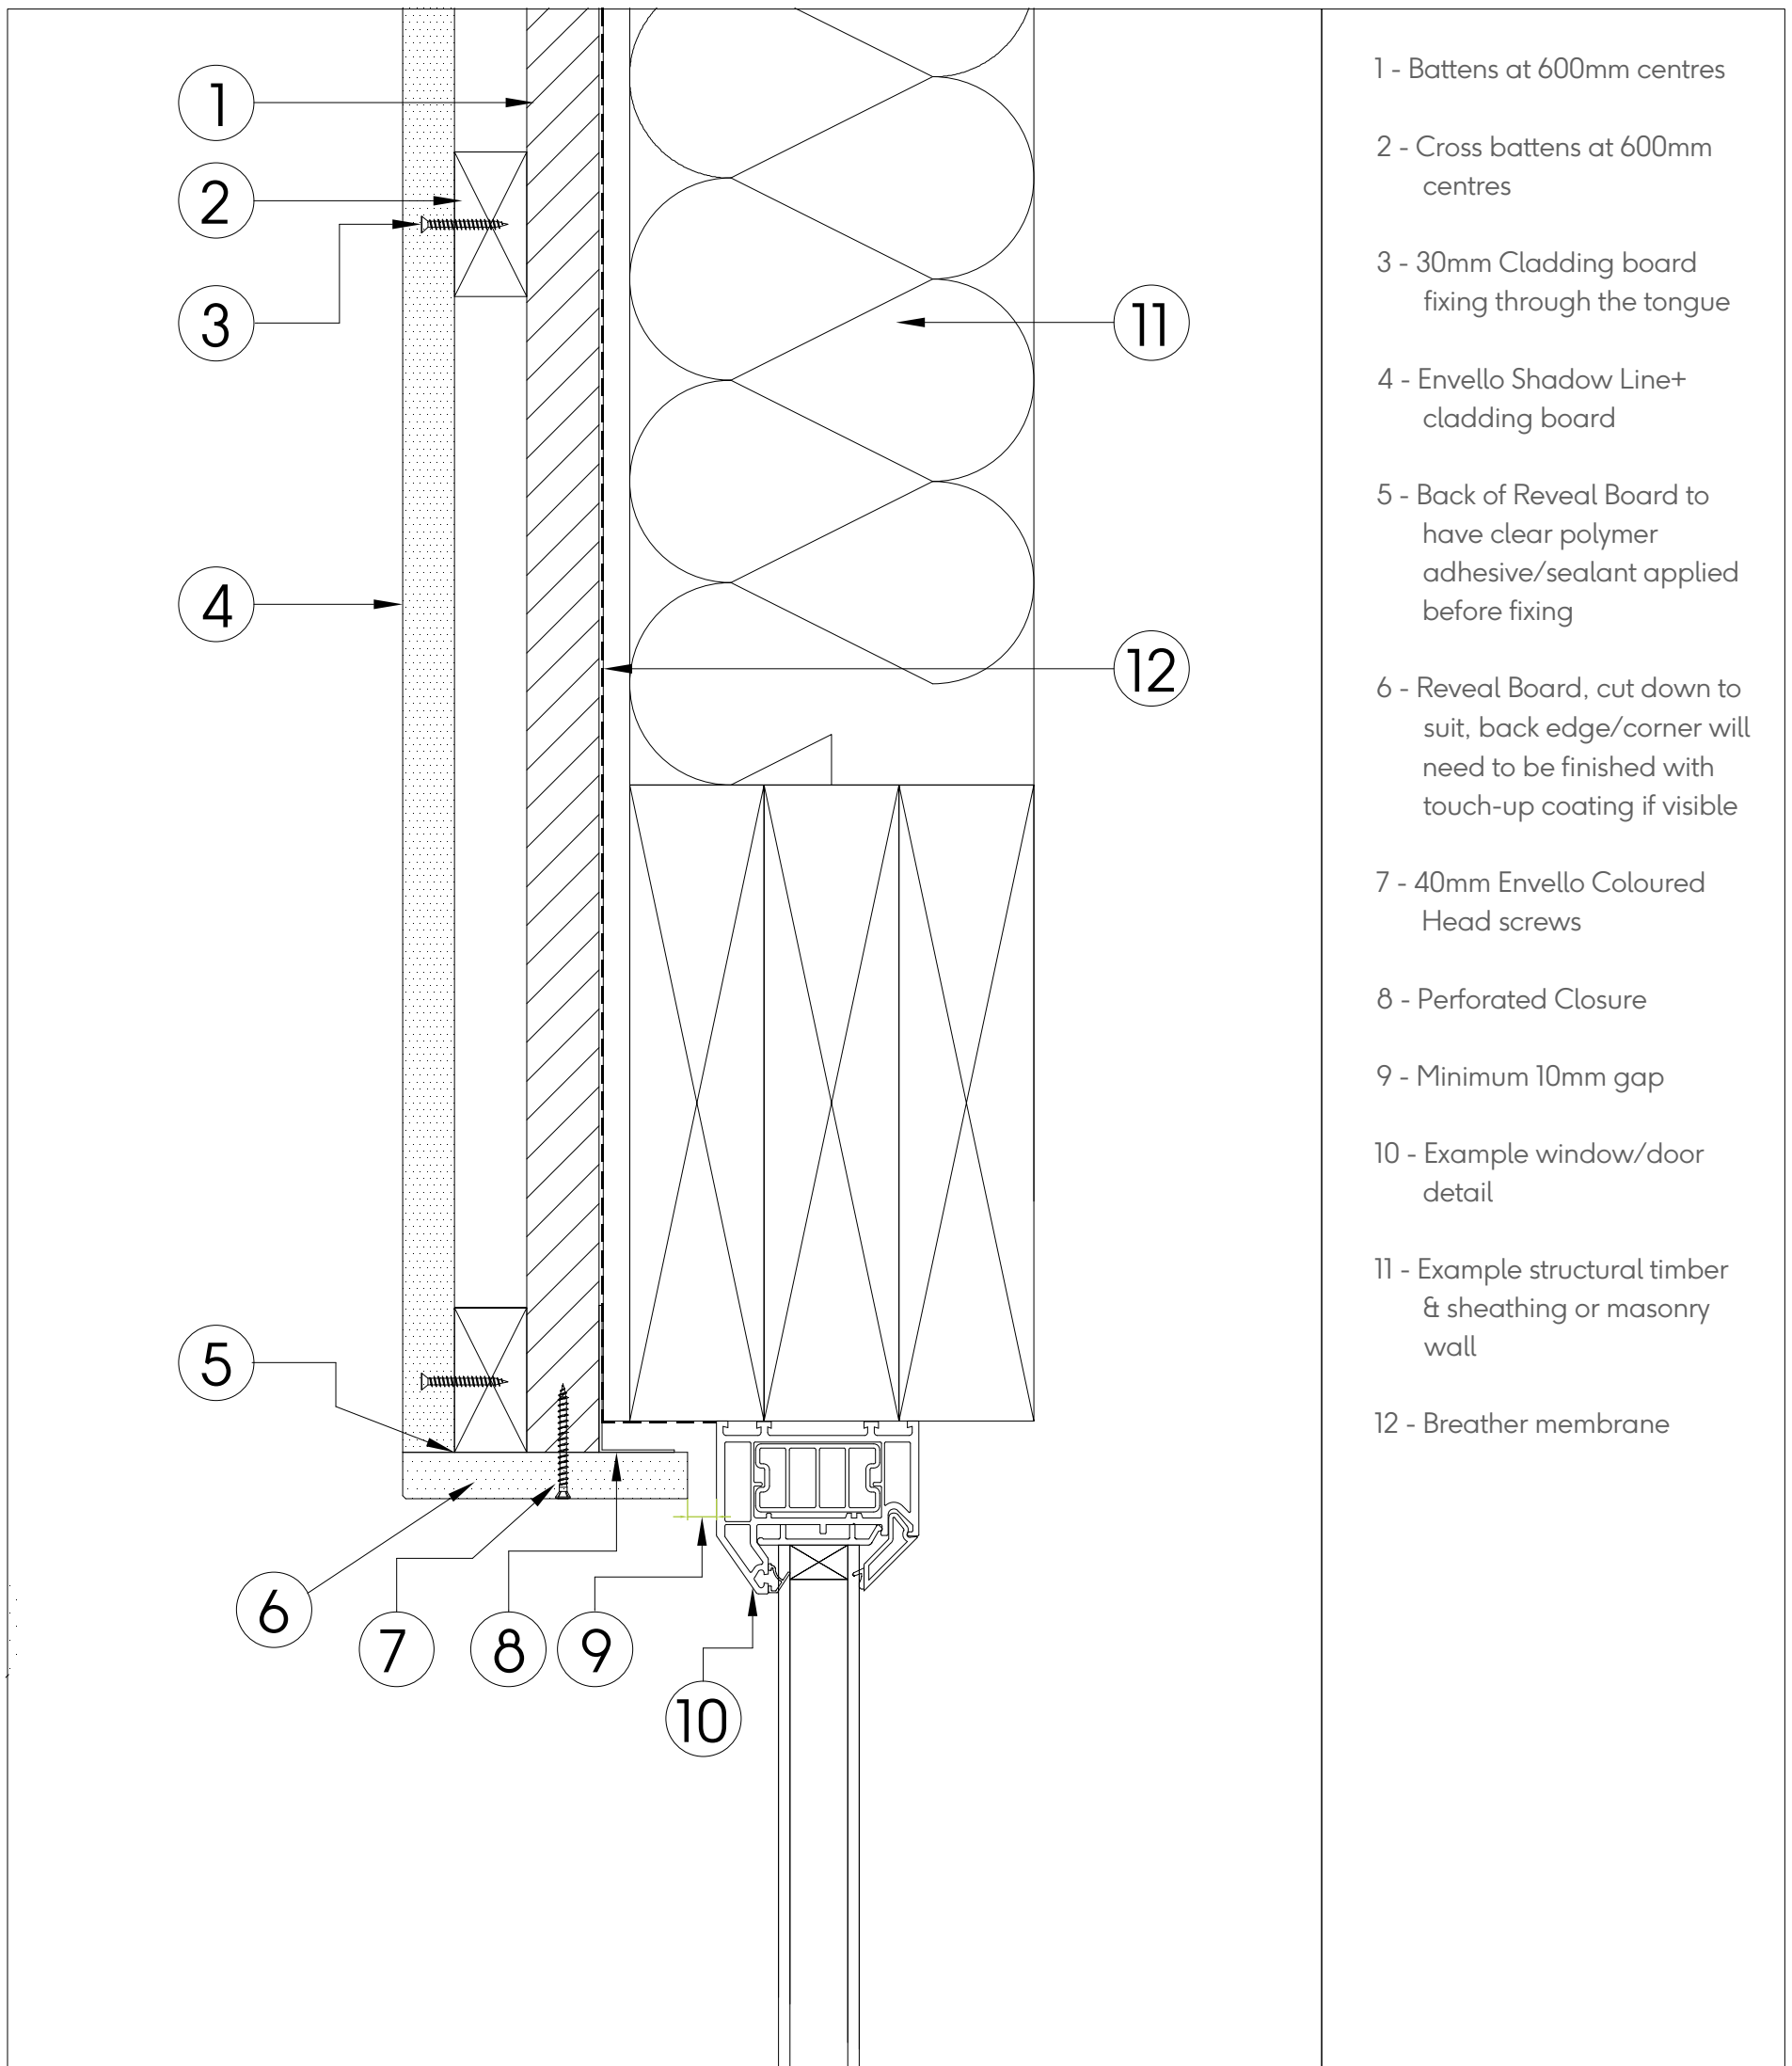
#120.22.01

Window/door head junction with Reveal board

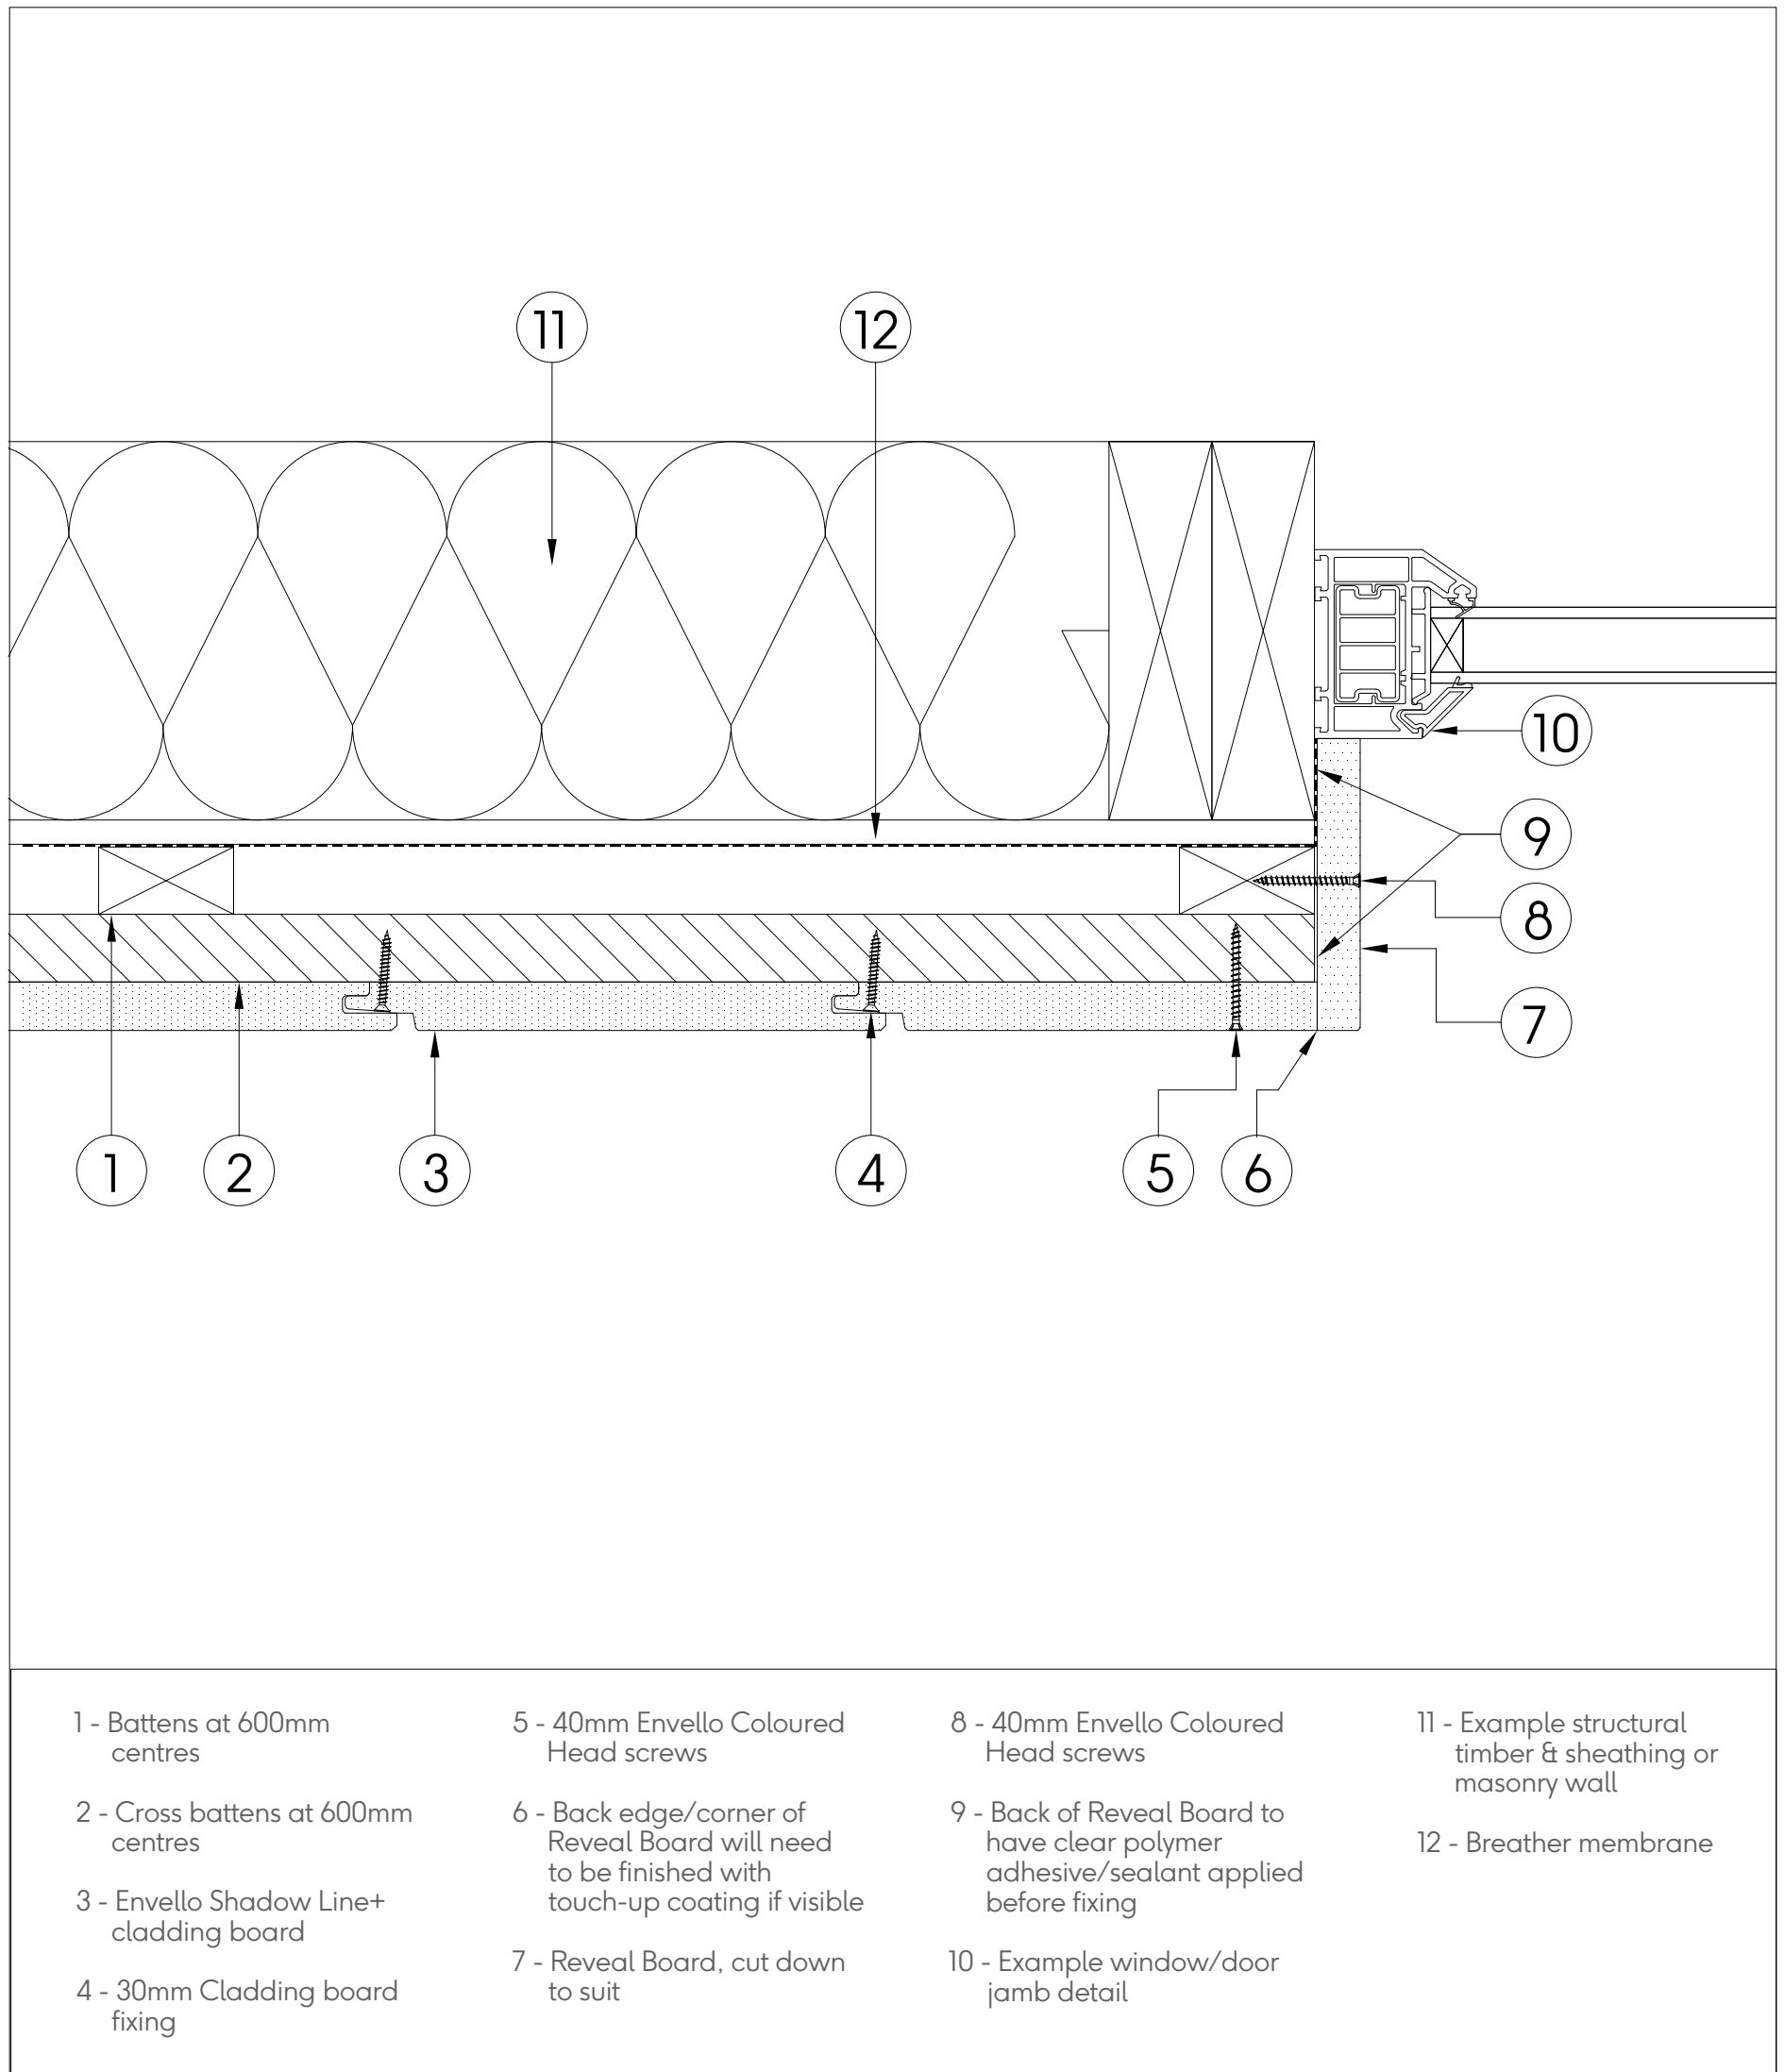
#121.22.01

Window/door jamb junction with Reveal board

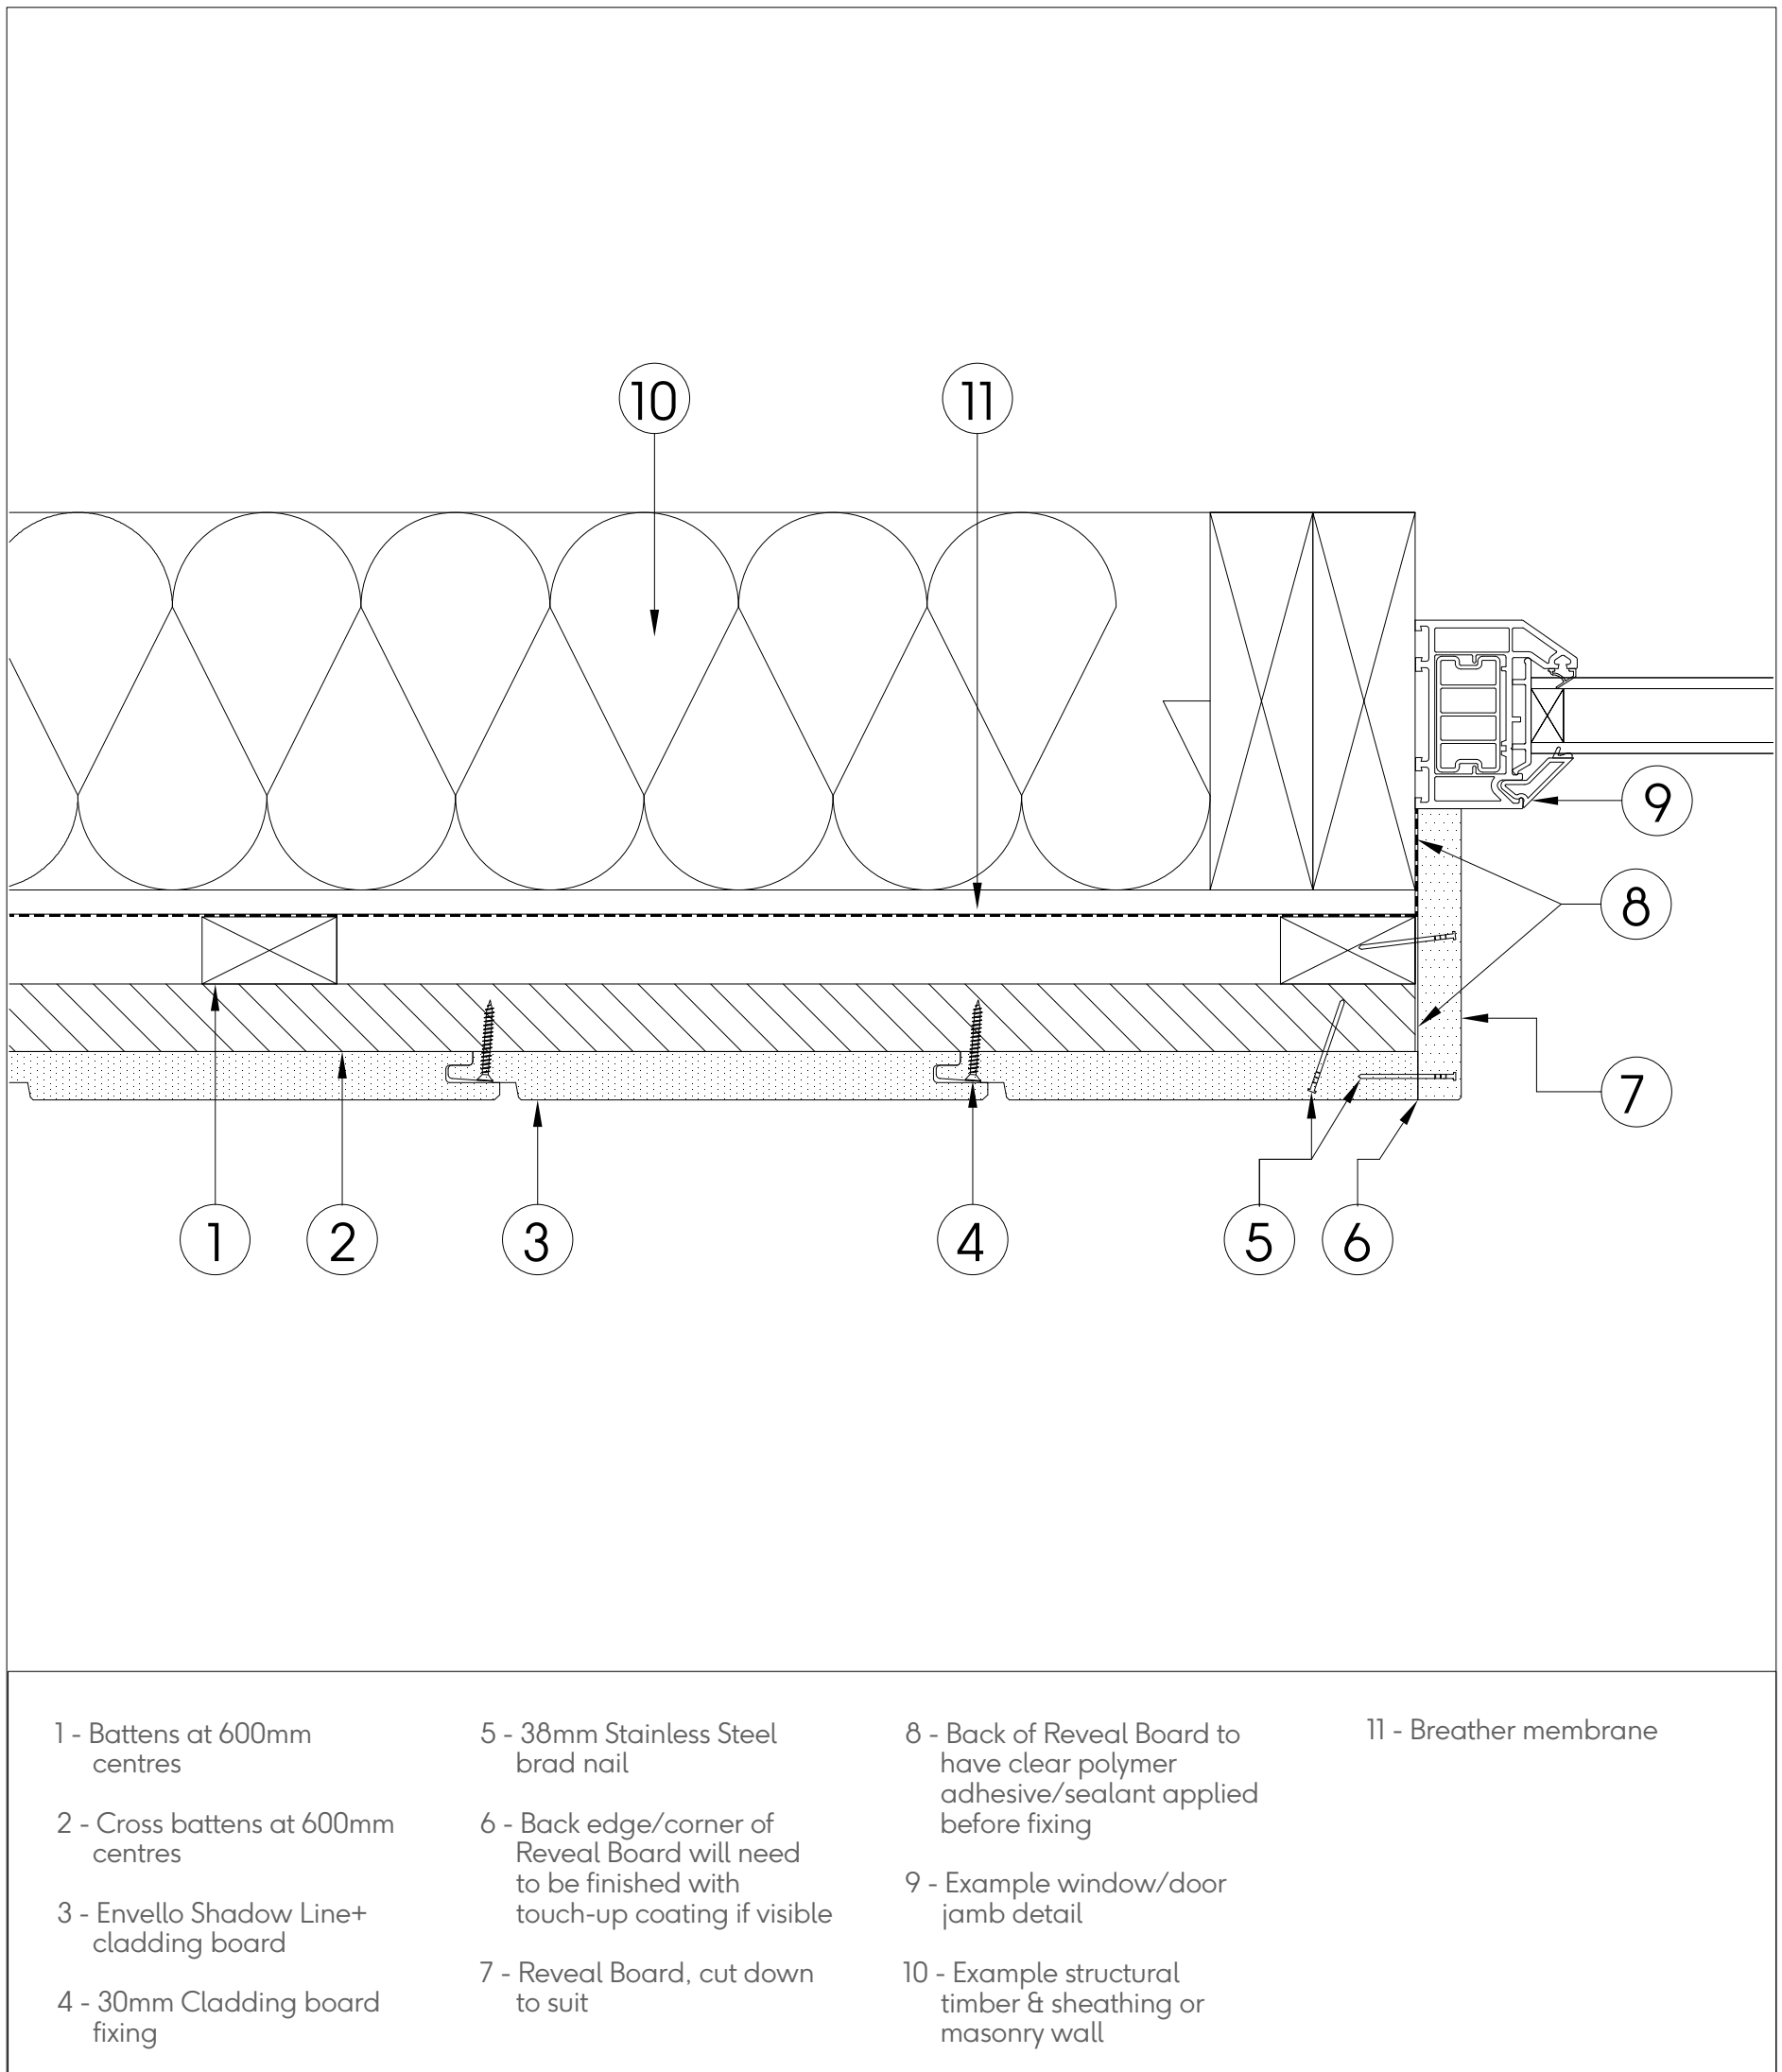
#121a.22.01

Window/door jamb junction with Reveal board - brad nails

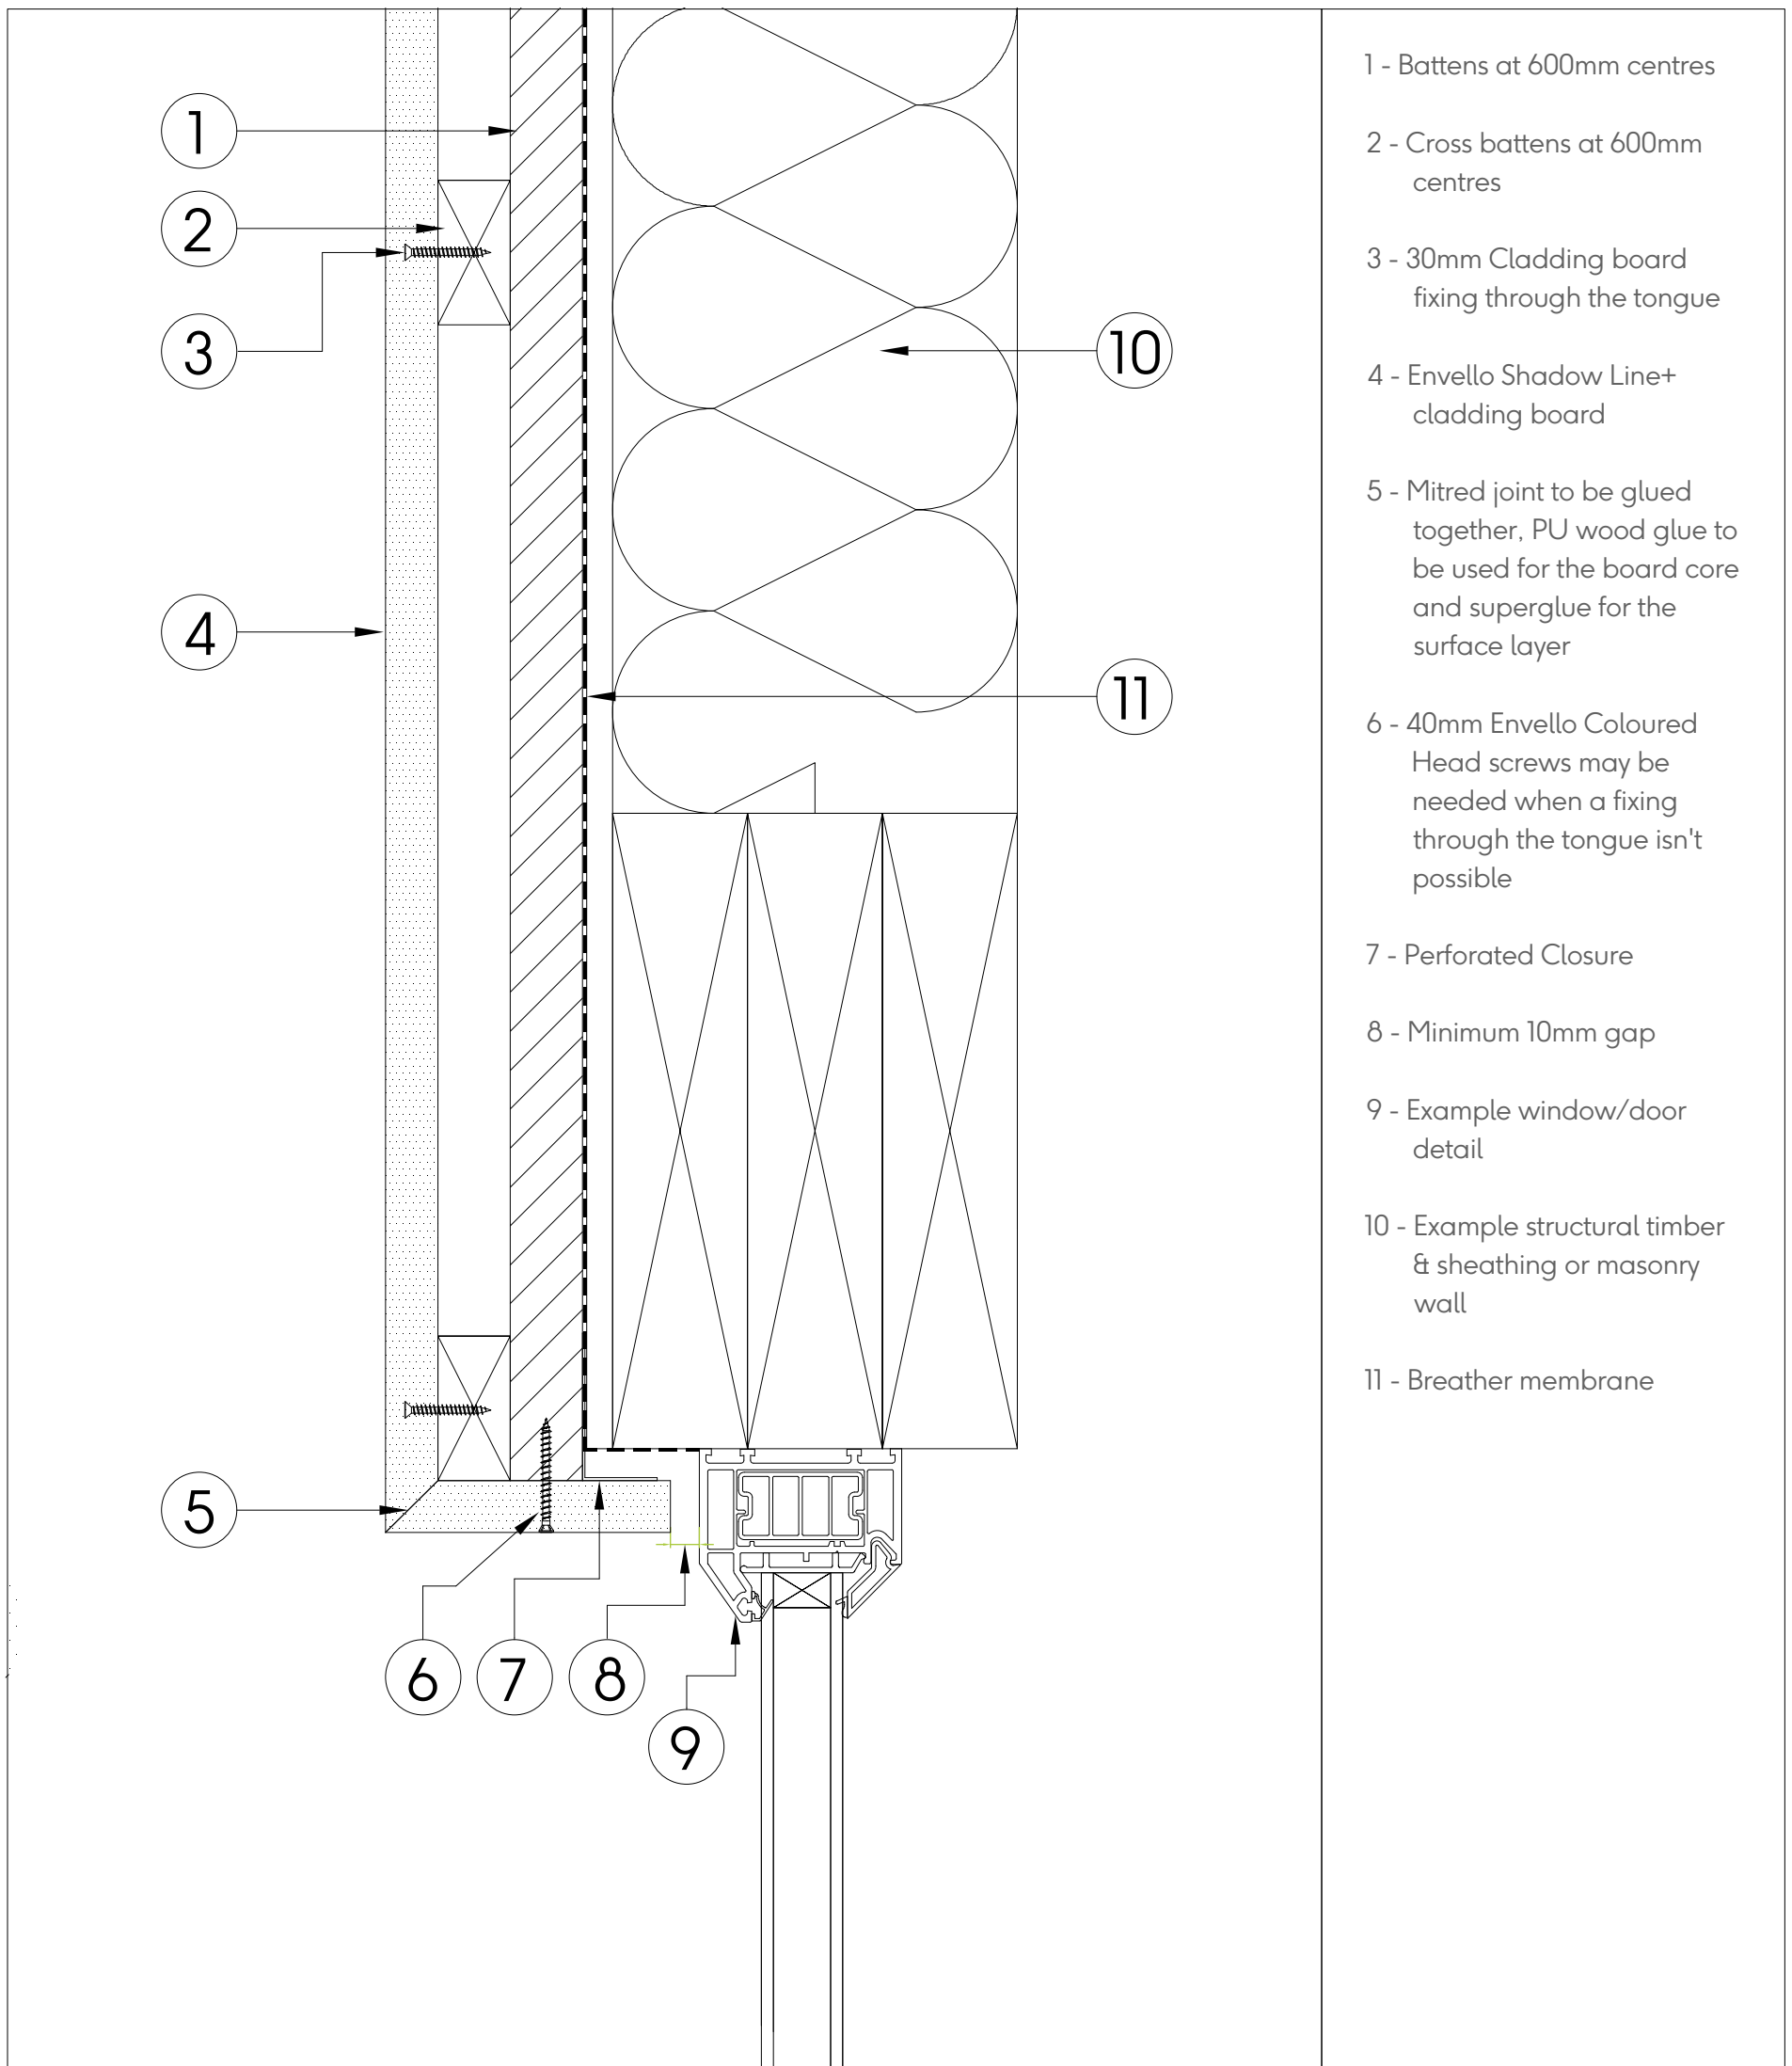
#122.22.01

Window/door head junction with mitred joint

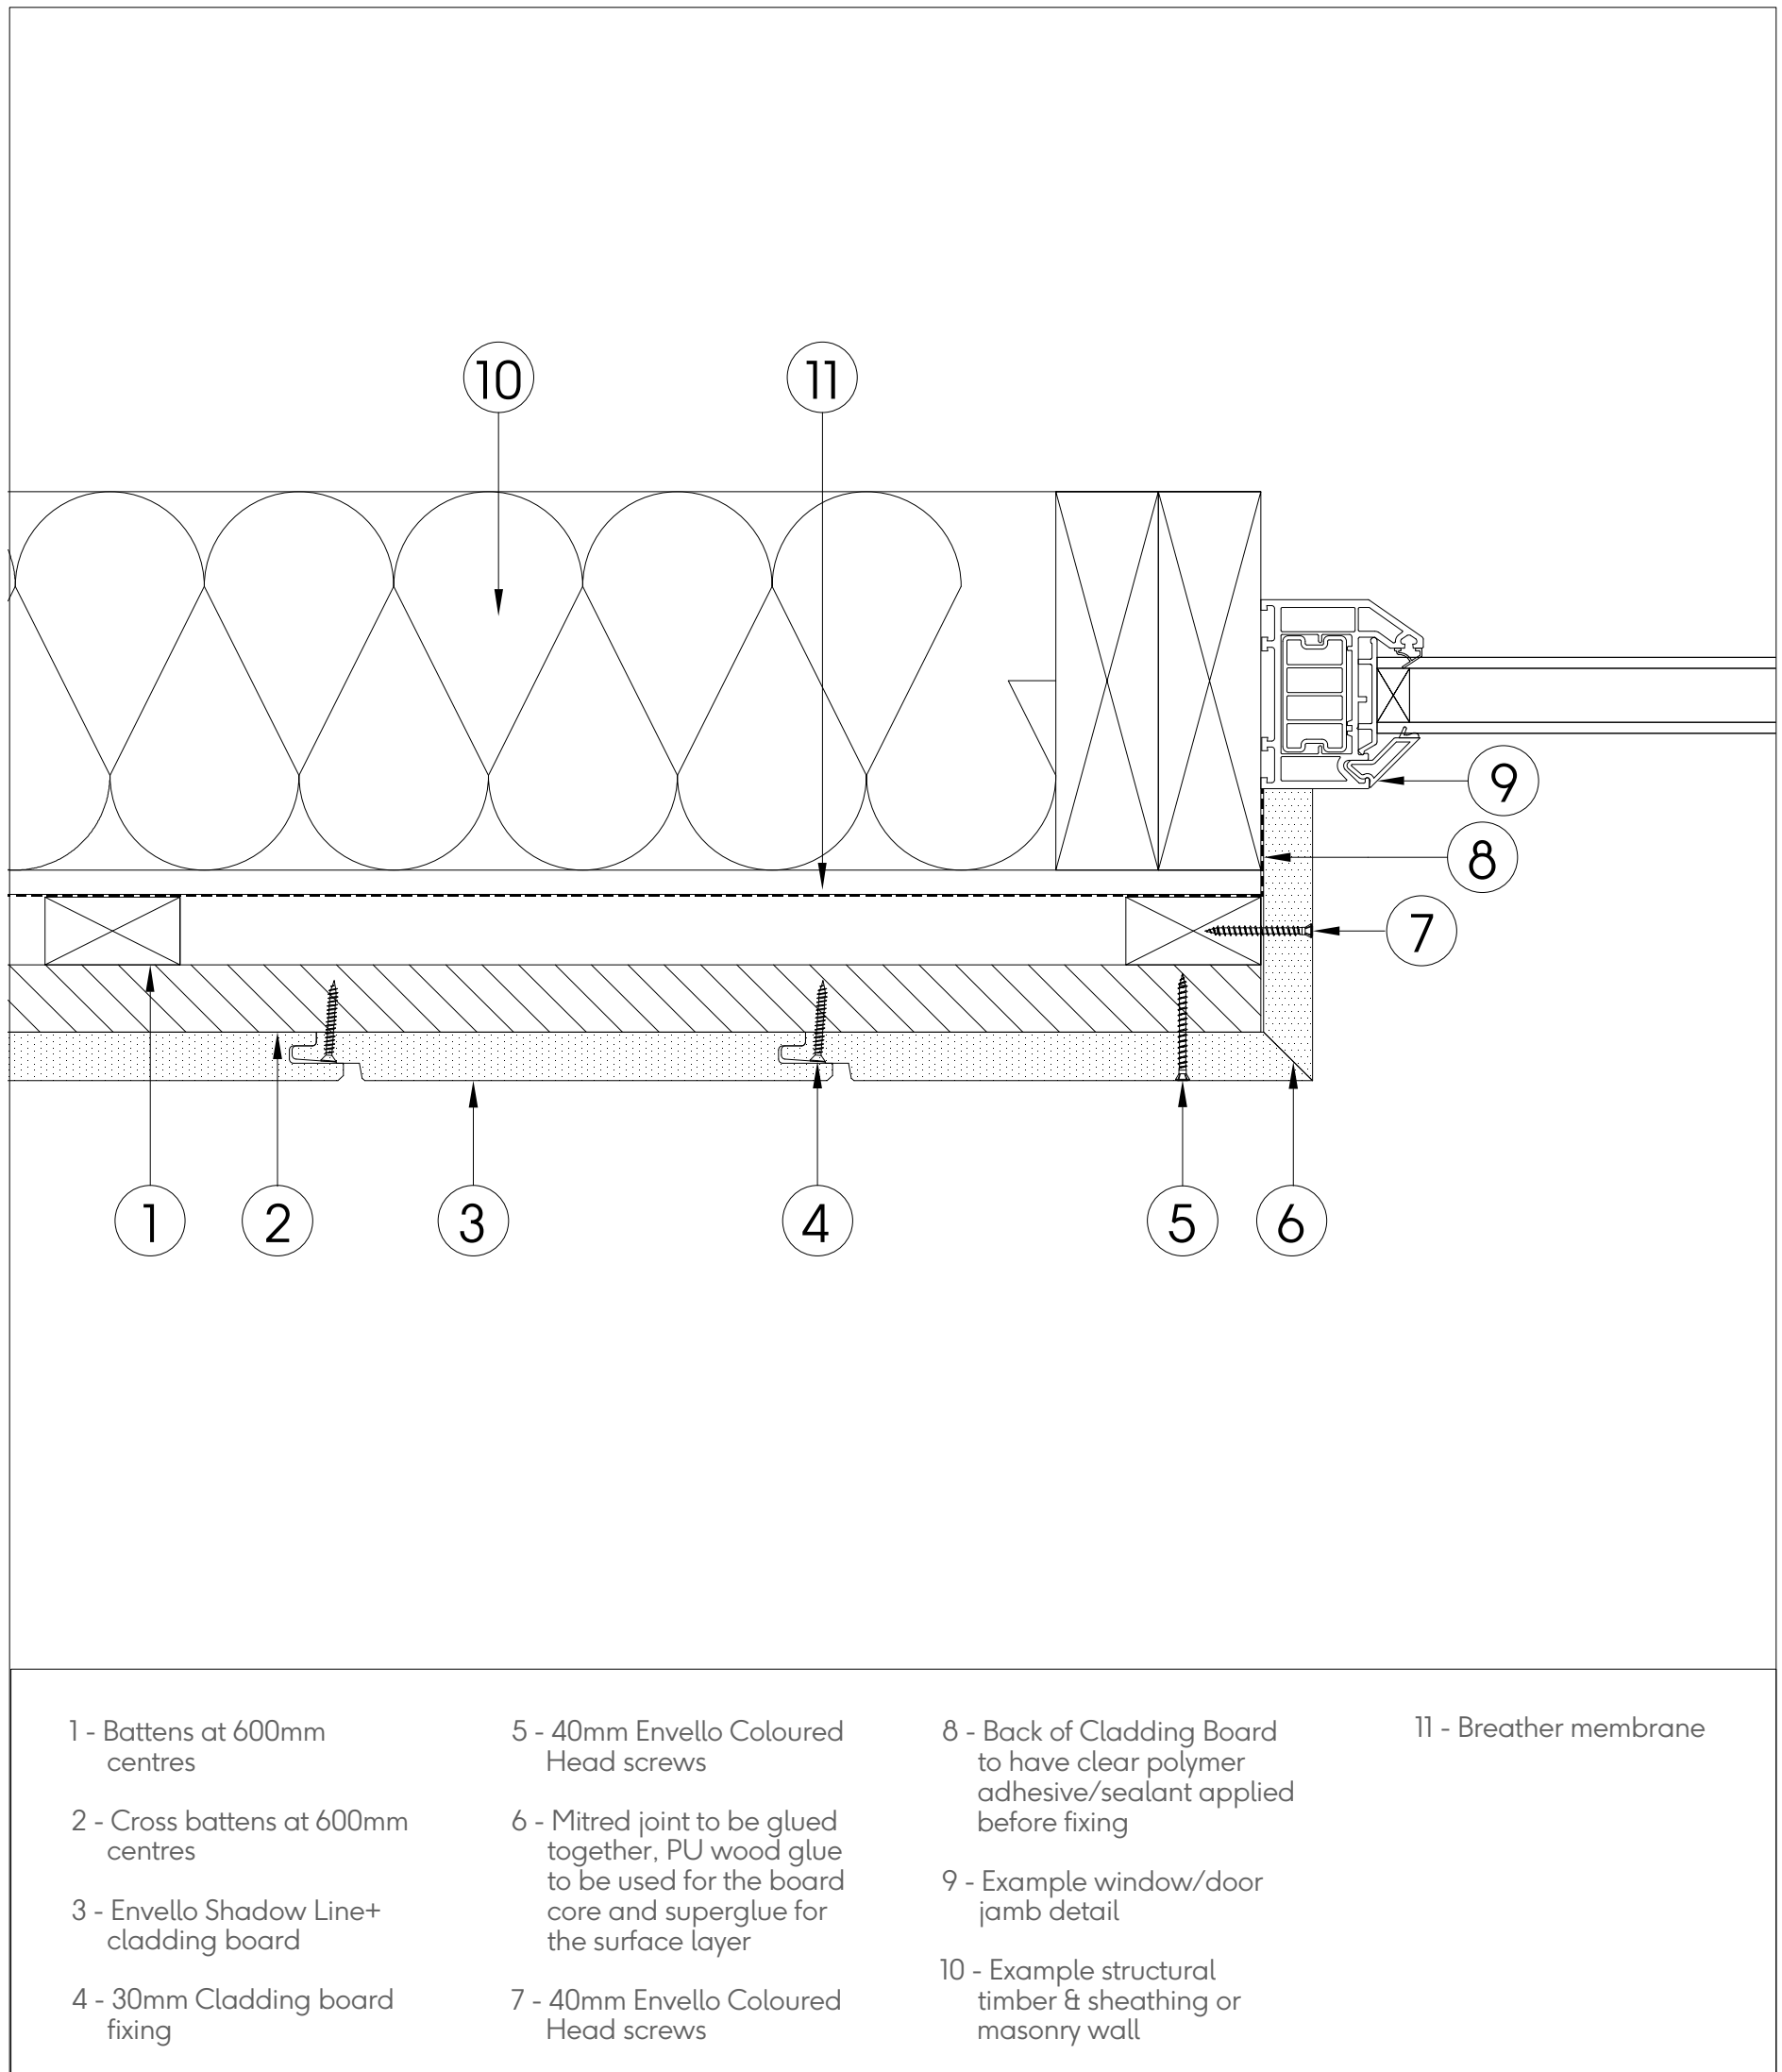
#123.22.01

Window/door jamb junction with mitred joint
