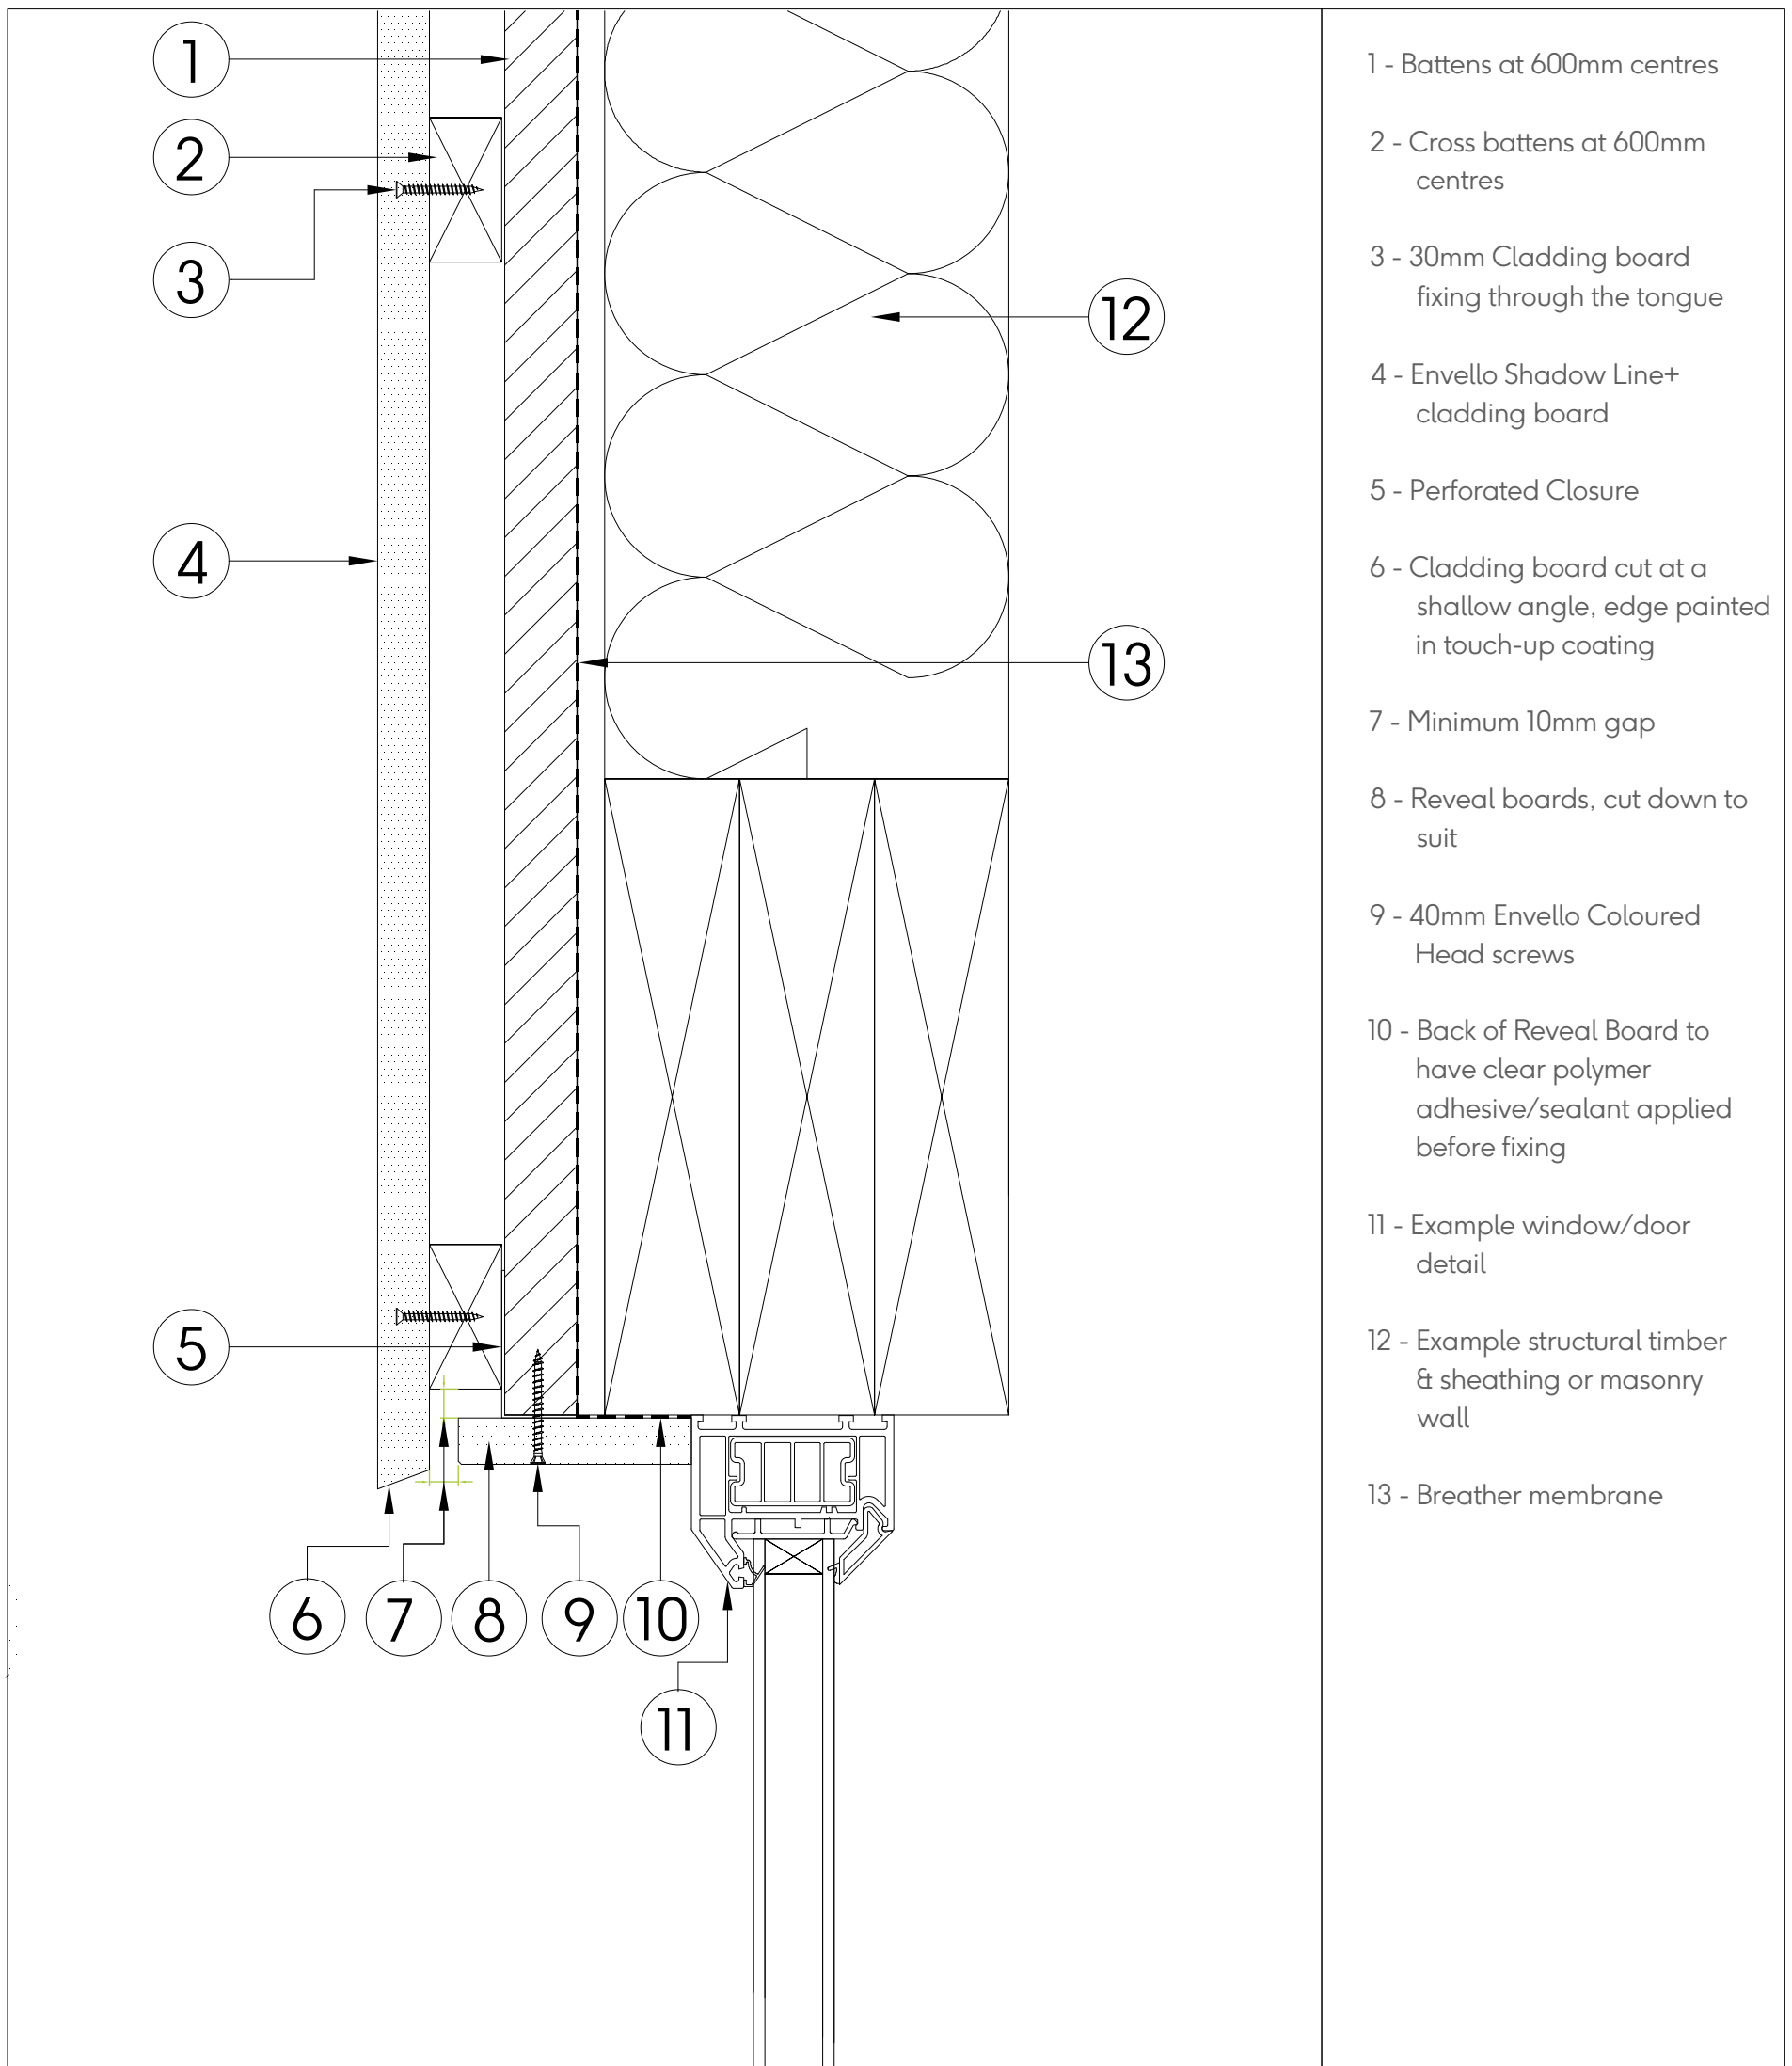
#124.22.01

Window/door head junction with angled cut

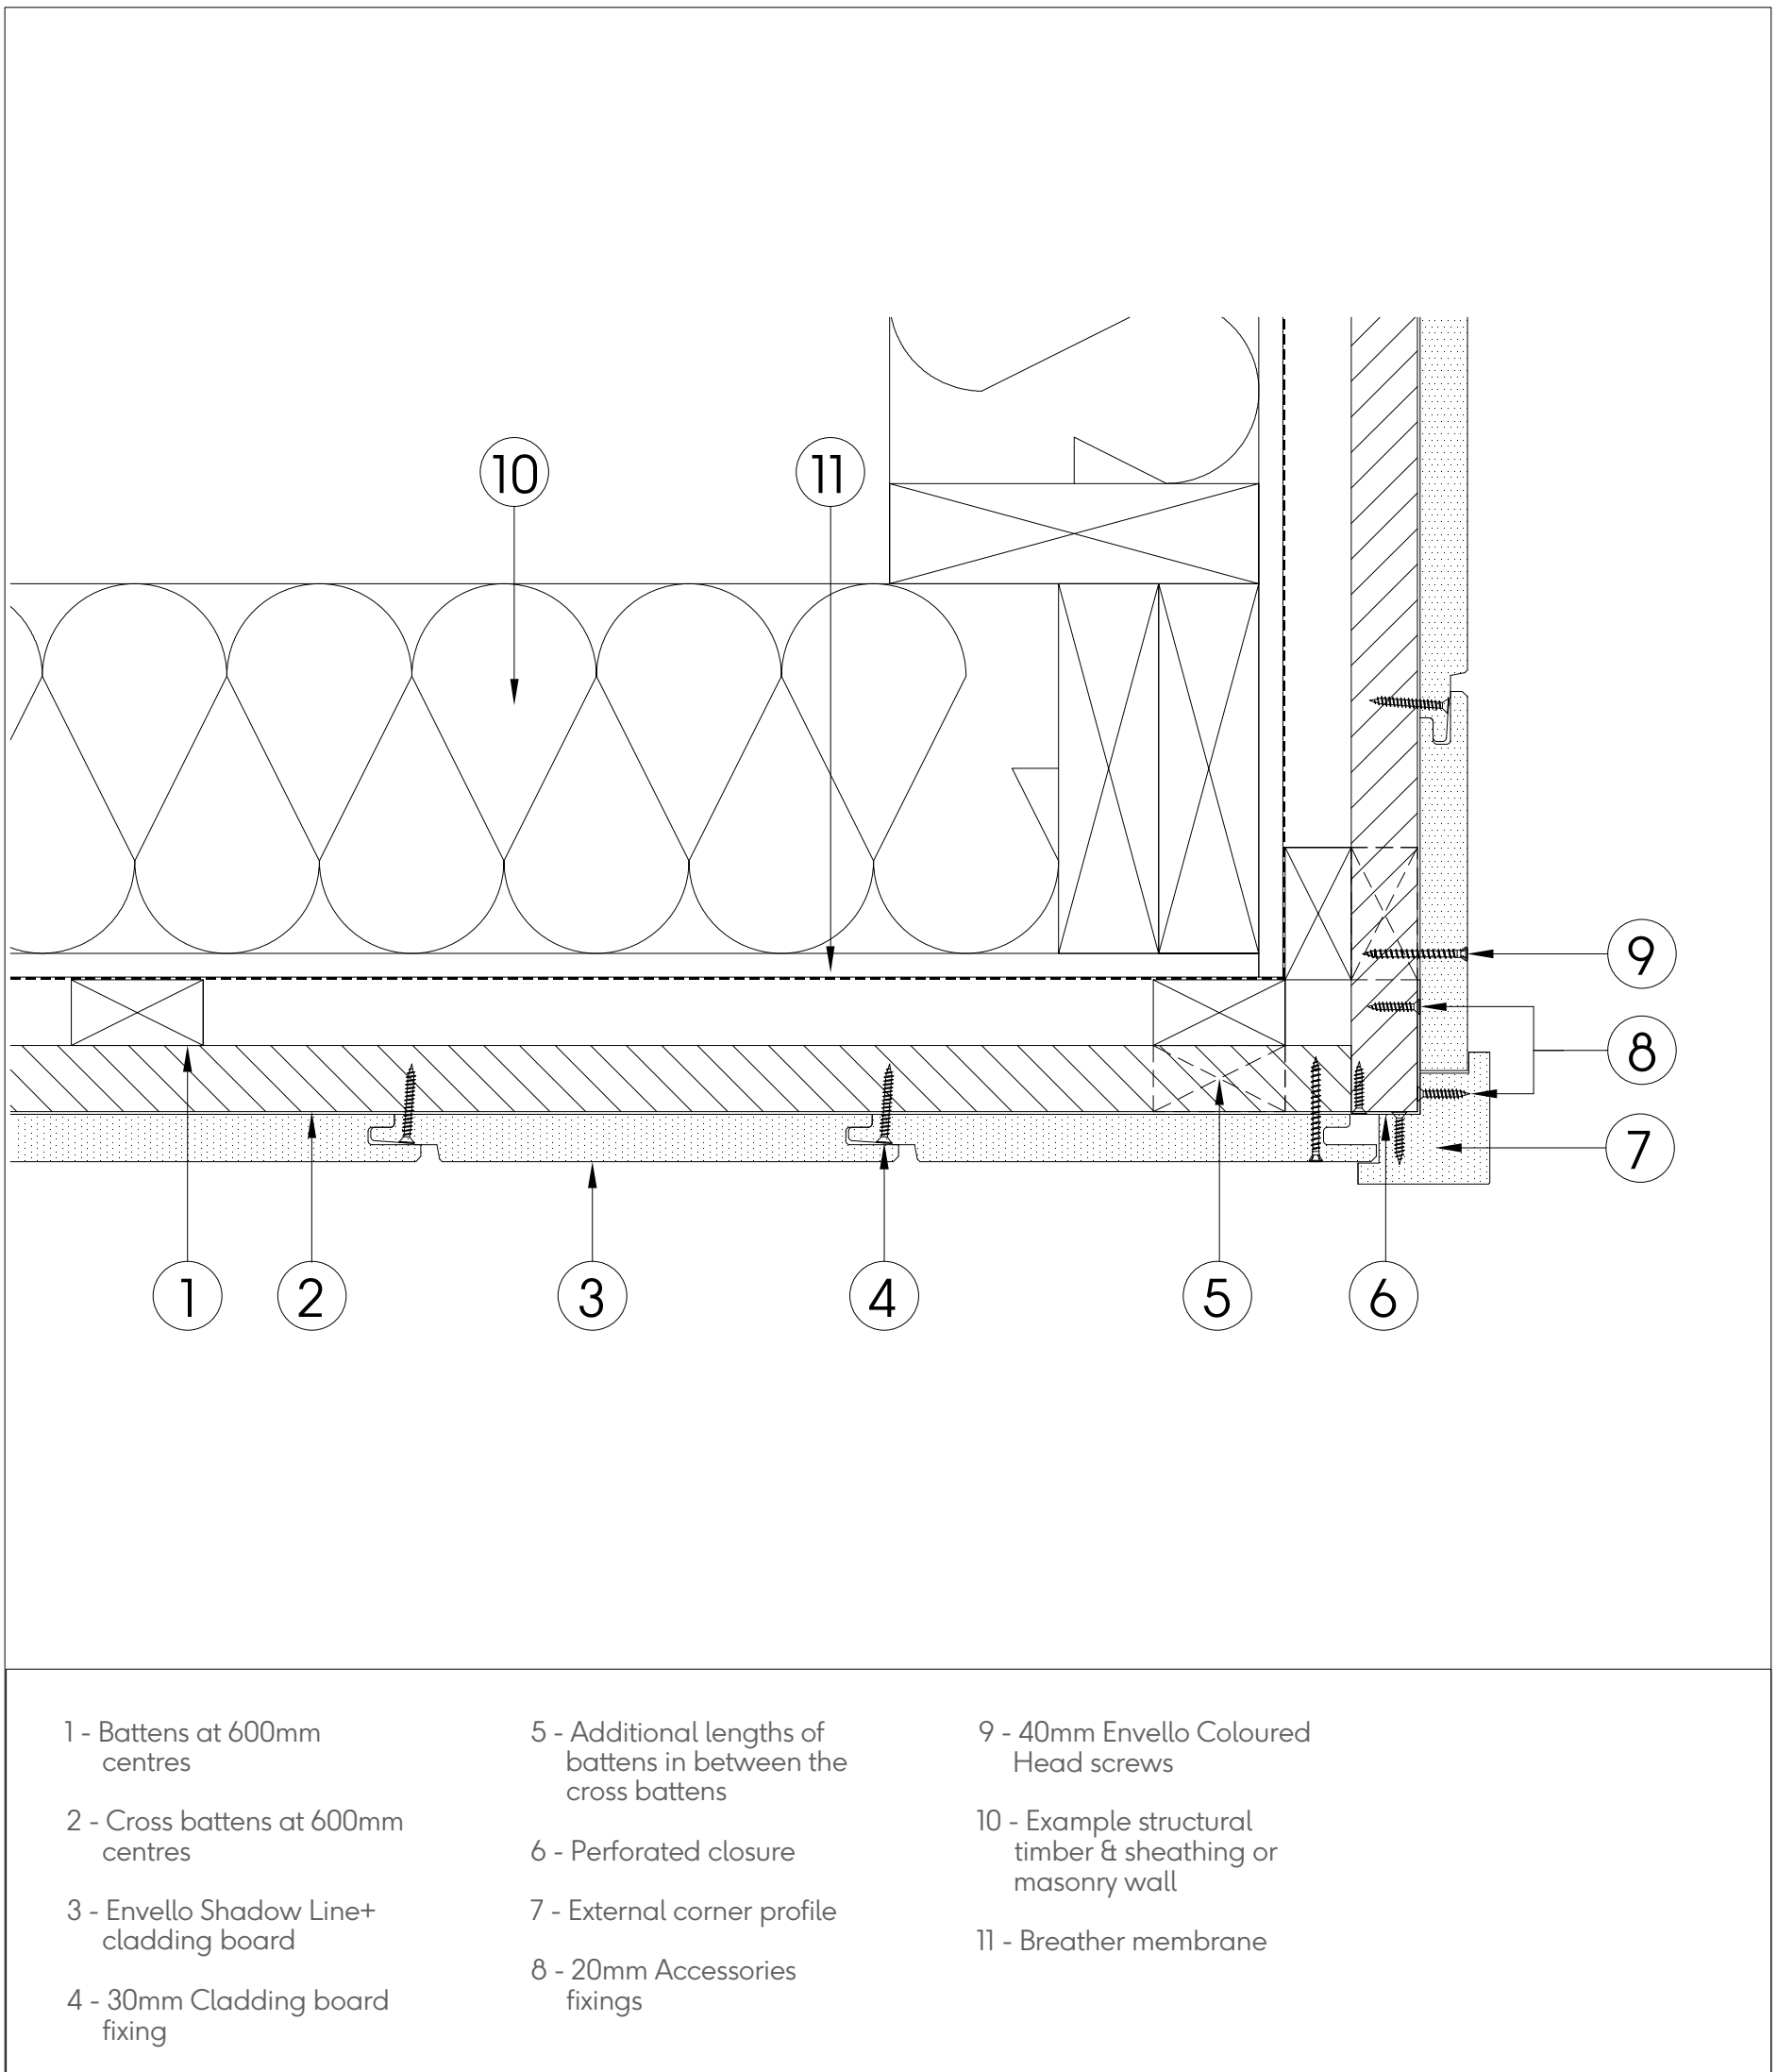
#140.22.01

External corner profile detail

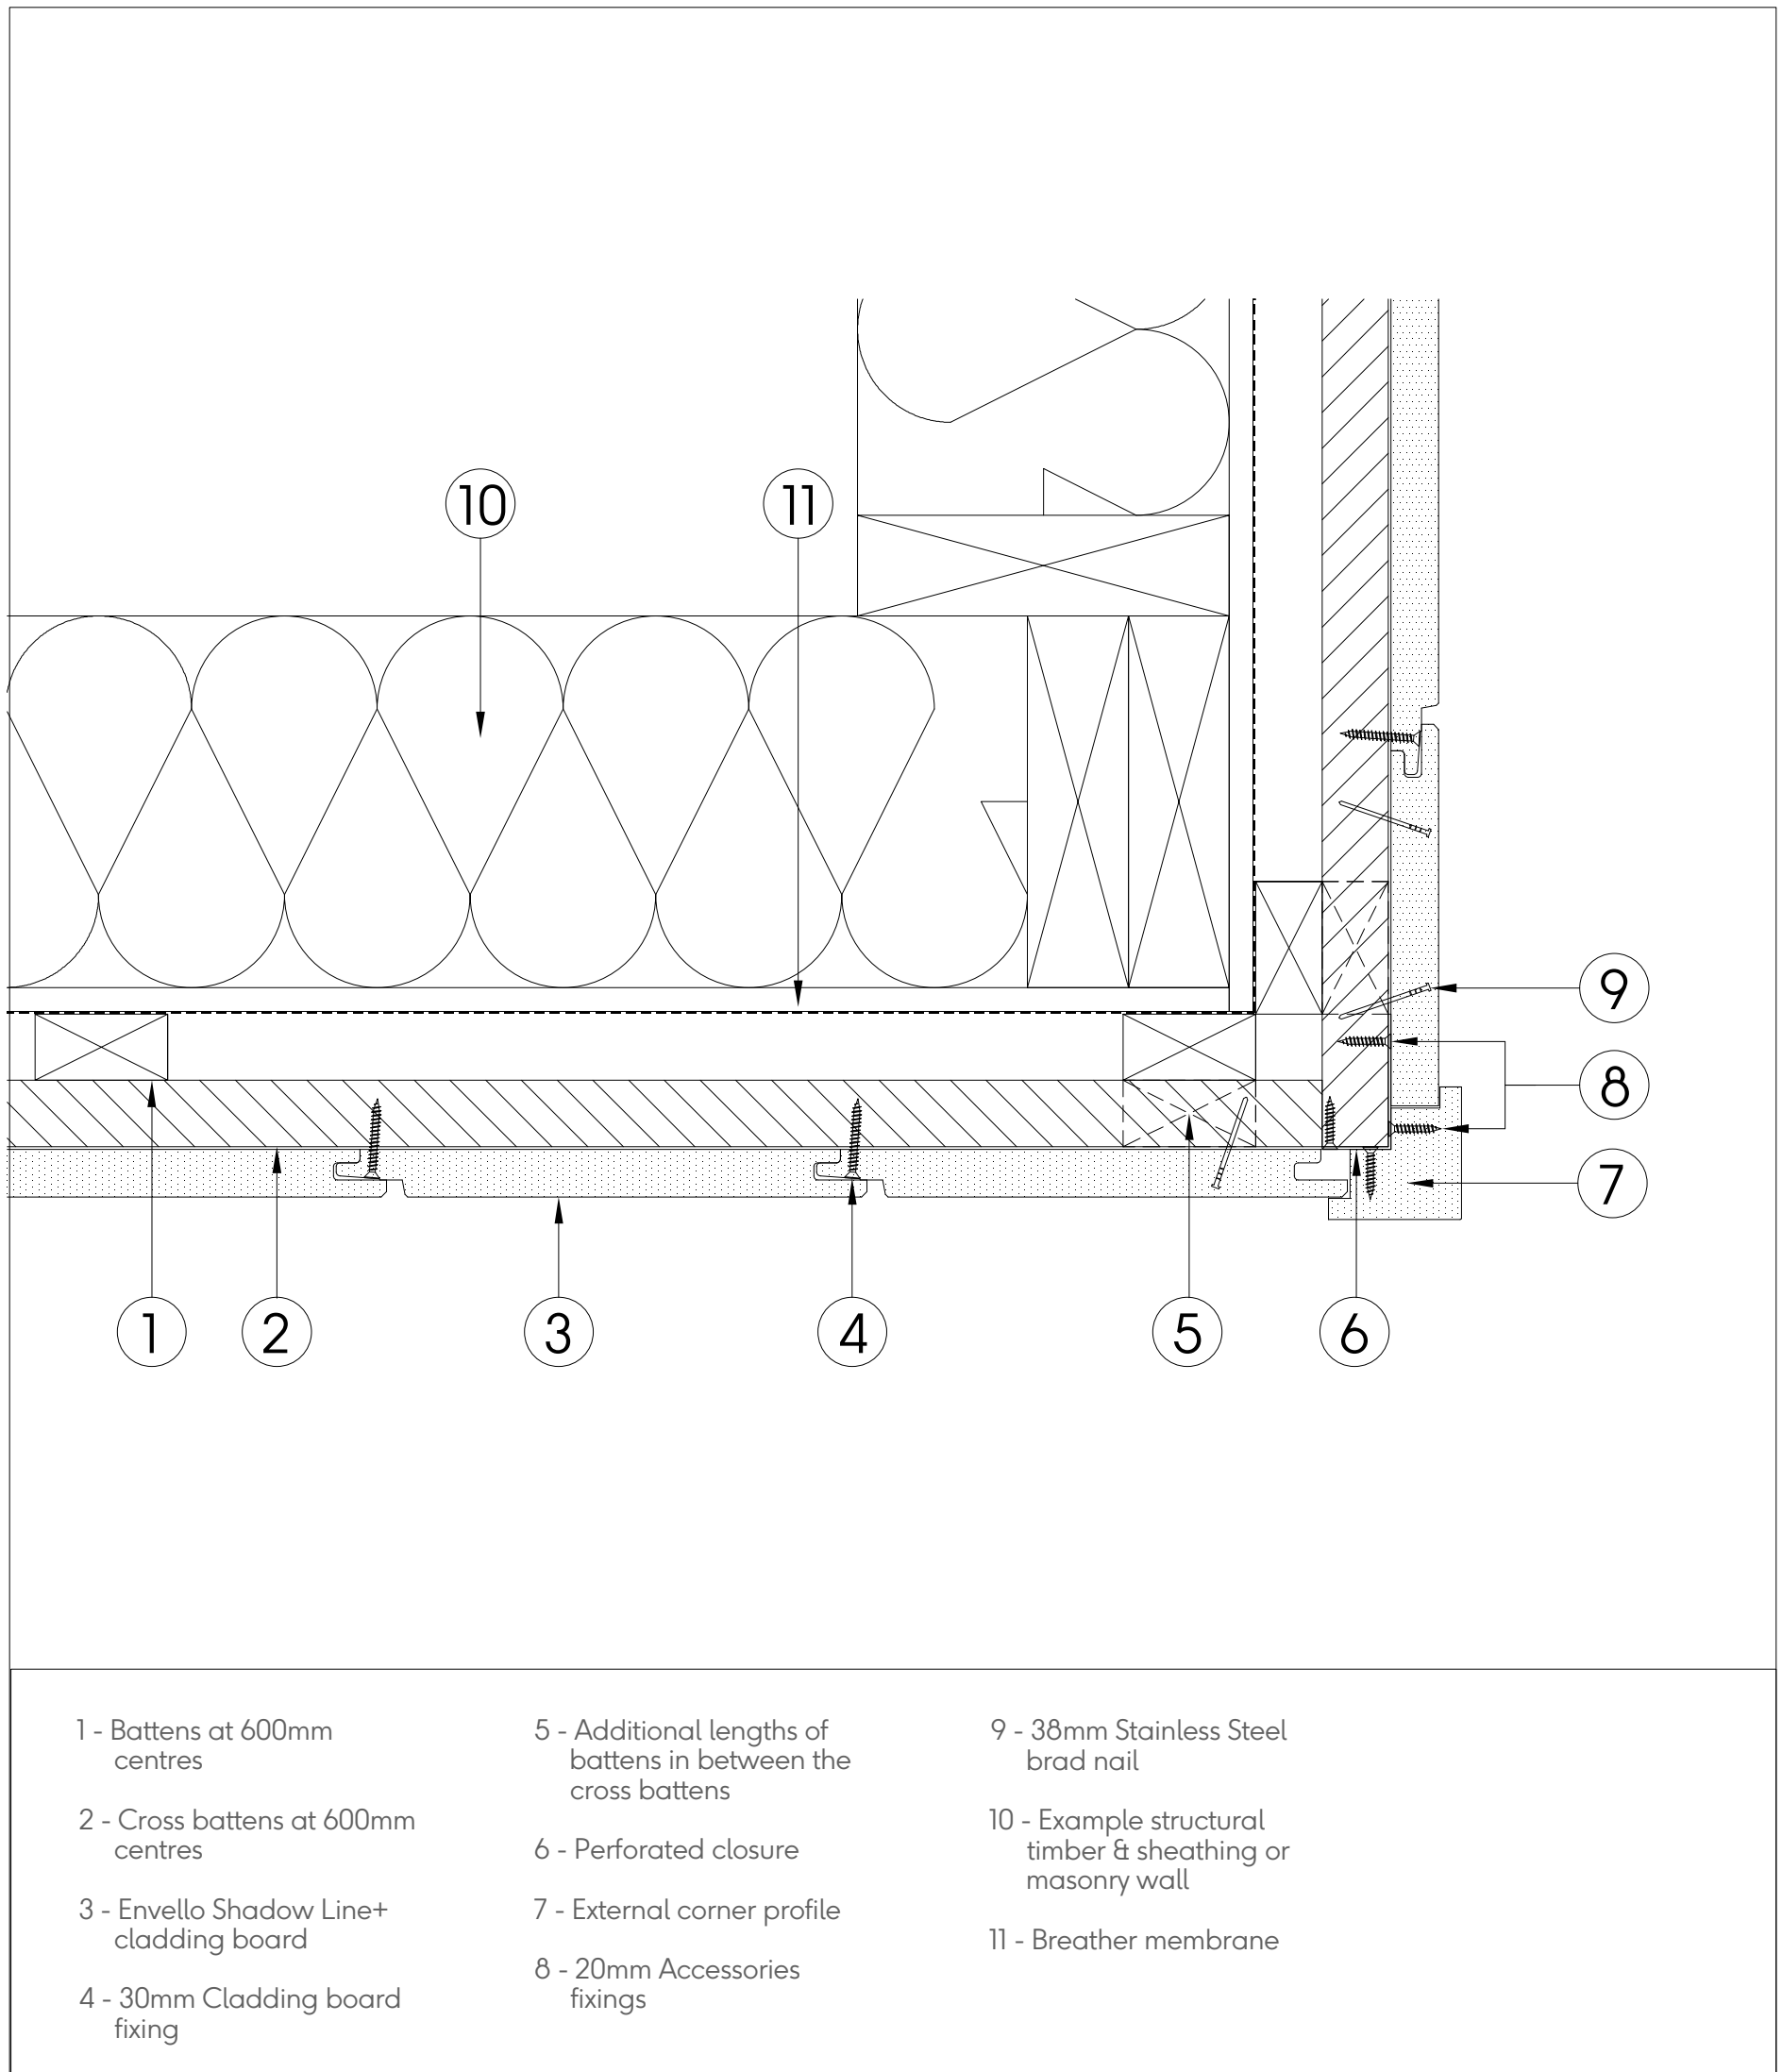
#140a.22.01

External corner profile detail - brad nails

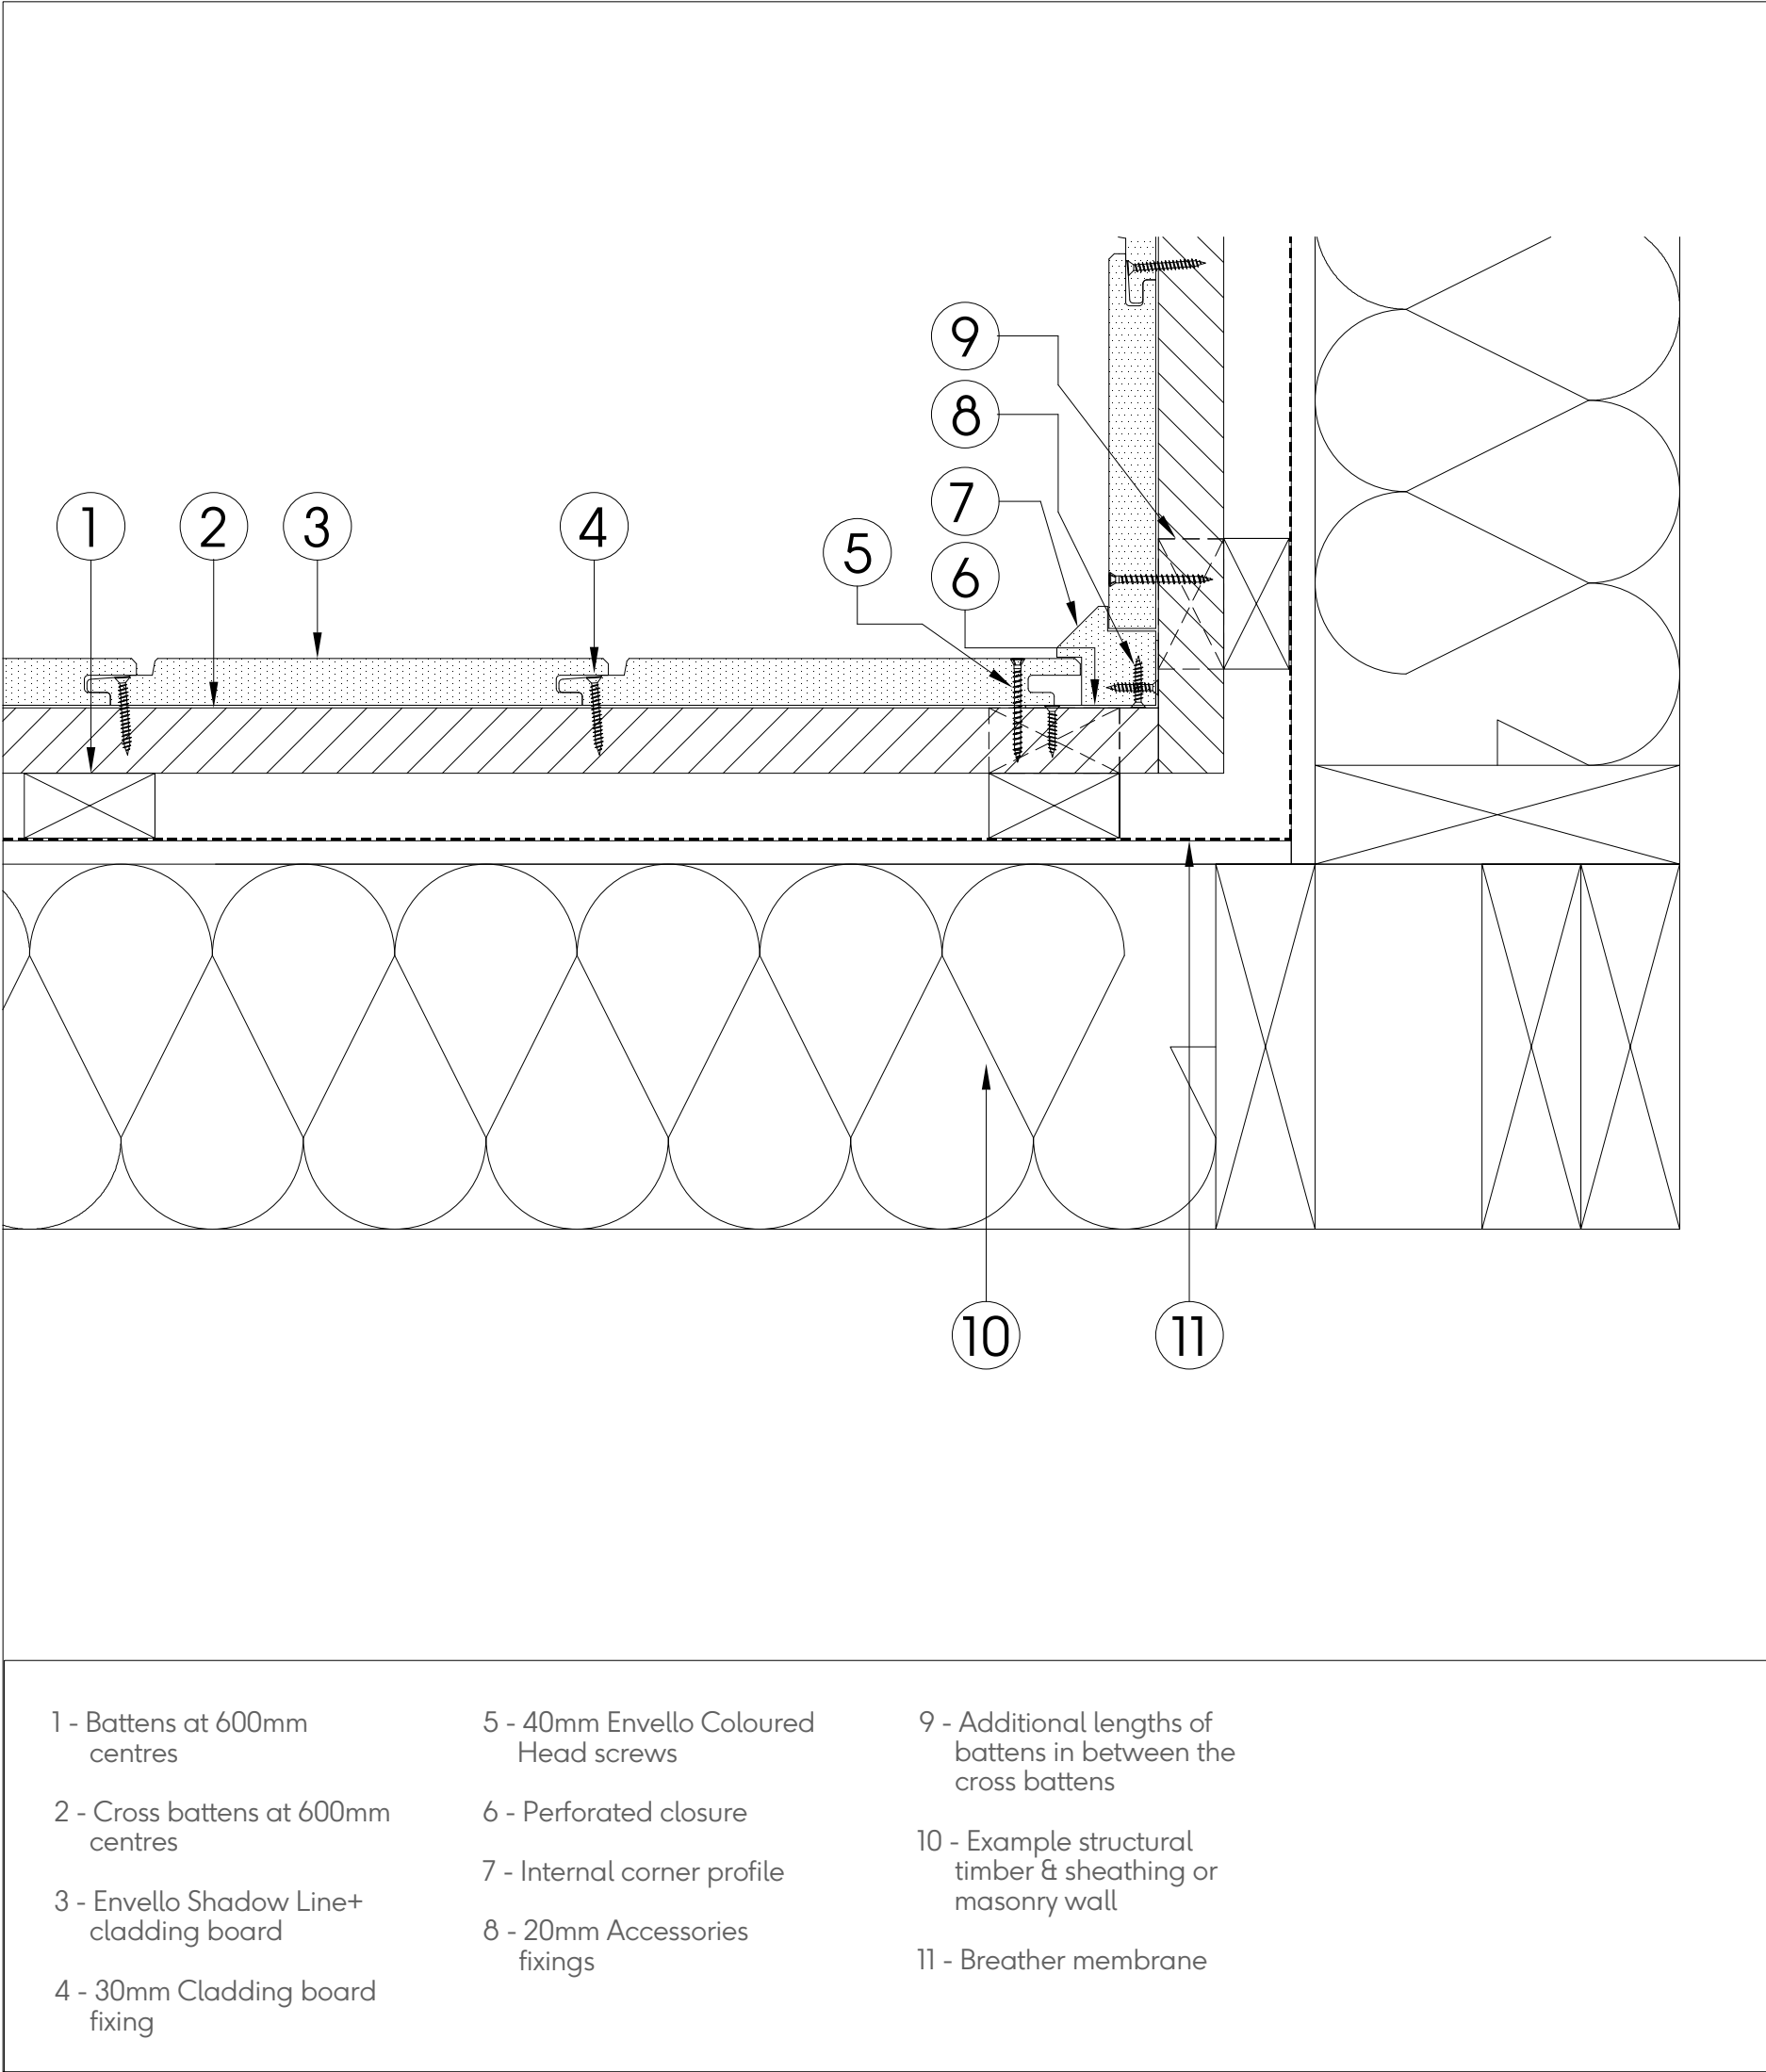
#141.22.01

Internal corner profile detail

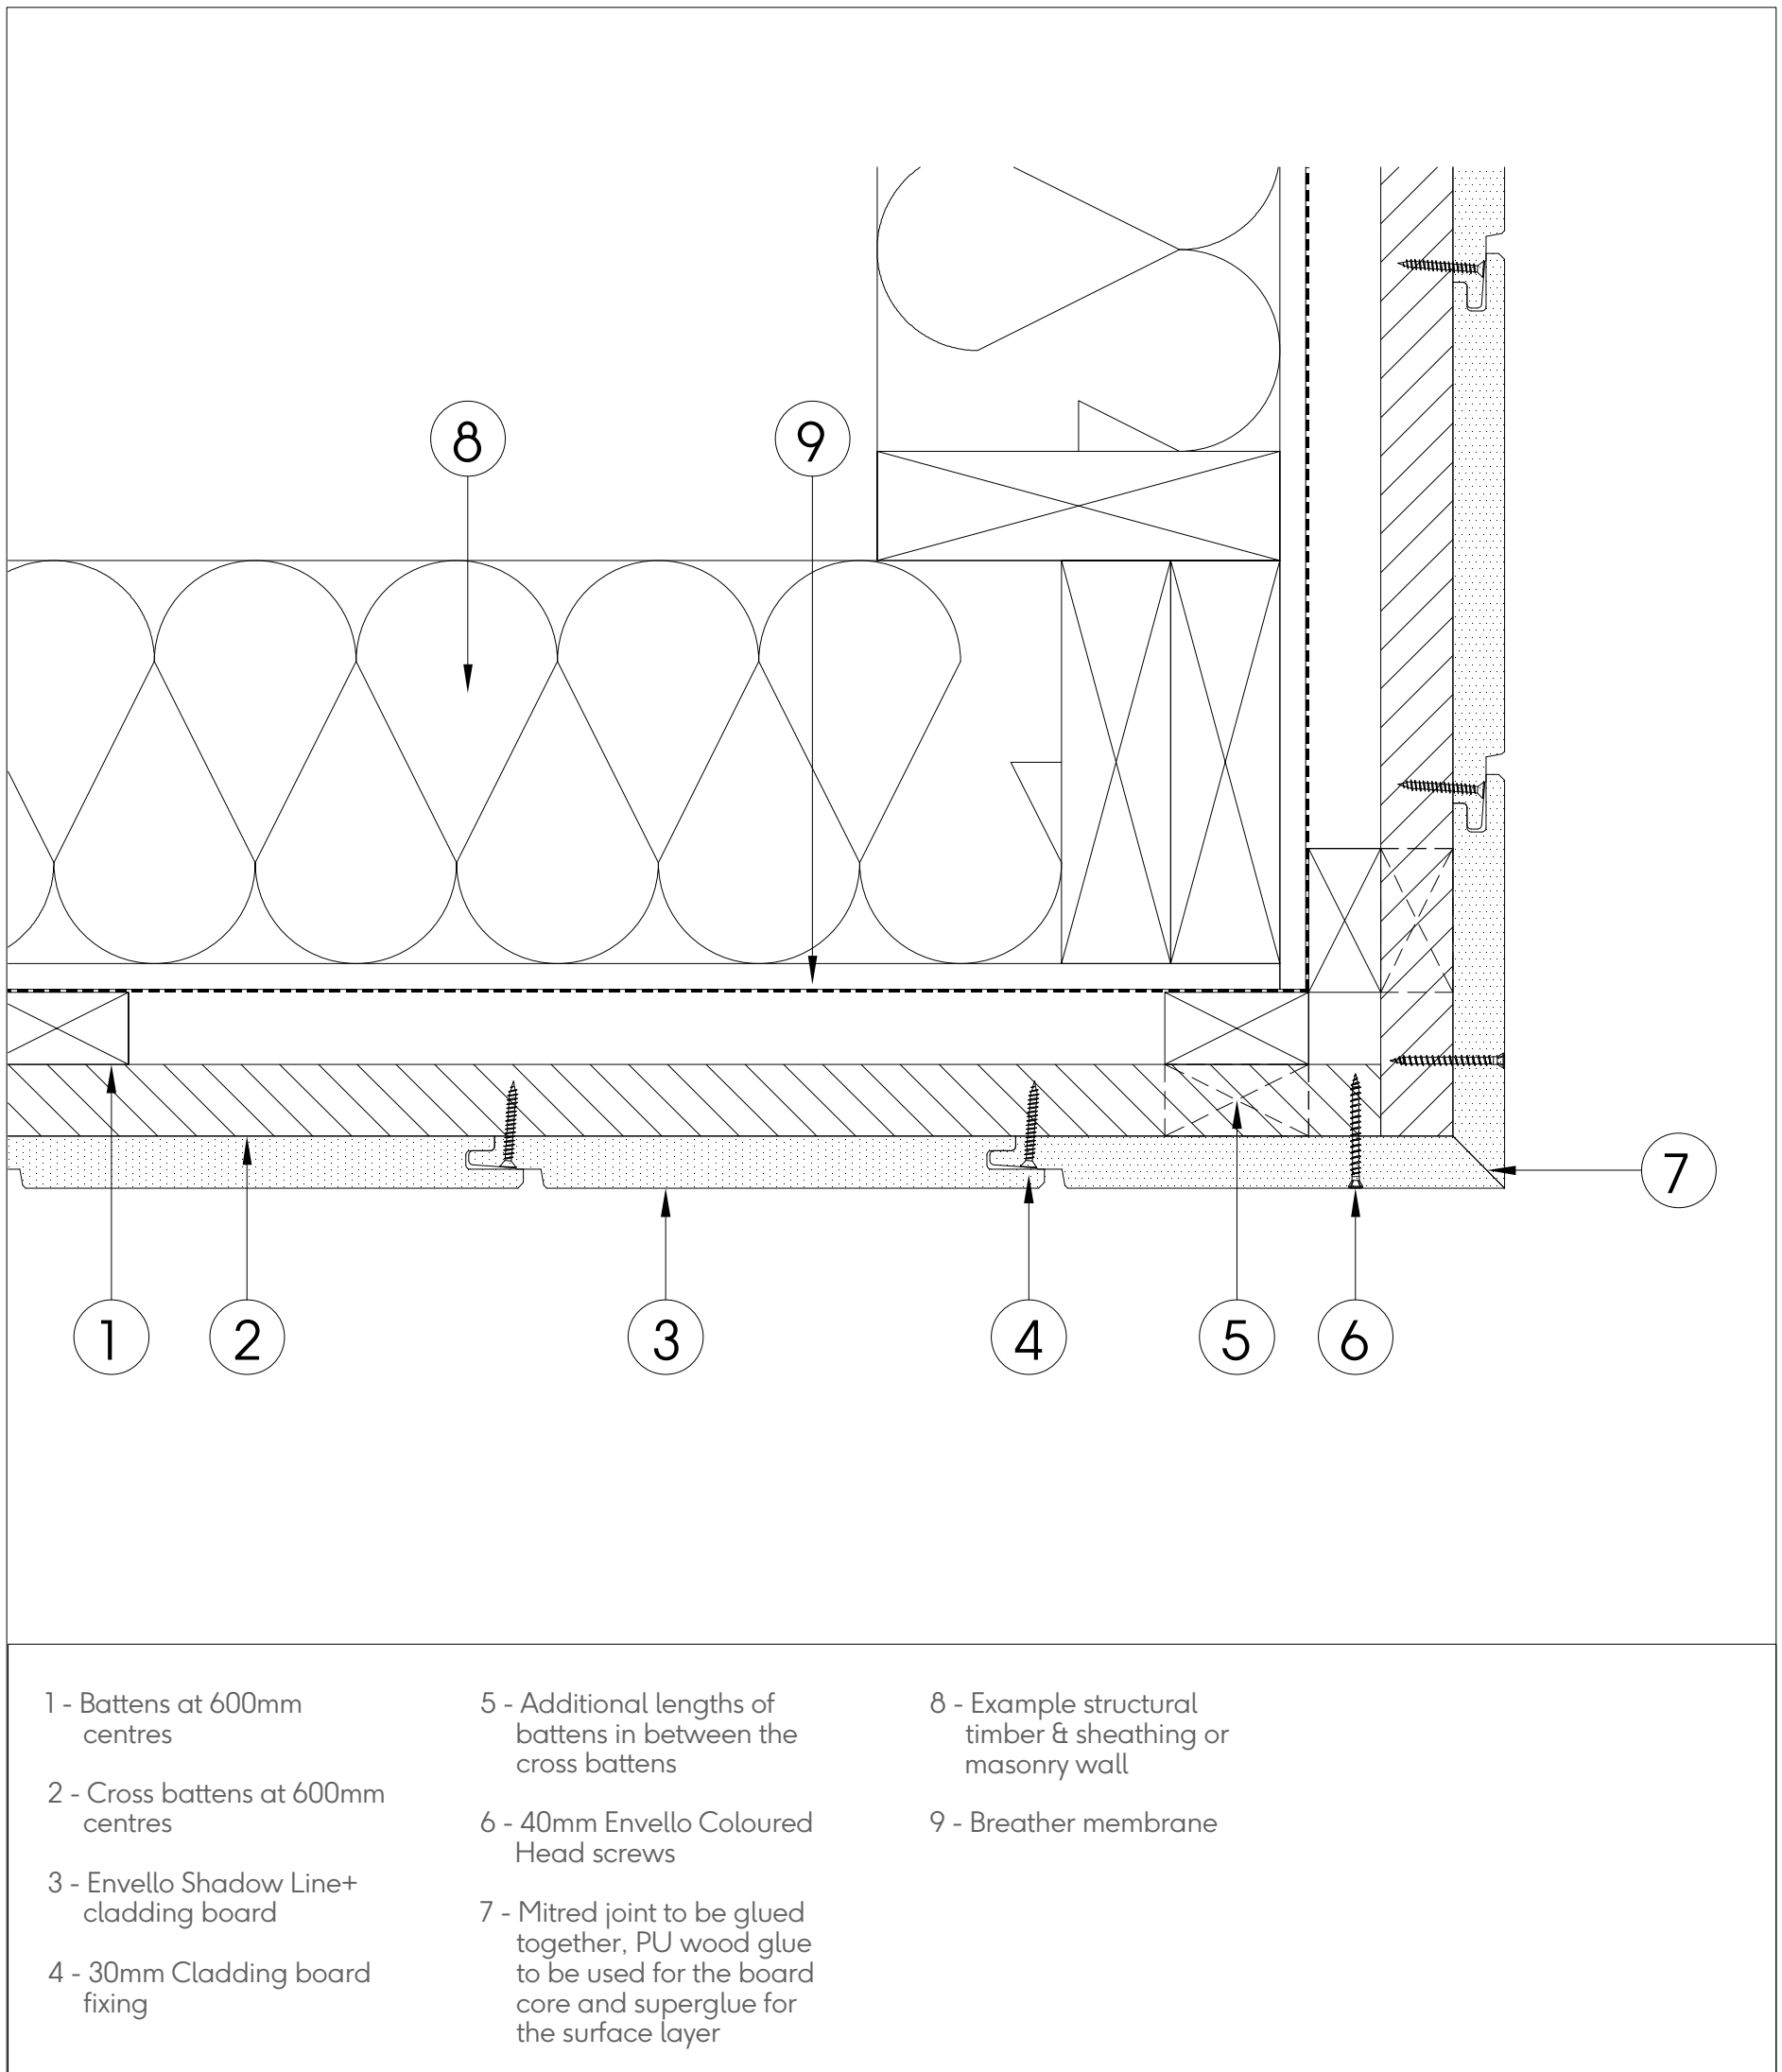
#142.22.01

Mitred corner detail

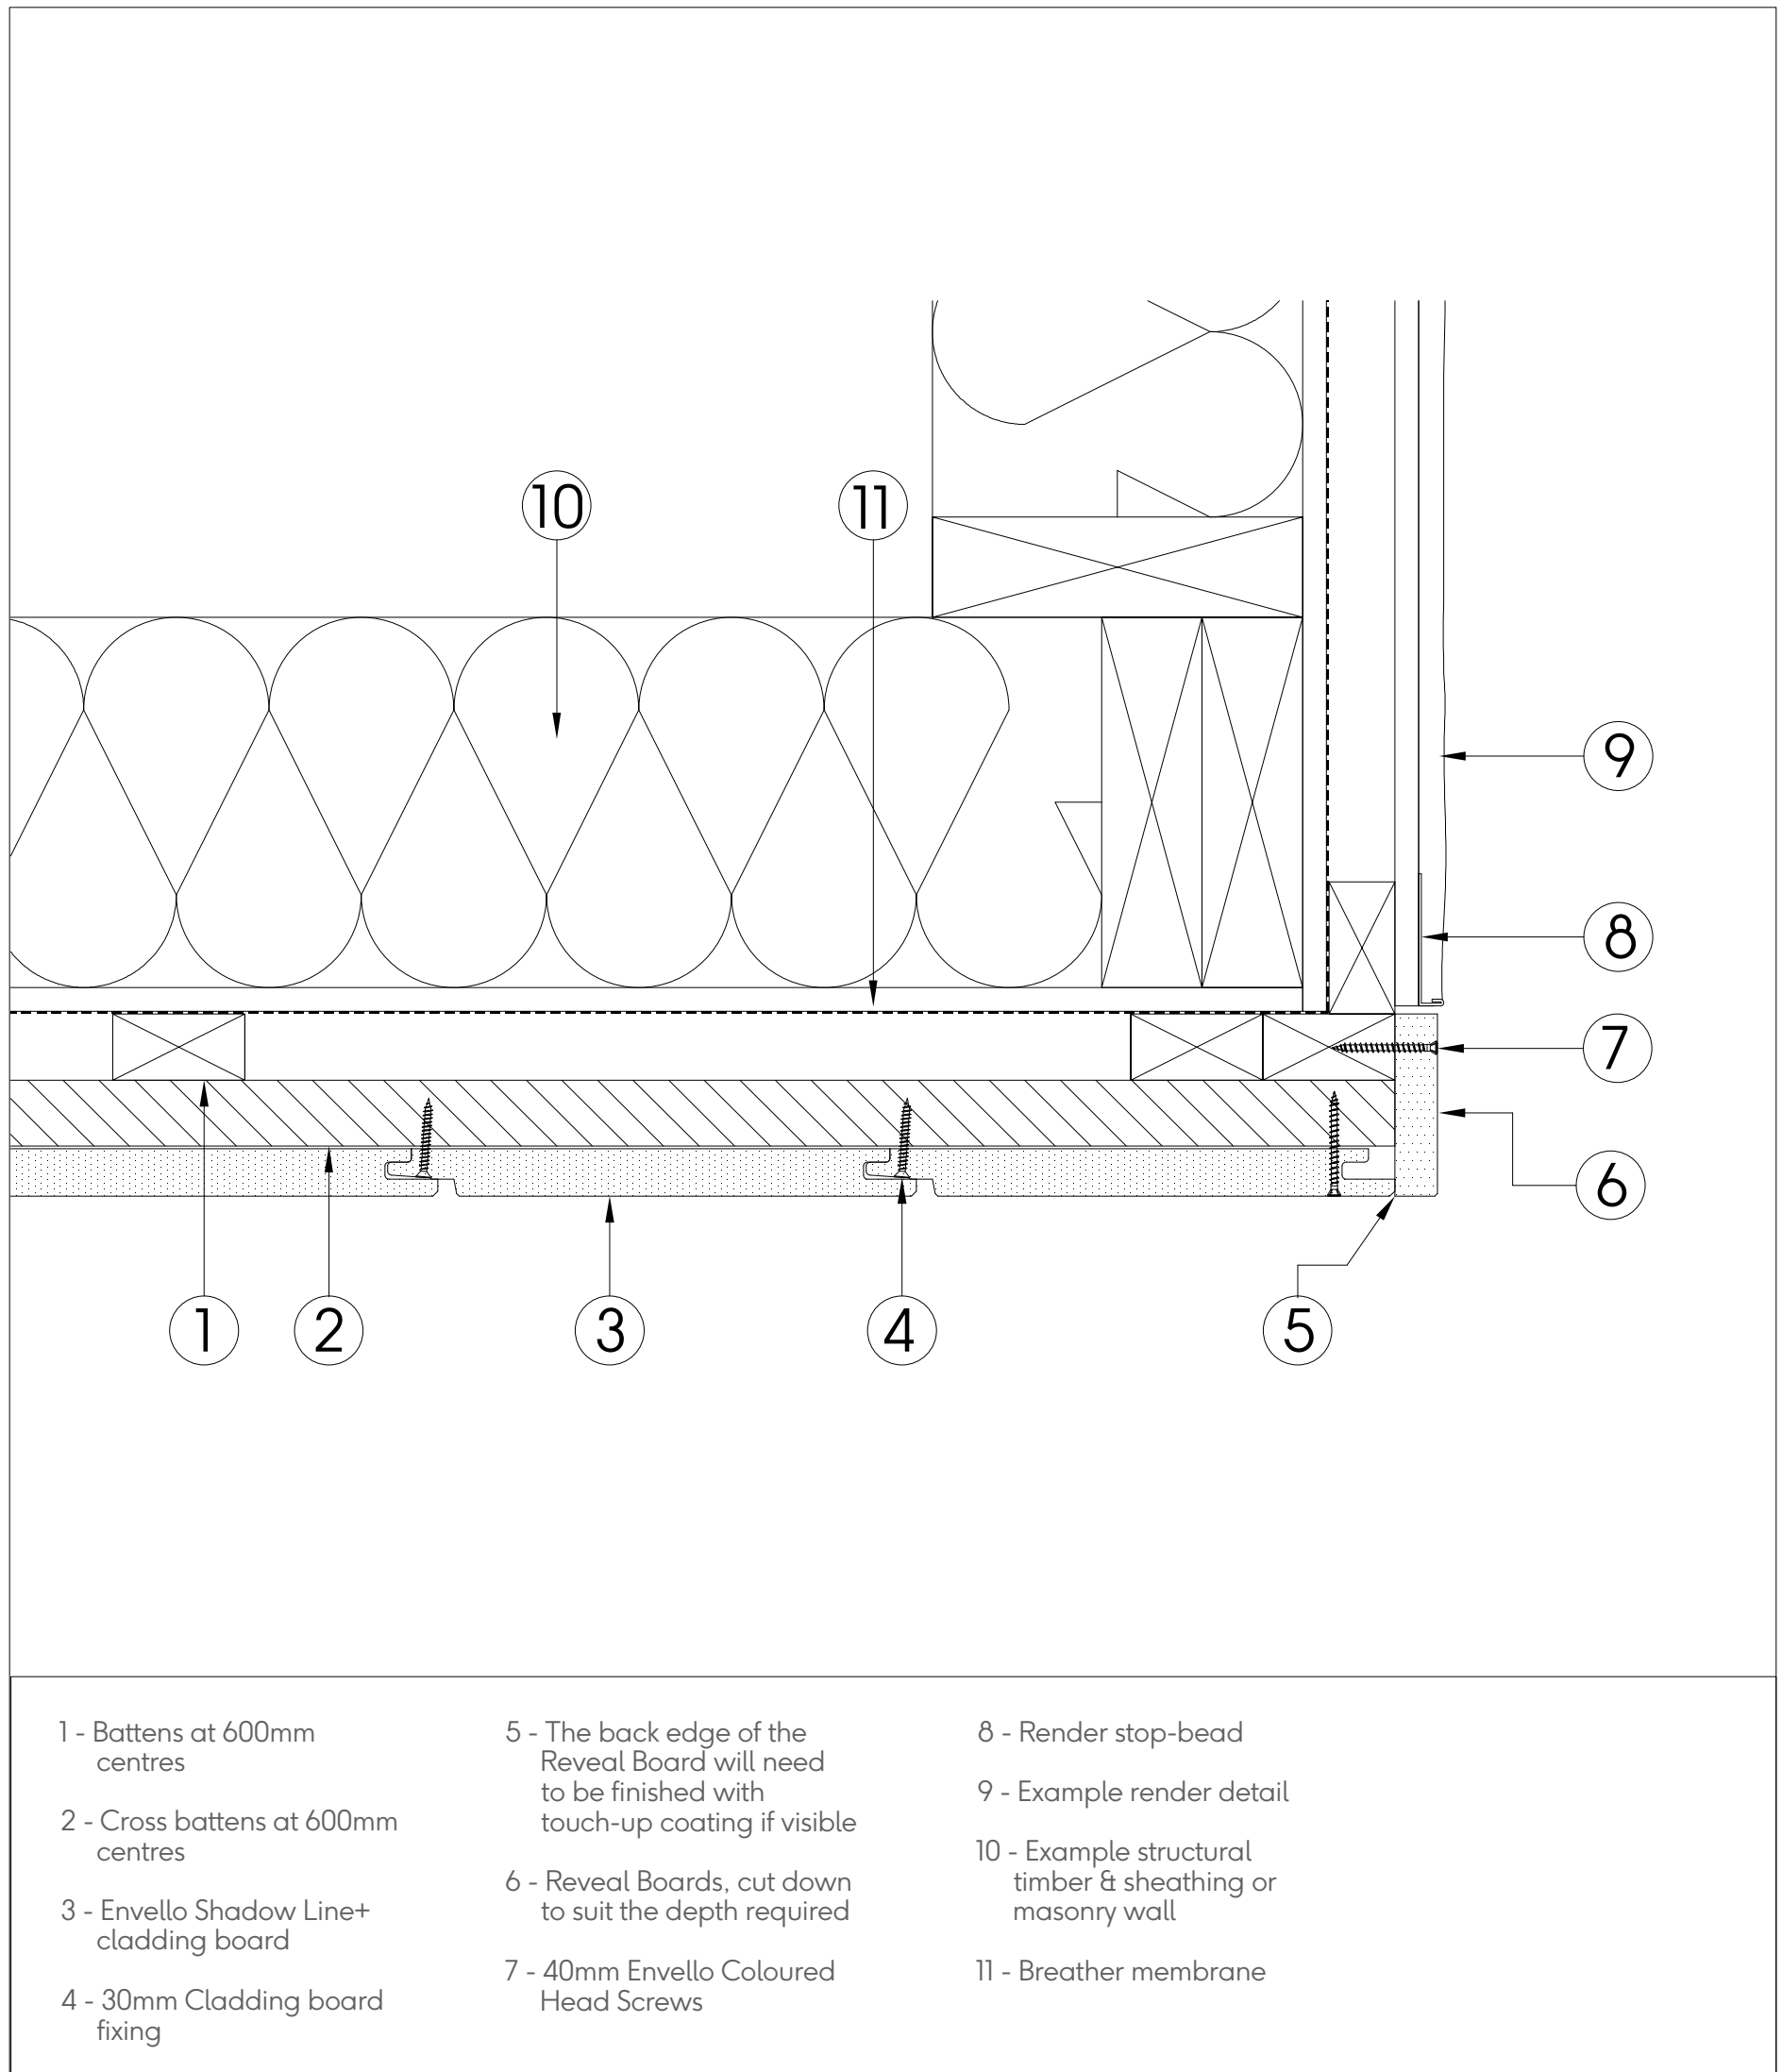
#146.22.01

External corner detail abutting render
