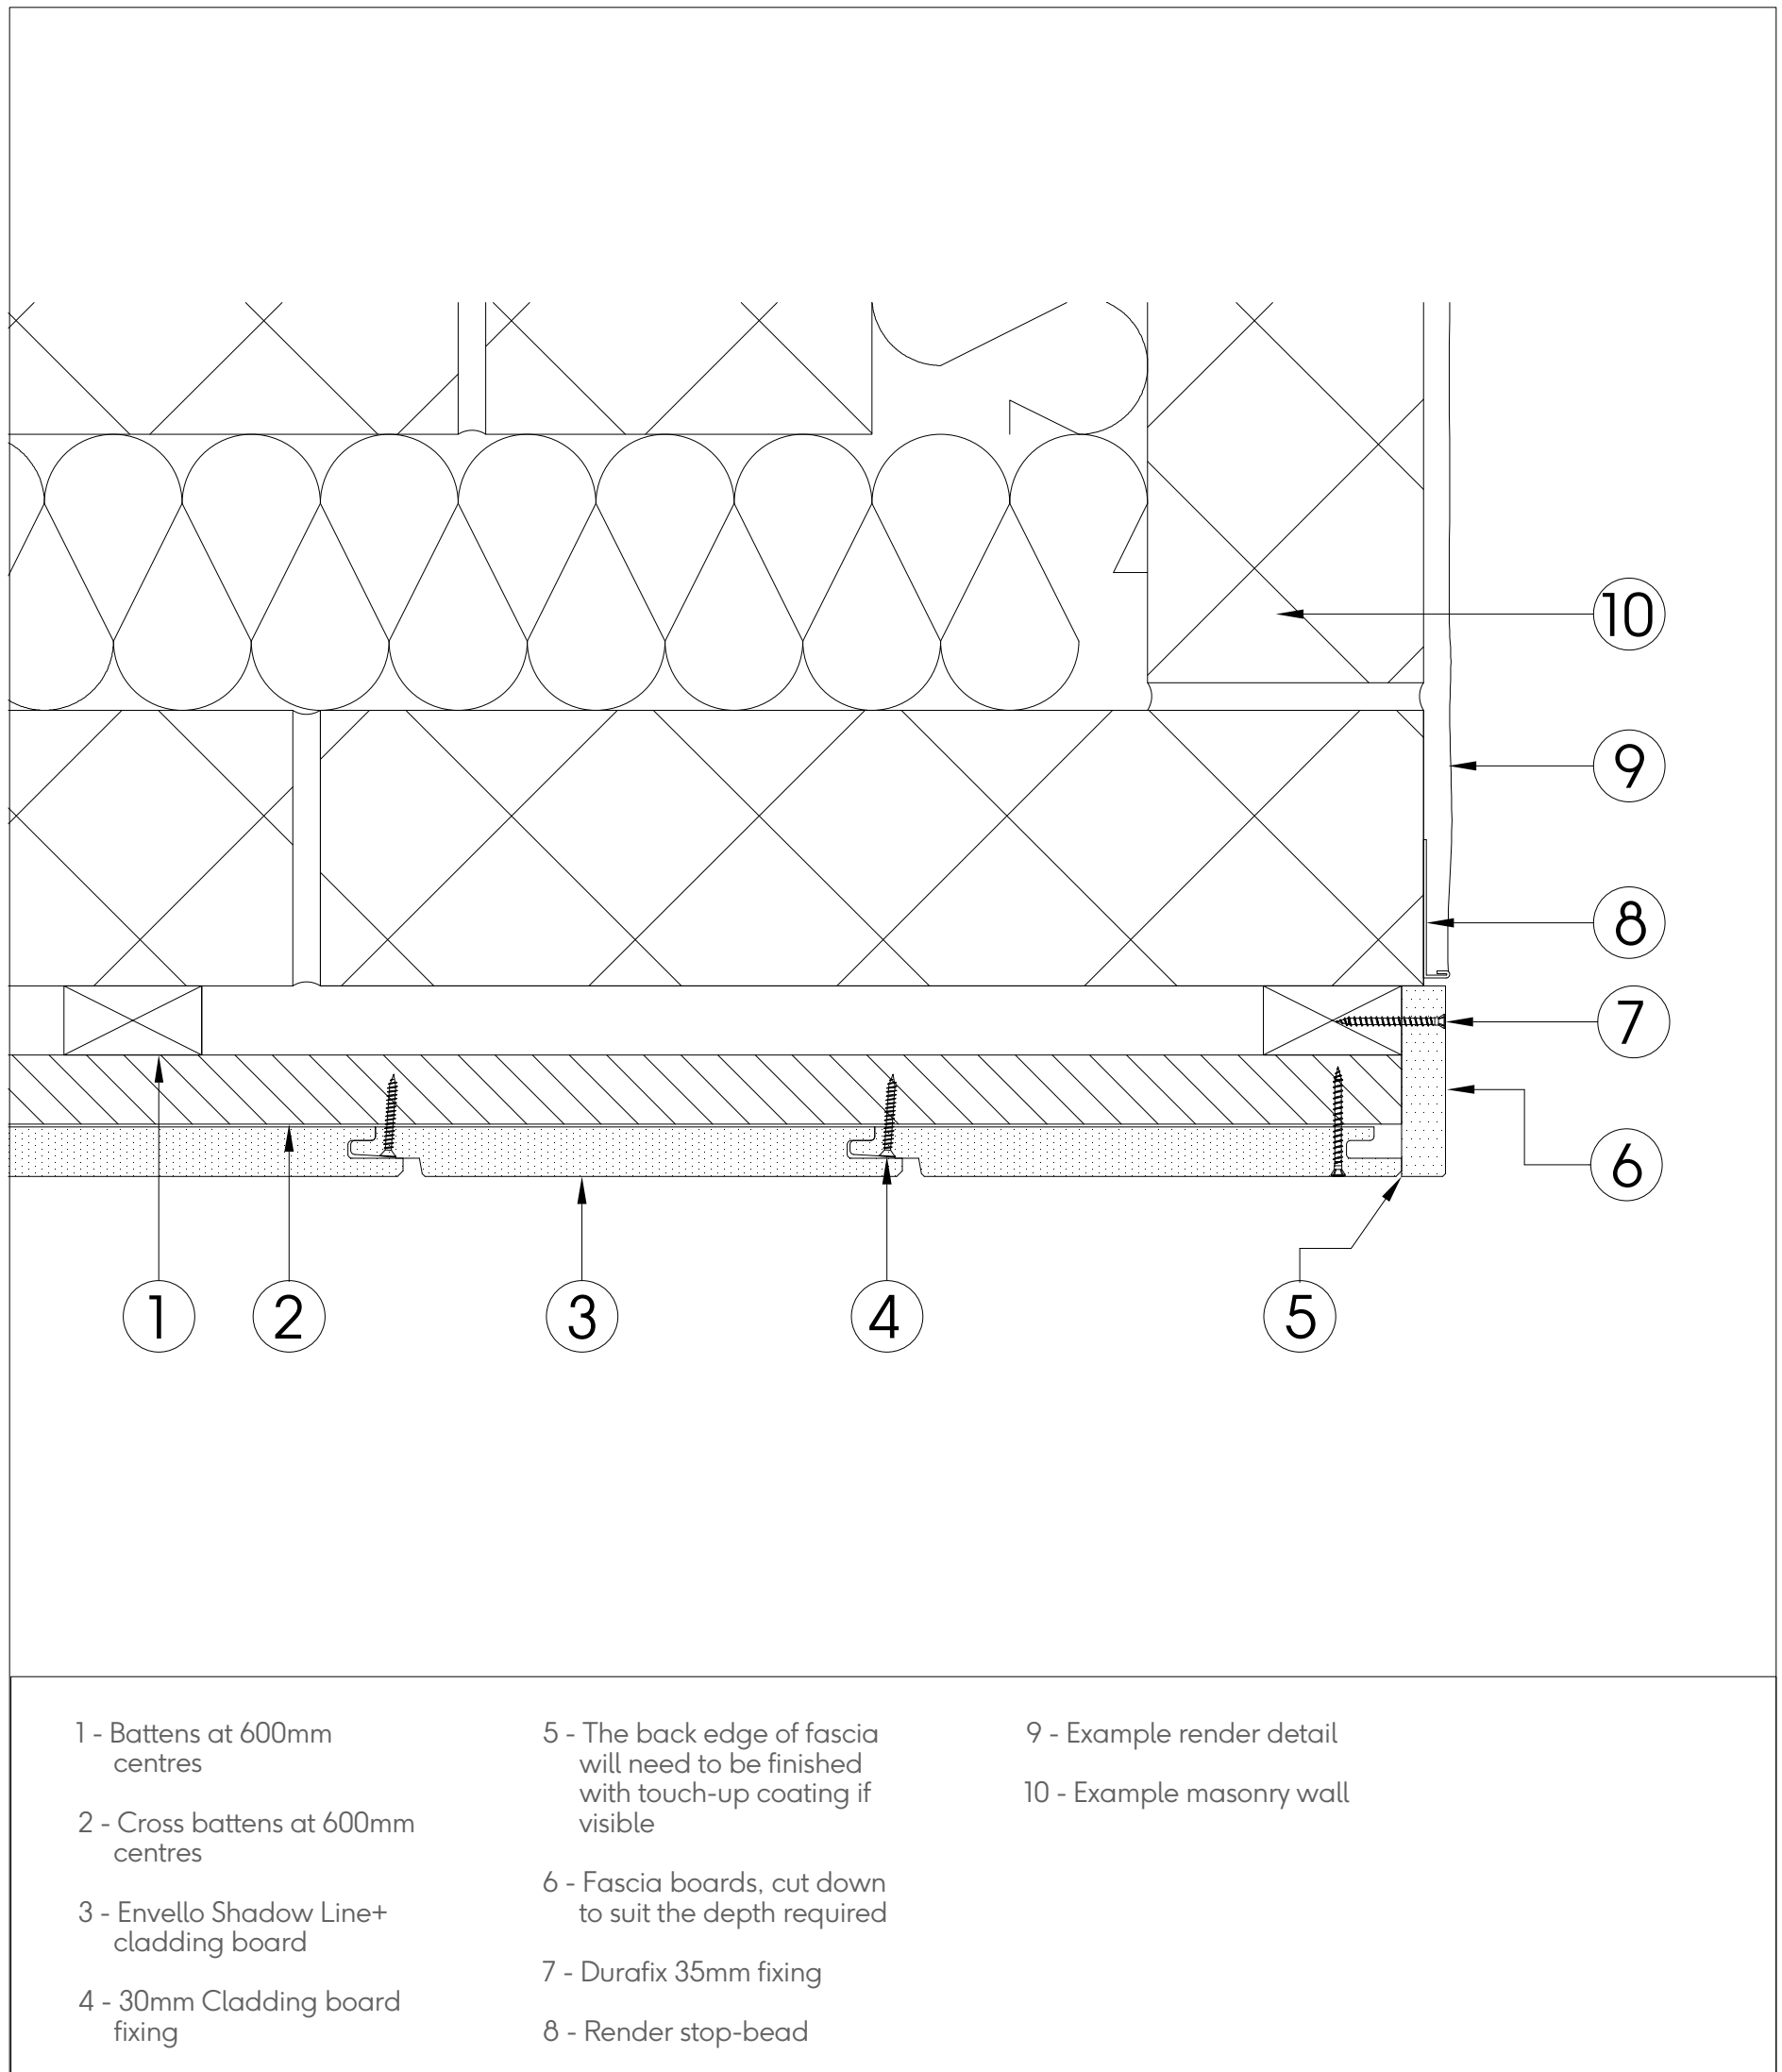
#148.22.01

External corner detail abutting render - Masonry
