DesTestMAX

Matthew Desmond
factorofmatt.com

Introduction

The DesTestMAX project aims to improve upon Commodore's Dead Test cartridge by using a more comprehensive memory test strategy and provide easier to interpret diagnostic output.

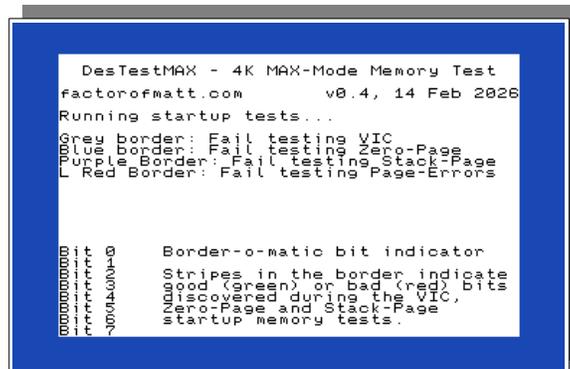
When the cartridge first starts it tests the VIC-II, Zero-Page, the Stack Page and the checksum of its own ROM. The startup screen will be displayed immediately upon cartridge startup and remains only for a few seconds while the startup tests run.

- The VIC-II has 47 registers mapped into the \$D000 block of address space. We don't use all the features of the VIC-II during testing, so many of these registers can be considered as general read/write 'memory'. Testing is performed on these registers to verify that they can be written and read as expected.

- The Zero Page is one of the two 256-byte memory pages treated specially by the 6510. It would be impractical to write a full memory test without using at least some of zero-page, so we test it early here. The test does not use zero-page (or the stack) to do so.

- The Stack Page is the other 256-byte memory page treated specially by the 6510. The stack allows the use of subroutines (JSR/RTS). We test the stack page (without using it or zero-page) so that we have some confidence we can use subroutines for the more comprehensive tests.

- Failures in the C64's memory address multiplexer circuitry can lead to seemingly random memory corruption known as Page Errors. Since we do use a little of the 64K memory during tests, we test the multiplexers early to avoid possible corruption.

- A 16-bit checksum is calculated for the entire contents of the DesTestMAX code (\$E000-\$FFFF). If the checksum is incorrect the EPROM image could be corrupt or could indicate that address decoding logic in the C64 is faulty.

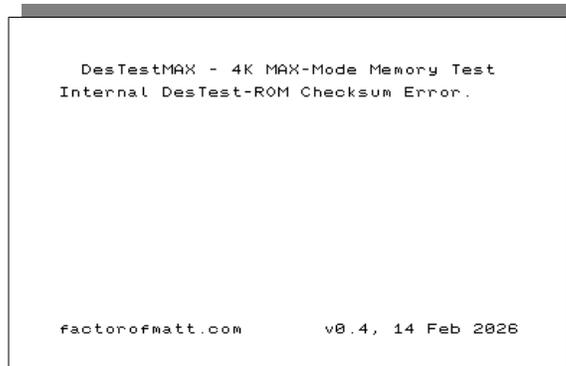
Code Checksum Failure

A checksum failure is indicated by a white border and a message indicating the checksum error. Under certain circumstances, the text of this screen may be garbled or otherwise unintelligible. See the Limitations section for details.

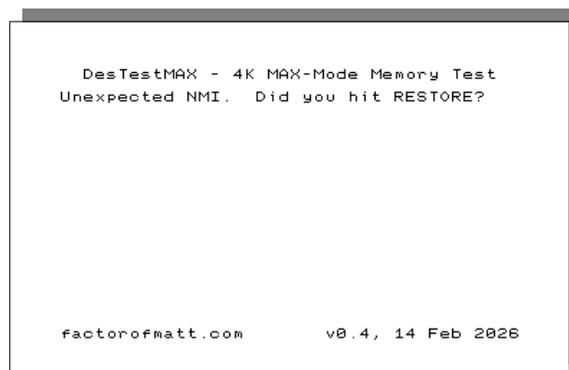
NMIs cannot be disabled. The best we can hope is to ensure that any sources of an NMI are disabled. Unfortunately, the RESTORE key when tapped will always generate an NMI and there's really nothing that can be done about it. If an NMI is received, the following screen is displayed:

If you see this screen and did not hit RESTORE then something (CIA) generated an NMI or something is wrong in the NMI signal path.

If you hit the RESTORE key (possibly in frustration if nothing seems to be happening) and you see this screen, then at least you know the CPU works.

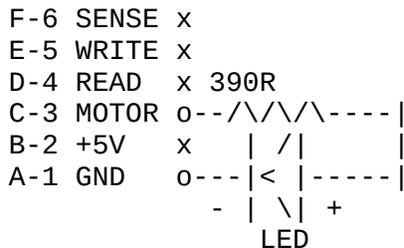
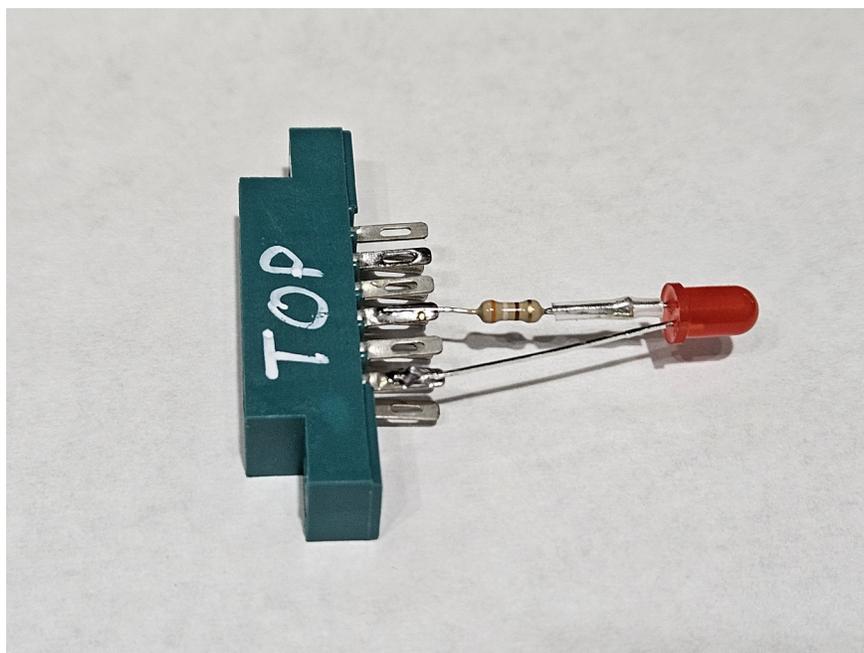
1 2 3 4 5 6 C64 cassette-port (viewed from the rear)

3. Alternatively you can attach an LED and 390R resistor between the GND and MOTOR conductors on the cassette-port. The LED has to be attached between the GND and MOTOR conductors in the correct polarity. The cathode (short-leg, flat-side) of the LED should attach to the GND conductor and the anode (long-leg) of the LED should attach via the resistor to the MOTOR conductor. See the diagram below.
Note 1: the resistor can attach to either the cathode or anode.
Note 2: the WRITE signal can also be used however it is connected directly to the 6510 and won't supply as much current to light the LED.
 Note 3: The value for the resistor (390R) should work for most red LEDs, but can be substituted as necessary for different LEDs. The voltage of the MOTOR signal is about 10V with no load.

A B C D E F The top and bottom conductors carry the same signals.

5. If you wish to make your LED fixture more permanent you can buy a 6-pin 0.156-inch edge connector from your favourite online electronic components retailer. Simply solder the LED/resistor to the appropriate pins on the edge connector. Be sure to clearly write the word "TOP" on your new fixture as plugging it in upside-down may cause damage to your CPU.

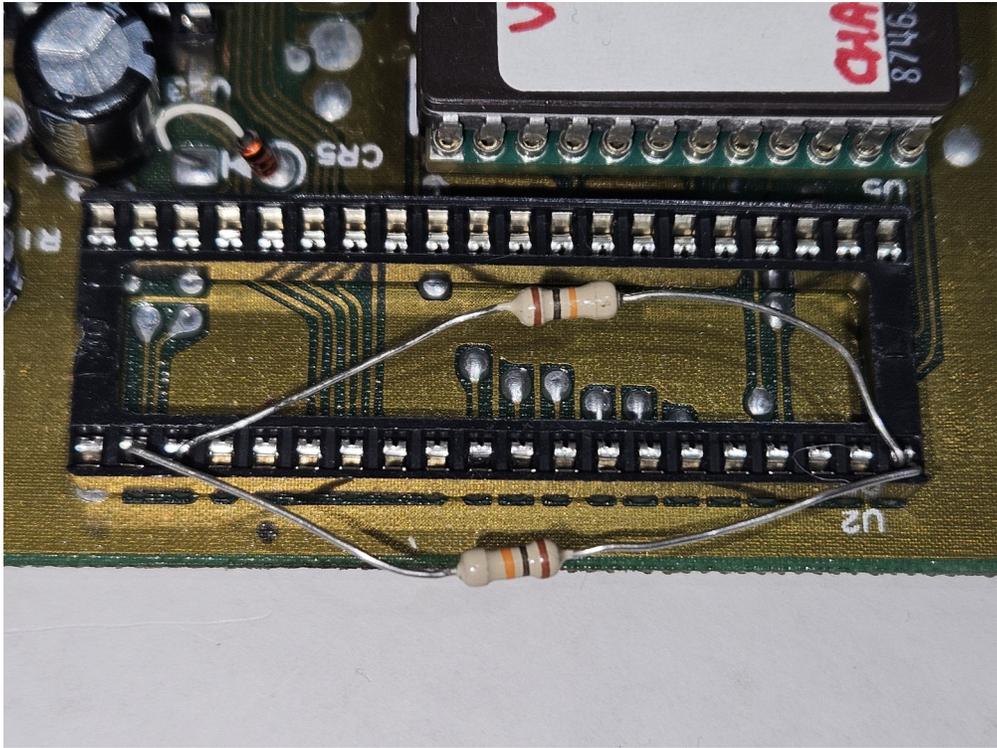
The shortboard motherboards don't use a 74LS258 to select the VIC-II block, rather it uses the 64-pin super-PLA for that job. For some reason, the PA0 signal no longer seems to float to high so the default block for the VIC-II is no longer 0 when CIA#2 is removed. The upshot is that the VIC-II looks at the wrong memory area during the latter stages of DesTestMAX and the screen is garbled. A 1K to 10K resistor placed between /VA14 (pin 2) and +5v (pin 20) on the CIA#2 (U2) socket should be enough to overcome this limitation in the short term.

Elsewhere in this document we've discussed the fact that DesTestMAX doesn't require the CIAs to be installed in order to operate correctly. Unfortunately that isn't quite true for the most recent version of the C64 motherboard. The Assy 250469 "shortboard" as found in later C64Cs operates a little differently from the other motherboards when it comes to a missing CIA#2 (\$DD00-\$DDFF).

The PA0 and PA1 signals from CIA#2 control which of the 4 16K blocks of memory the VIC-II will address. The logic is inverted, so to select block 0 (\$0000-\$3FFF) both bits are set high.
