DesTest MAX-Switch

The DesTest MAX-Switch (aka DesTest Switch, aka ‘Switch) project builds upon the DesTestMAX cartridge to provide a complete 64K RAM test solution.

The ‘Switch boots into MAX (or ULTIMAX) mode to perform the initial 4K memory test, then switches to 64K mode to test the full 64K of memory. This arrangement allows the ‘Switch to work in a wide-range of situations.

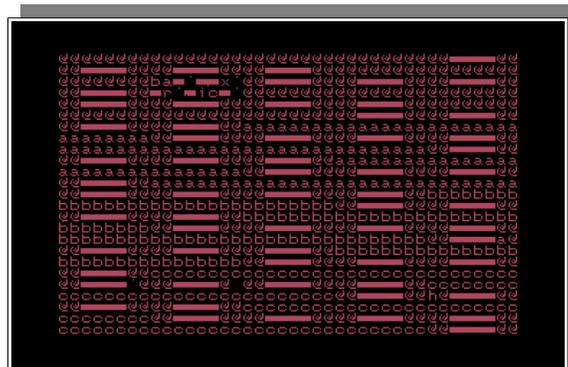
Multiplexer Failure/VIC Test Failure

Unlike other custom chips in the C64, the VIC address bits used for register access are attached to the multiplexed RAS/CAS address bits as used by the DRAM. This means that faults in the address multiplexers (on longboards) or the PLA (on shortboards) can cause the VIC registers to not be accessible correctly. Failures in the multiplexers or in the VIC itself are difficult to communicate effectively since, depending on the failure mode, we might not be able to display meaningful text or change the border/screen colours. This earliest of tests verifies that communication with the VIC is as expected. If errors are discovered, DesTestKernal will do its best to alert the user as best it can:

The screen matrix data (text) is set to a hopefully distinctive set of characters. Additionally the colour of the text is alternately switched between red and white. These are best-effort measures since

multiplexer issues affecting the VIC will also affect the screen-matrix RAM – some of the screen will likely be garbage no matter what.

As an additional indicator the cassette write and motor lines are toggled at the same rate that the colours toggle between white and red. See the “Cassette Port Indicator” section for details on how to build and use such a cassette port indicator.

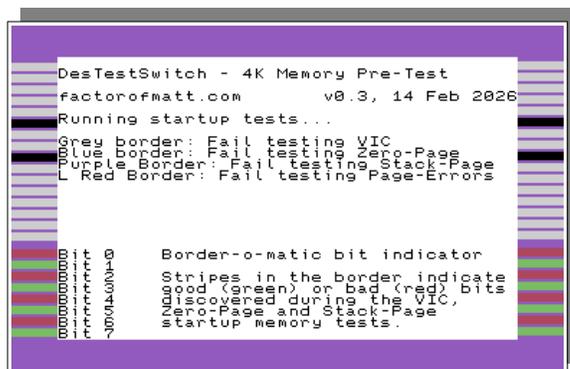
Zero Page or Stack Page Failure

A failure during either of these tests results in a blue (zero-page) or purple (stack page) border plus stripes indicating the fail-address and failed bits:

The border stripes show address bits (A0-A15, top-to-bottom) and data bits (D0-D7, top to bottom). A black address bit is 1, light grey is 0. A green data bit indicates a good bit, red indicates bad. Here we see that data bit 2 was detected as bad and that the most recent memory location found to be bad was \$01B3.

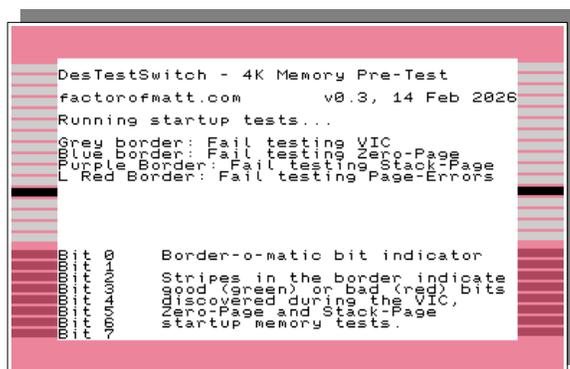
Page Error Failure

A failure during the page-error (multiplexer) tests results in a light-red (pink) border plus stripes indicating the fail-address-bits and failed bits:

Unlike other tests, the fail-address-bits indicate which address-bits seem to be faulty (bits 9 and 11 in the above example) rather than a specific address. Such information can be useful (with help from the C64 schematics) to determine which multiplexer is likely faulty.

Page errors occur when some set of addresses gets incorrectly mapped to a different set of addresses. This can happen both inside a memory chip or in the case of a C64 when the address multiplexers fail. Imagine that address-bit 2 is always stuck ‘on’: a read or write at address 0 would actually be a read or

write at address 4 (plus 1 maps to 5, 2 to 6 and 3 to 7 and so on every 4 bytes throughout memory). Similar situations exists if a bit is stuck 'off' or accidentally tied to another bit entirely.

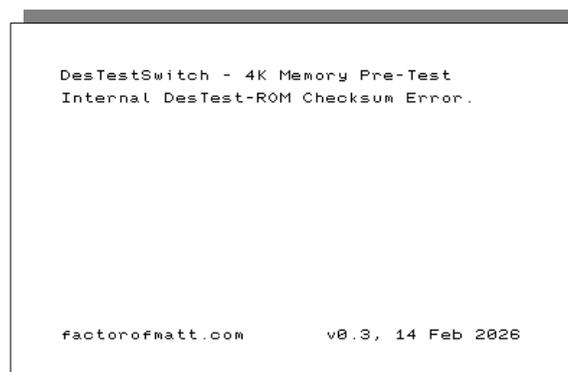
Code Checksum Failure

A checksum failure is indicated by a white border and a message indicating the checksum error. Under certain circumstances, the text of this screen may be garbled or otherwise unintelligible. See the Limitations section for details.

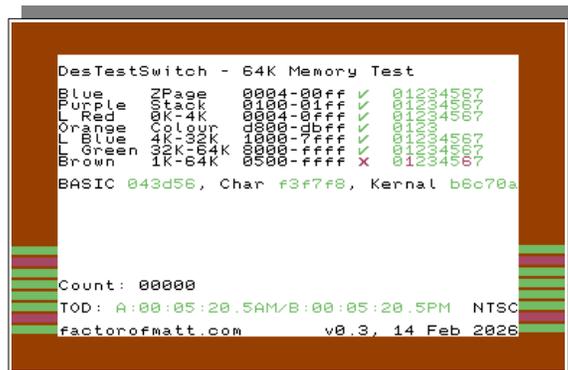
Error Detected, No information saved

If no error information was collected, the border stripes show data bits (D0-D7 top to bottom) green for good, red for bad.

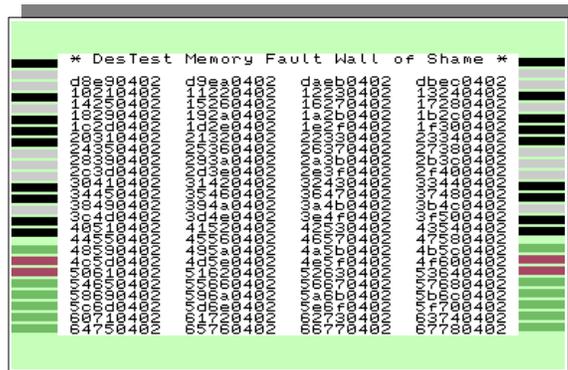
Error Detected, Information saved.

In the event that we were able to collect some address/bit-error information it is displayed on the following screen. Each error record is 8 hex digits wide:

- First 4 digits: The address at which an error was detected
- Next 2 digits: An indication of bits that were written as 0 but were read as 1
- Last 2 digits: An indication of bits that were written 1 but were read as 0

An error record of 04150402 indicates that at address \$0415 bit 2 (\$04) was mistakenly read as 1 and bit 1 (\$02) was mistakenly read as 0. Patterns may emerge both in addresses and bad bits that can indicate the source of problems.

Note: some addresses may appear multiple times since the testing algorithm walks through memory both backwards and forwards a couple of times each.

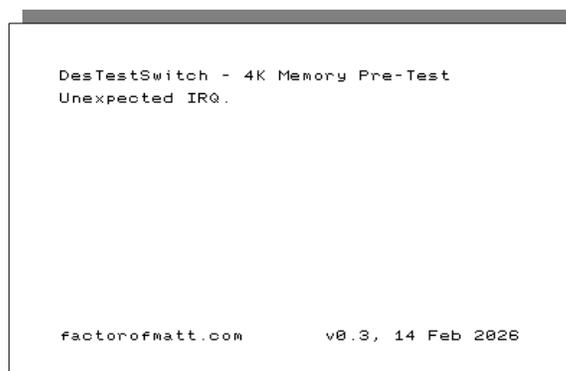
IRQ (4K)

Under normal circumstances no IRQs should occur during normal DesTestMAX operation. The CPU is left free to respond to IRQs and will display the following screen should any occur.

The receipt of an IRQ during the execution of tests could very well indicate something wrong with the interrupt-signal path or a misbehaving interrupt source (VIC-II, CIA etc.).

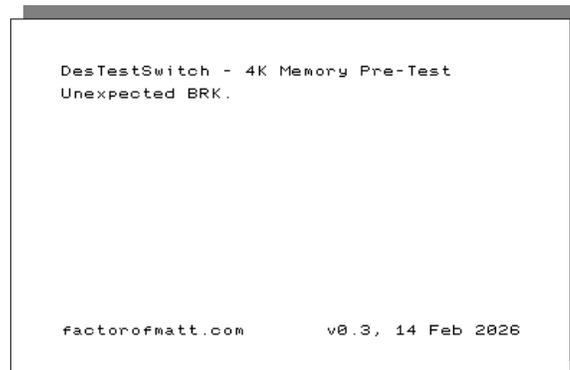
BRK (4K)

The BRK instruction of the 6502/6510 will interrupt the CPU in much the same way that an IRQ does – though it is straightforward to differentiate the two.

If you see this screen then the CPU has somehow executed a BRK instruction – something that won't happen during the normal operation of DesTest MAX-Switch. This might indicate a marginal 6510, PLA or other chip that is affecting data reads.

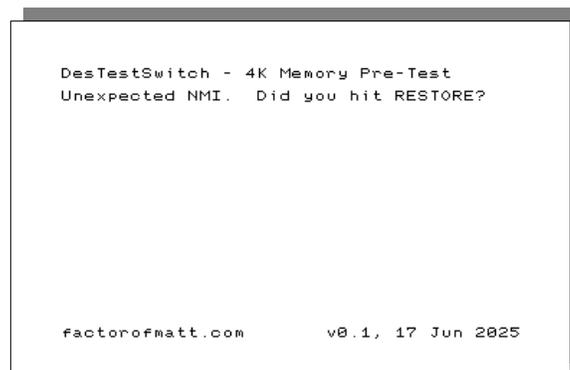
NMI (4K)

NMIs cannot be disabled. The best we can hope is to ensure that any sources of an NMI are disabled. Unfortunately, the RESTORE key when tapped will always generate an NMI and there's really nothing that can be done about it. If an NMI is received, the following screen is displayed:

If you see this screen and did not hit RESTORE then something (CIA) generated an NMI or something is wrong in the NMI signal path.

If you hit the RESTORE key (possibly in frustration if nothing seems to be happening) and you see this screen, then at least you know the CPU works.

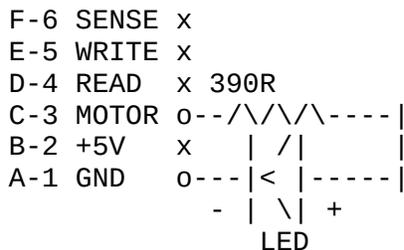
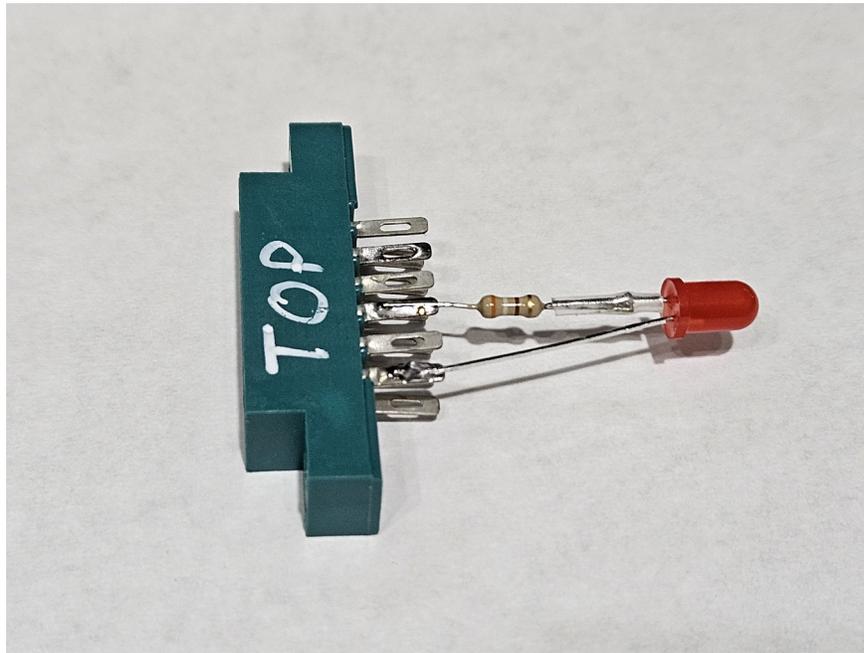
1 2 3 4 5 6 C64 cassette-port (viewed from the rear)

3. Alternatively you can attach an LED and 390R resistor between the GND and MOTOR conductors on the cassette-port. The LED has to be attached between the GND and MOTOR conductors in the correct polarity. The cathode (short-leg, flat-side) of the LED should attach to the GND conductor and the anode (long-leg) of the LED should attach via the resistor to the MOTOR conductor. See the diagram below.
Note 1: the resistor can attach to either the cathode or anode.
Note 2: the WRITE signal can also be used however it is connected directly to the 6510 and won't supply as much current to light the LED.
Note 3: The value for the resistor (390R) should work for most red LEDs, but can be substituted as necessary for different LEDs. The voltage of the MOTOR signal is about 10V with no load.

A B C D E F The top and bottom conductors carry the same signals.

4. You can use small crocodile or alligator clip to attach to the GND and WRITE, just be sure to only touch the copper trace (top and bottom) of the signal you are after.

5. If you wish to make your LED fixture more permanent you can buy a 6-pin 0.156-inch edge connector from your favourite online electronic components retailer. Simply solder the LED/resistor to the appropriate pins on the edge connector. Be sure to clearly write the word "TOP" on your new fixture as plugging it in upside-down may cause damage to your CPU.

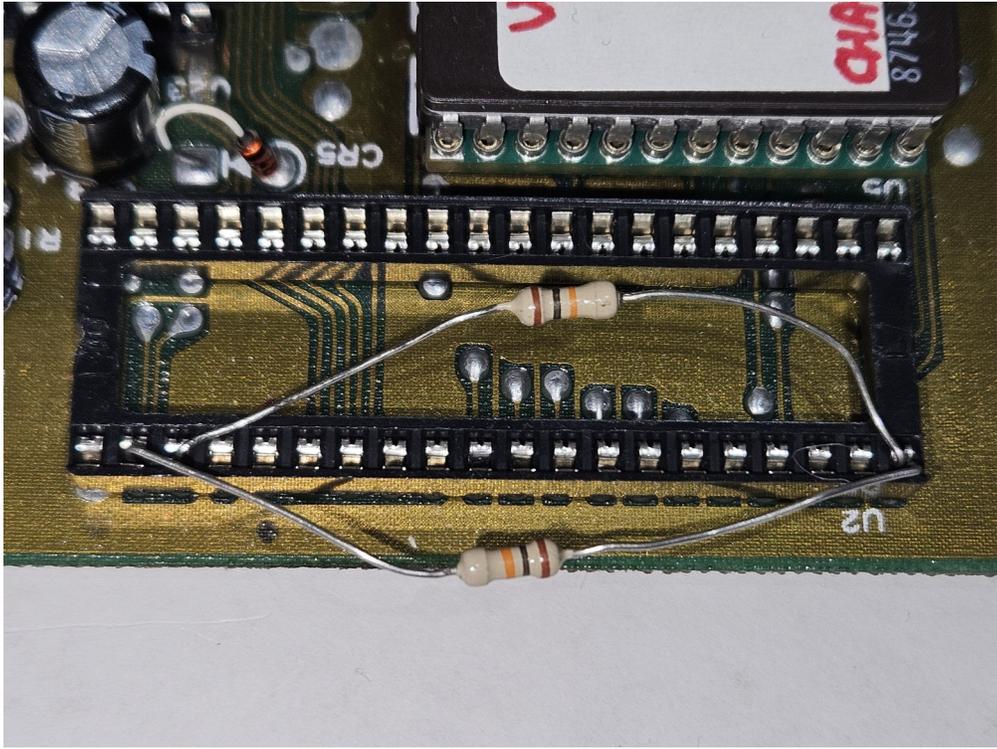
The shortboard motherboards don't use a 74LS258 to select the VIC-II block, rather it uses the 64-pin super-PLA for that job. For some reason, the PA0 and PA1 signals no longer seems to float to high so the default block for the VIC-II is no longer 0 when CIA#2 is removed. The upshot is that the VIC-II looks at the wrong memory area during the latter stages of DesTest MAX-Switch and the screen is garbled. A 1K to 10K resistor placed between /VA14 and /VA15 (pins 2 and 3) and +5v (pin 20) on the CIA#2 (U2) socket should be enough to overcome this limitation in the short term.

The PA0 and PA1 signals from CIA#2 control which of the 4 16K blocks of memory the VIC-II will address. The logic is inverted, so to select block 0 (\$0000-\$3FFF) both bits are set high.
