1972 Triumph 2000

Rust protection, plus the rest...

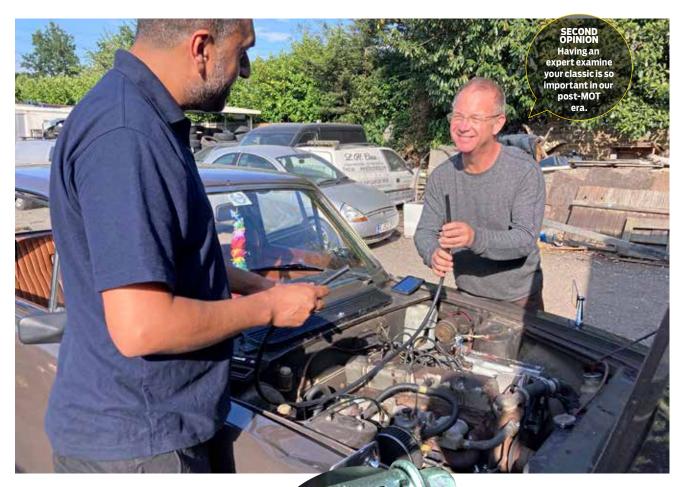
The old hoses – only six-years-old – were cracked and badly degraded from the inside out. No wonder there was debris trapped in the filter. Shocking, and potentially deadly. We fitted new stainless steel fuel hose clips which clamp with an even concentric force (unlike Jubilee clips).

Hoses looked OK-ish on the outside, but inside,, unsafe,

lines, the highest SAE specification petrol fuel hose available. The outer part of the hose is made from nitrile rubber with a thin flexible layer of fluoro-elastomer in the bore, which provides an exceptional resistance to sour petrol plus methanol and ethanol additives. The hose has a working pressure of 100psi and is suitable for use with both carburettor and fuel injected cars... I'm very glad to have it.
