CORROSION UNDER INSULATION (CUI)

THERMACOAT - 400

ThermaCoat – 400 is a Water-borne two part thermally insulated liquid applied coating.

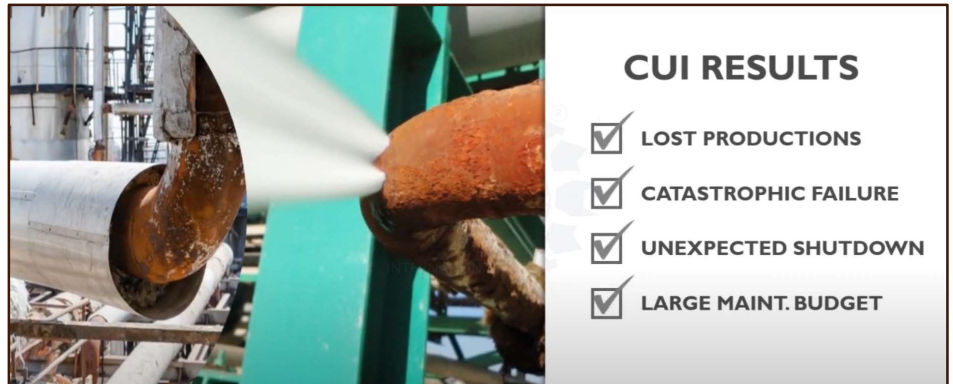
When corrosion takes place on the surface under the insulation, it is known as corrosion under insulation (CUI). CUI is a major common problem on a worldwide basis, it is responsible for many major leaks that leads to health and safety incidents.

Most pipes are made from low carbon or low alloy steel. Steel corrodes when it reacts with substances like water or moisture which acts as the electrolytes in a corrosion cell. CUI occurred under all types of insulation material (Fibrous, Granular and Cellular). Insulation material does not corrode steel, it is the space left open for moisture. The common insulation practice of using an insulation material covered by a jacket aid in allowing the moisture to get through via: Rainfall; Steam Discharge; Cooling Tower and Condensation.

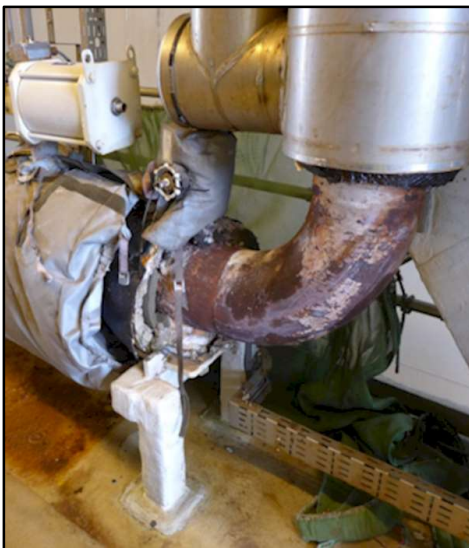
Corrosion Under Insulation (CUI) can be prevented by using ThermaCoat-400

With ThermaCoat – 400 the protective epoxy coating that can withstand temperature up to 400F is the insulation material. The coating will not leave space for moisture to occur on the steel surface. Advantages of ThermaCoat-400:
