# POOL AREA REMODELING

La Perla - Jacó, Costa Rica

07/11/2023

julin  
BACK ROSSO  
architecture

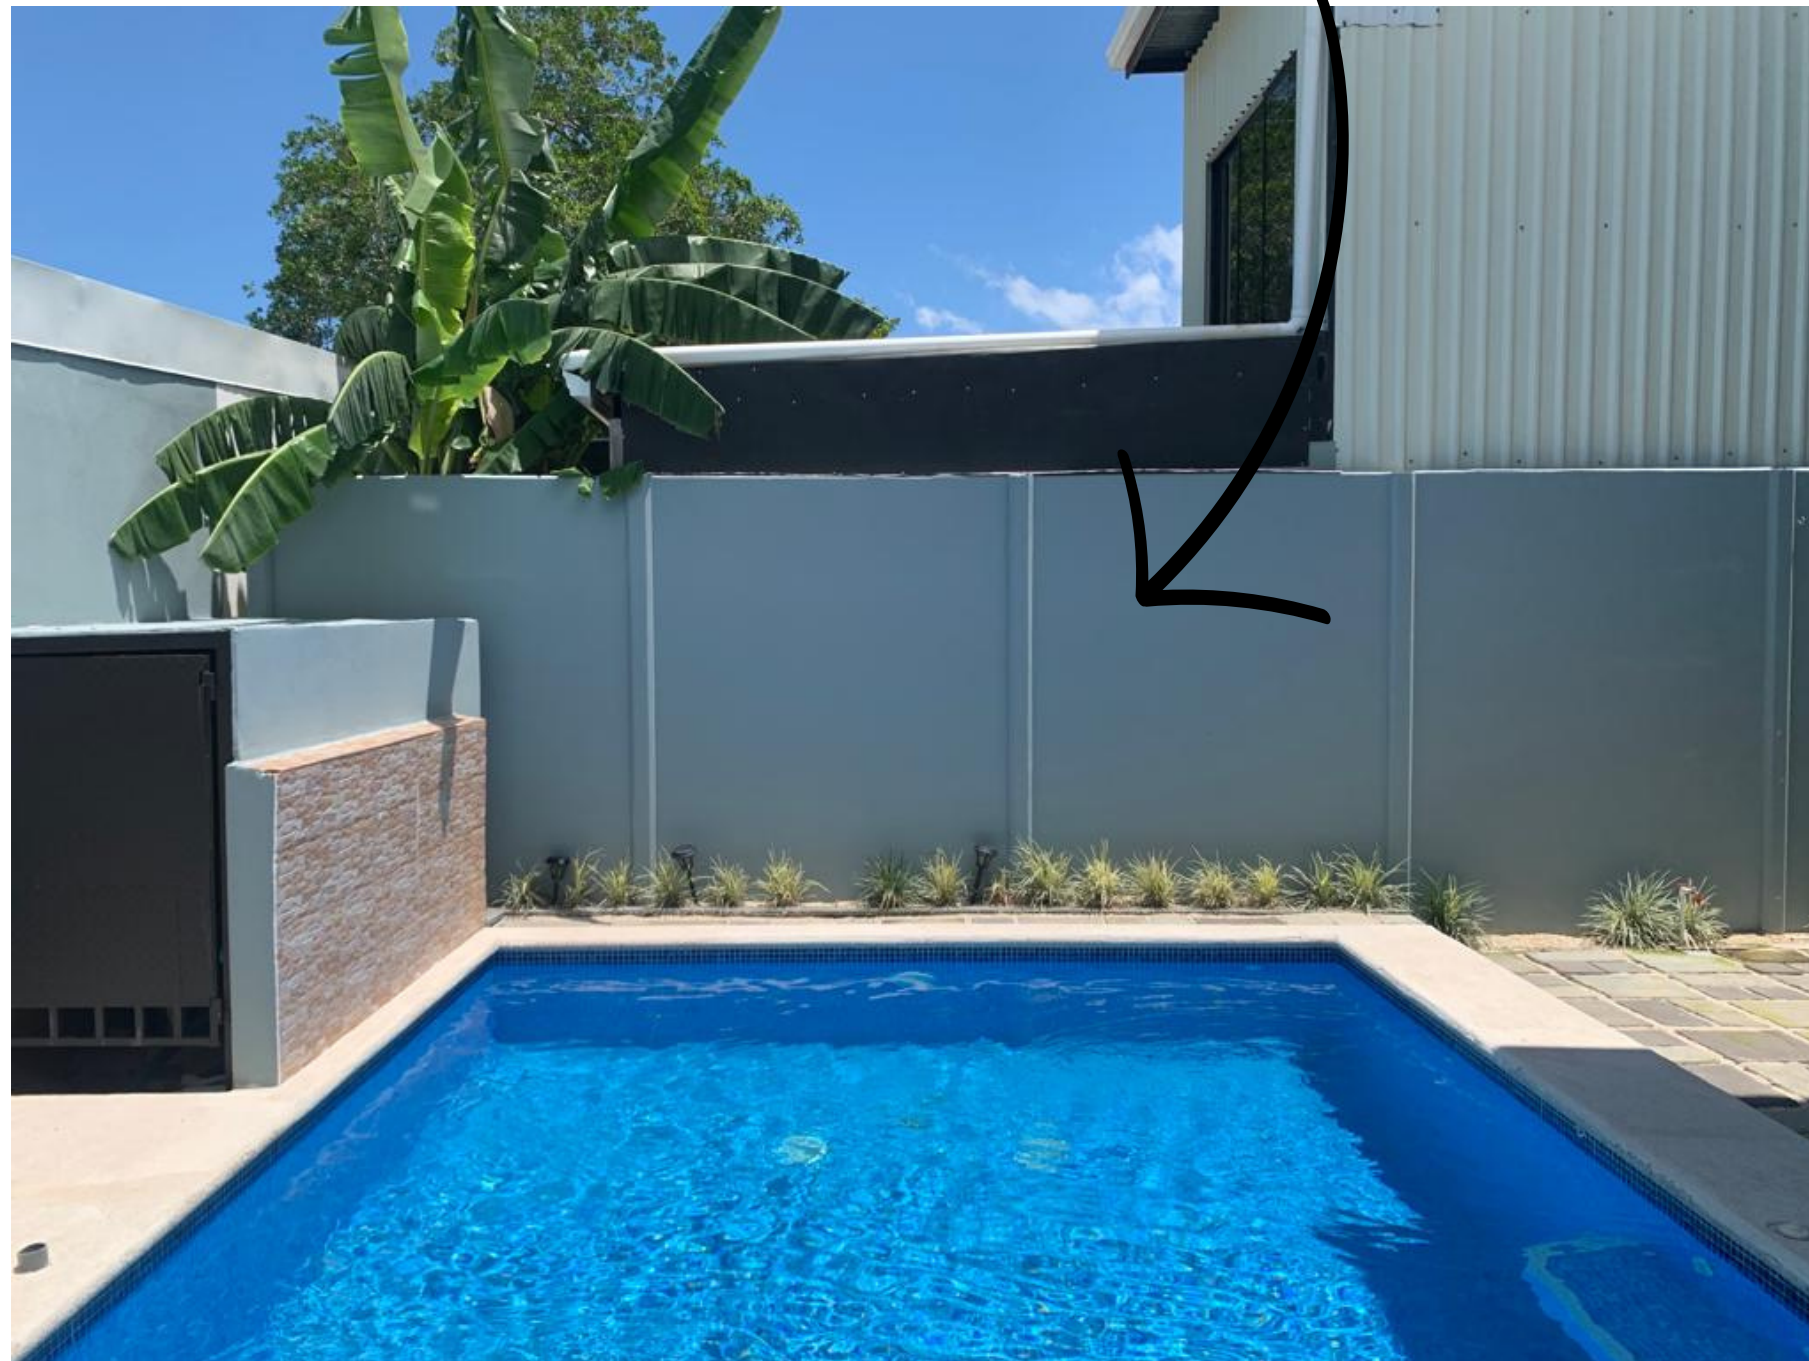
**Untextured and unlit walls, there is not enough space for new landscaping or furniture, it ends up being an unused space**

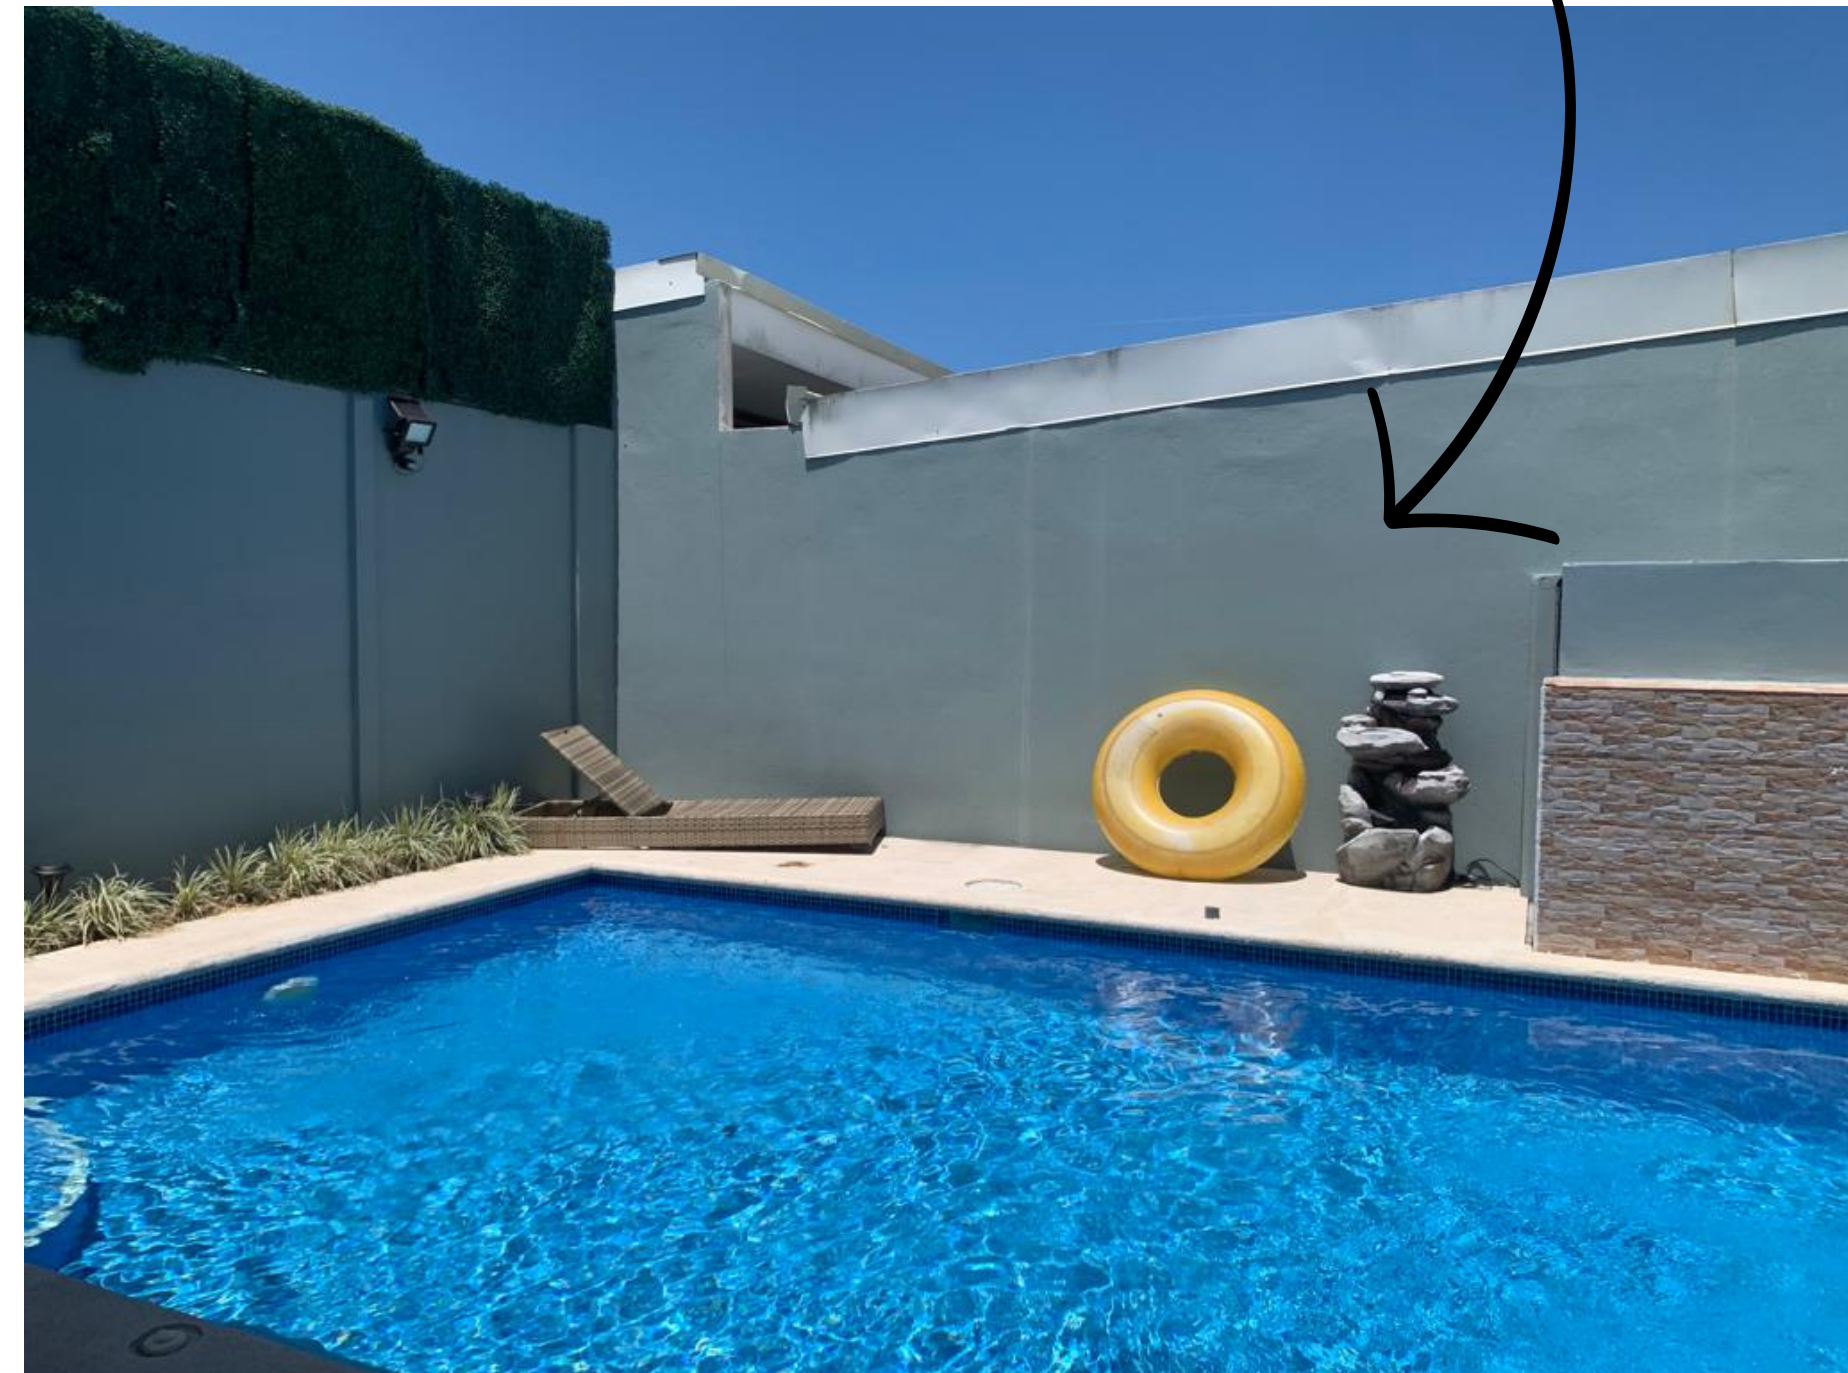
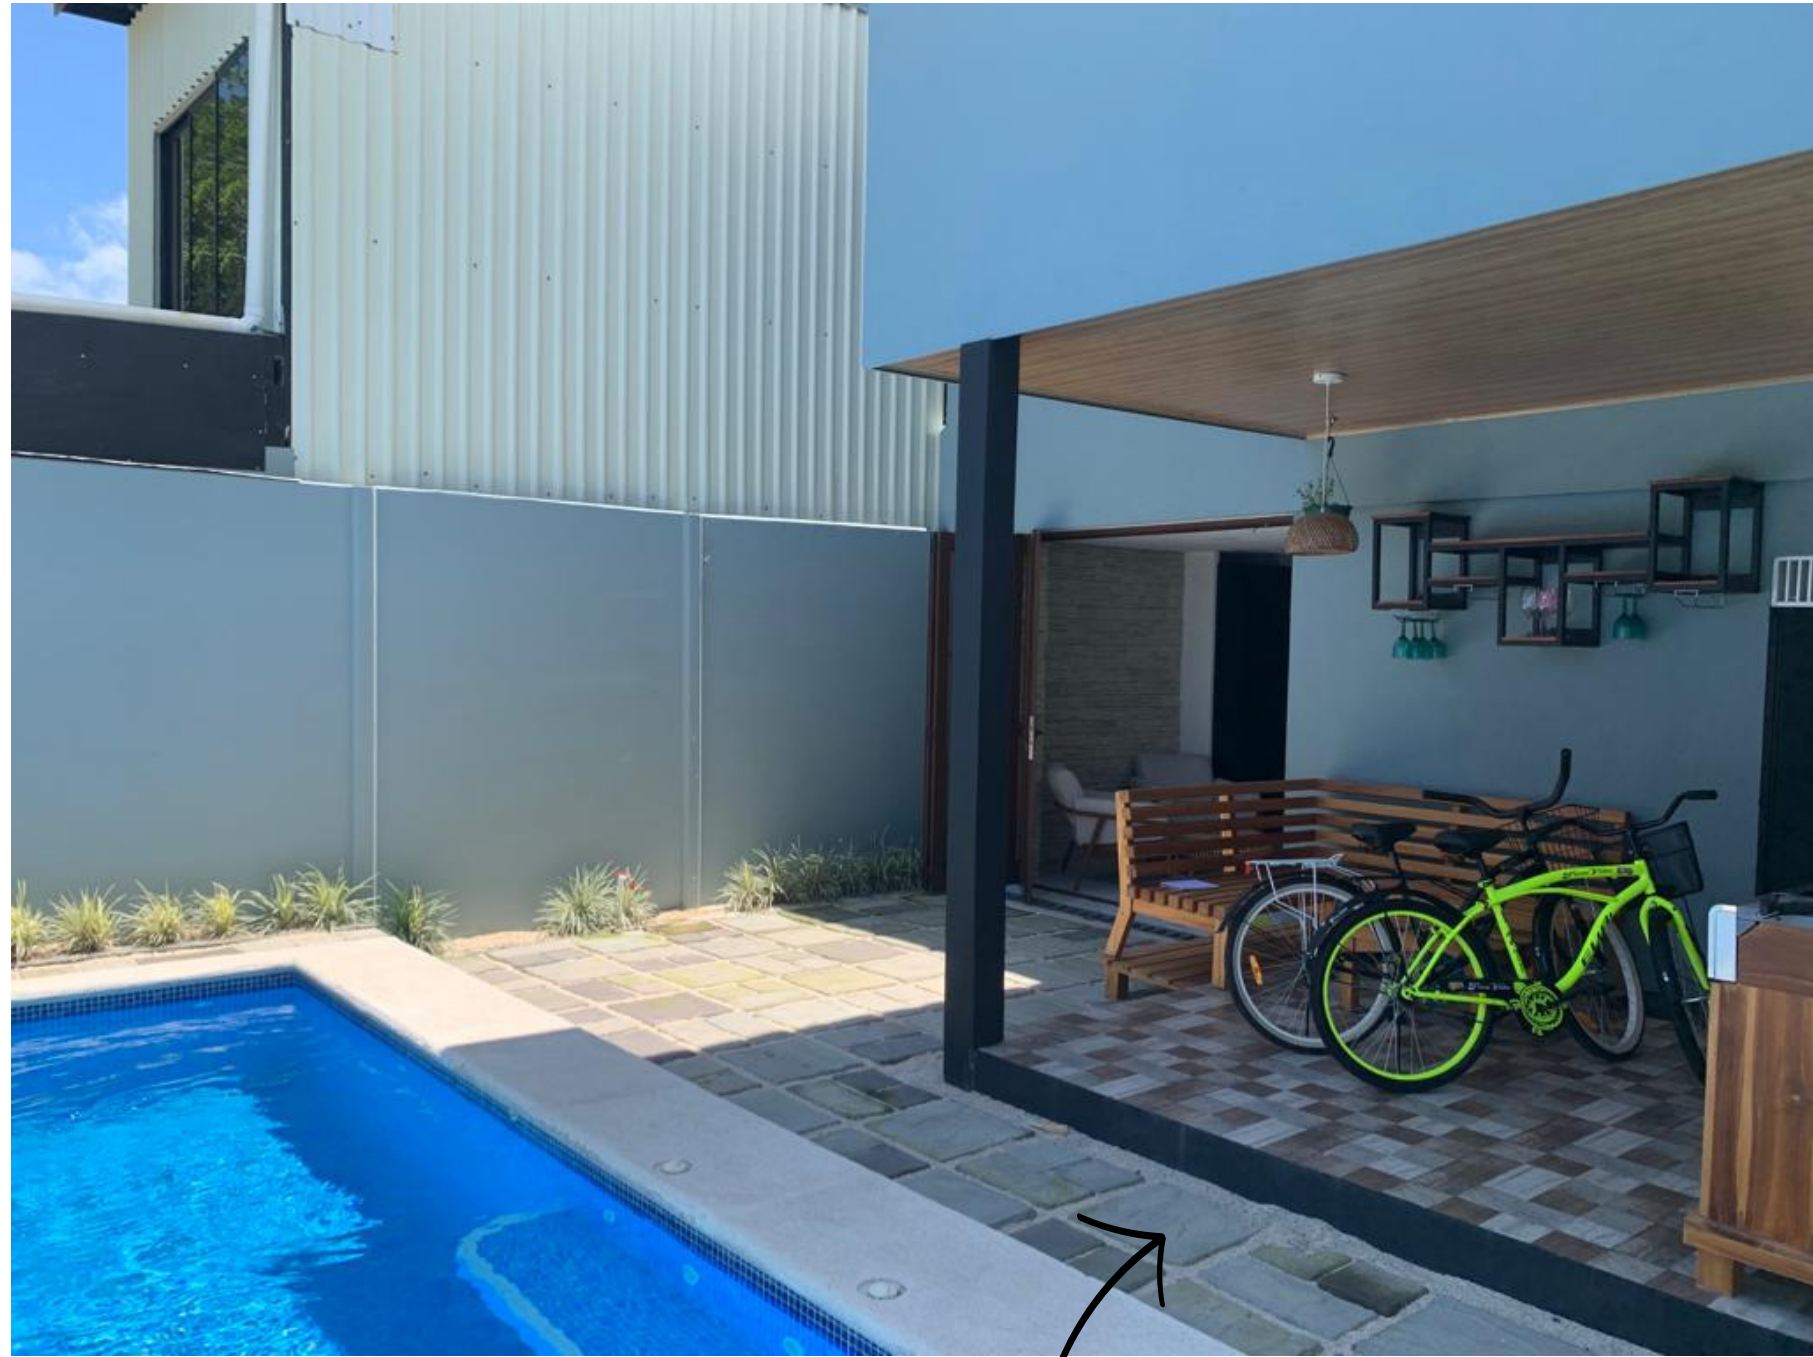
**Empty wall, unused space**

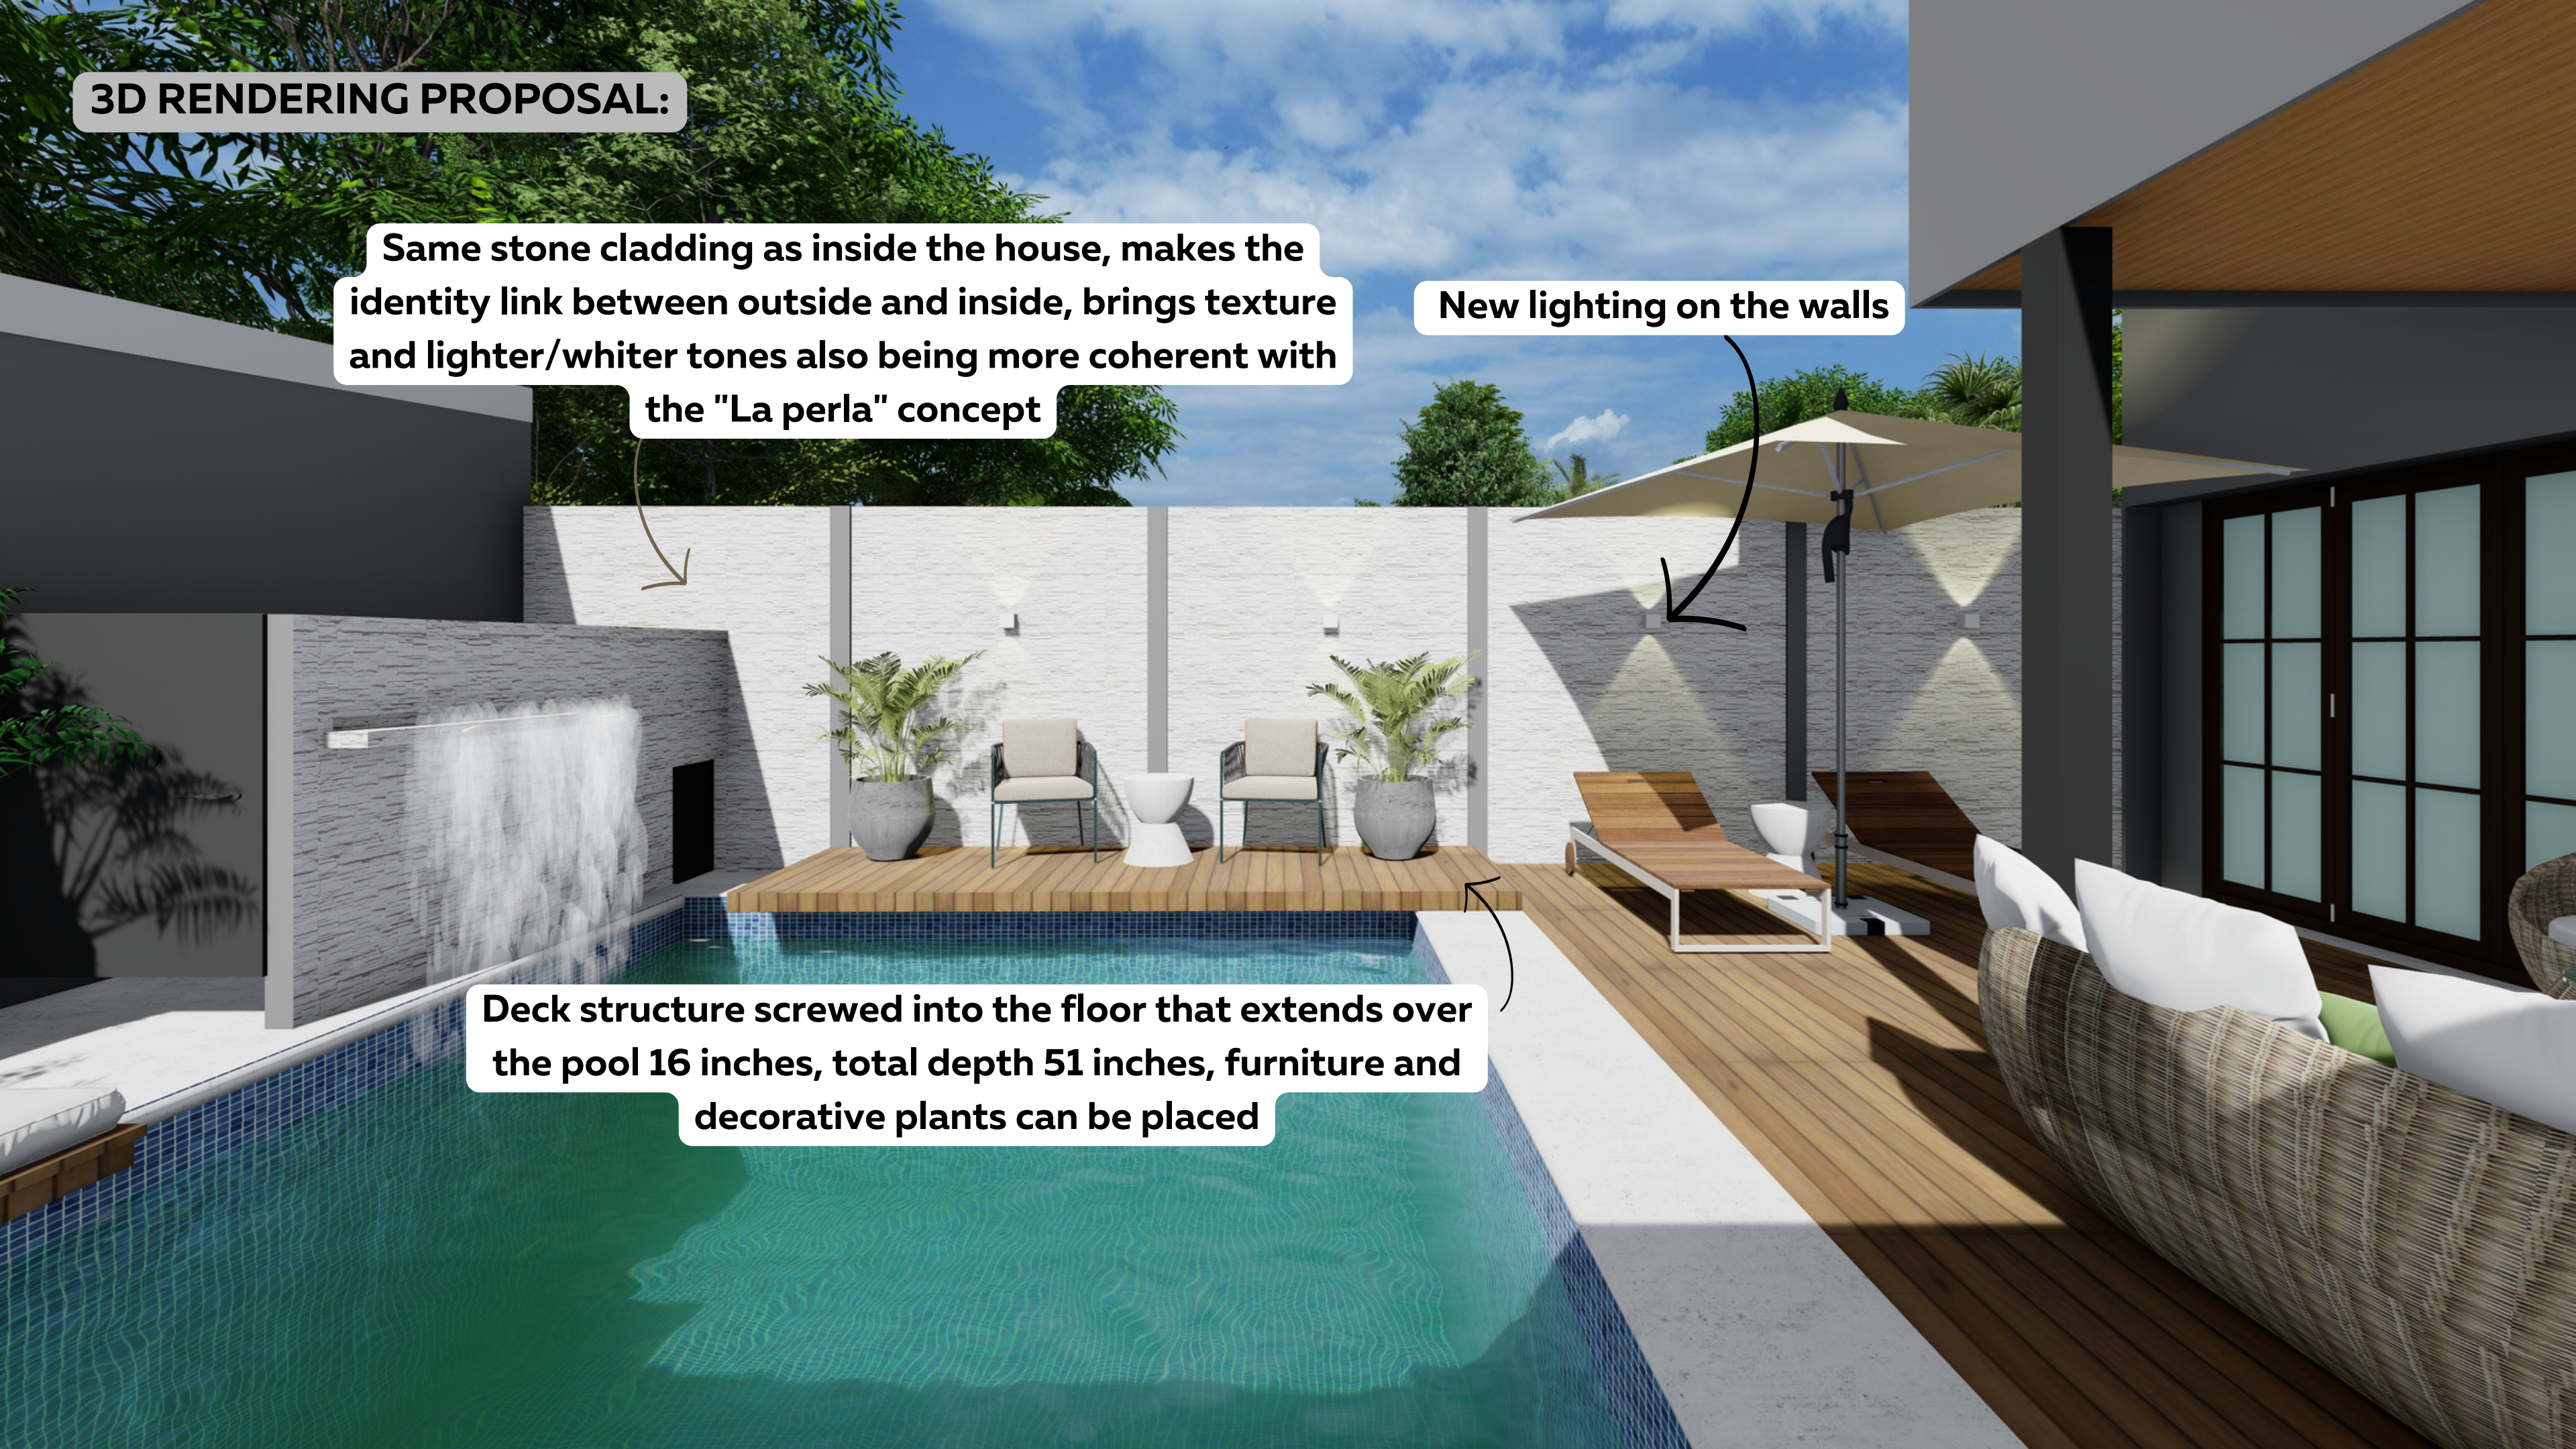
Same stone cladding as inside the house, makes the identity link between outside and inside, brings texture and lighter/whiter tones also being more coherent with the "La perla" concept

New lighting on the walls

Deck structure screwed into the floor that extends over the pool 16 inches, total depth 51 inches, furniture and decorative plants can be placed

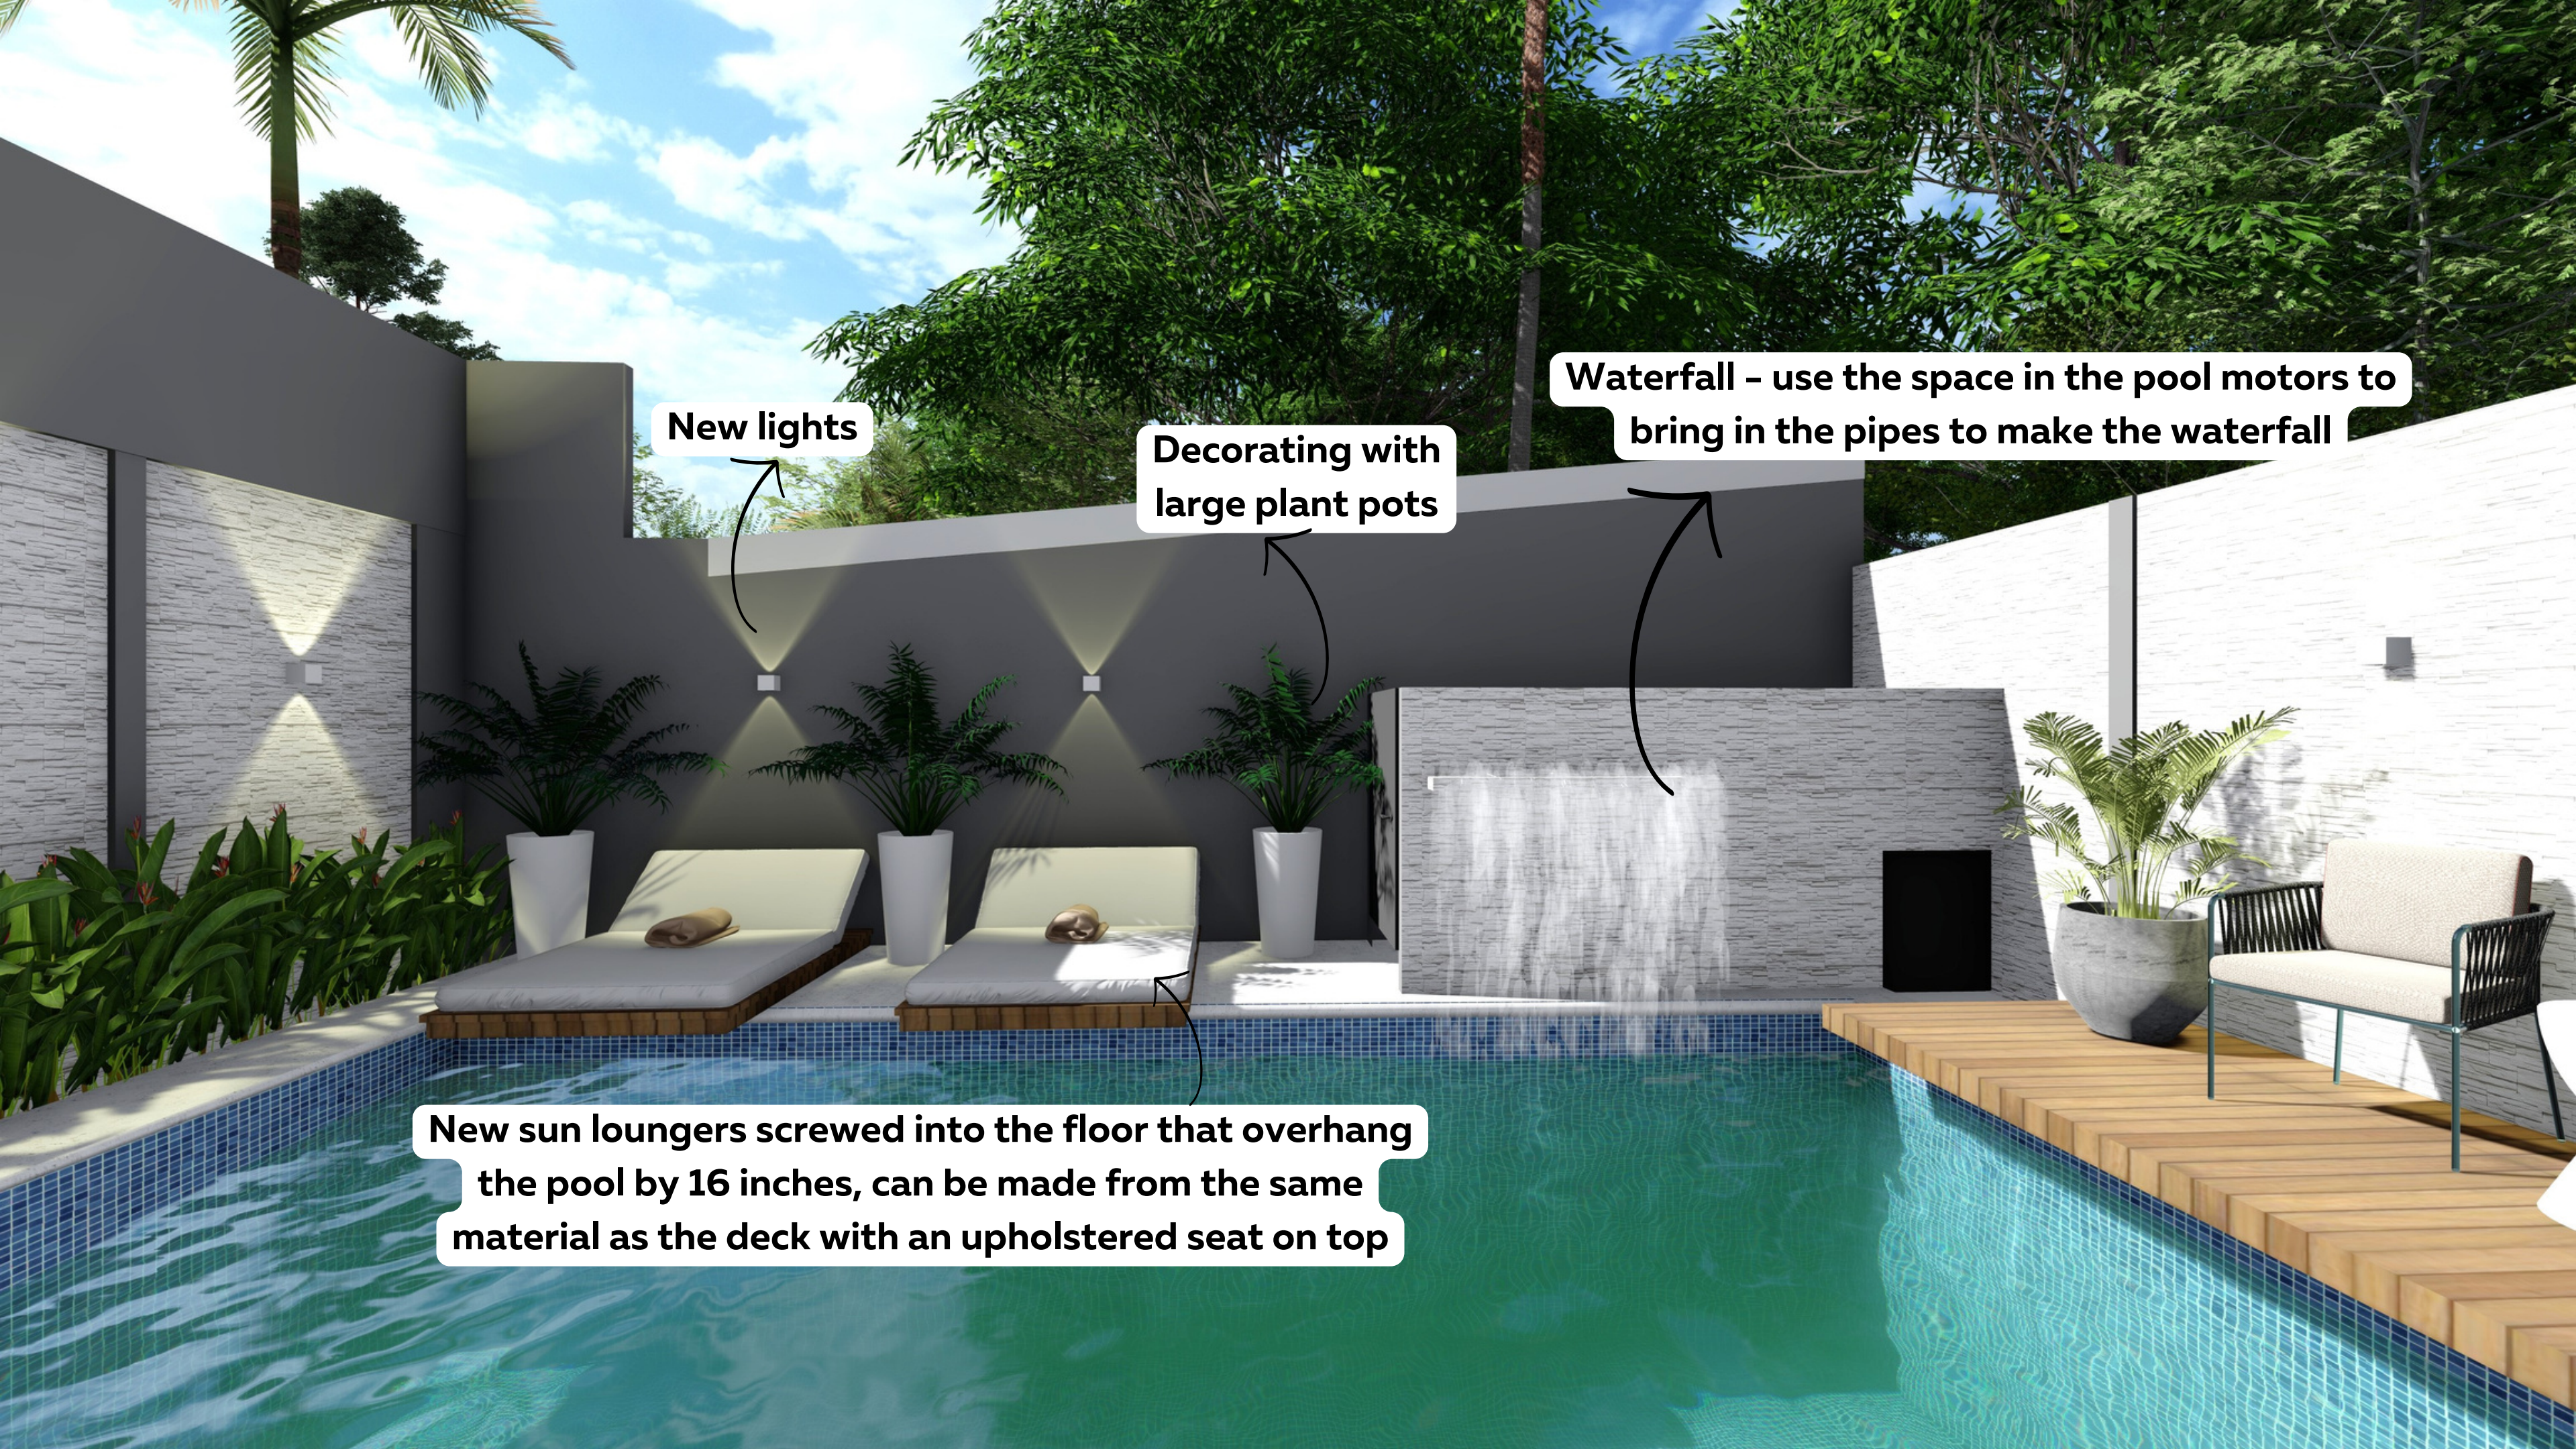
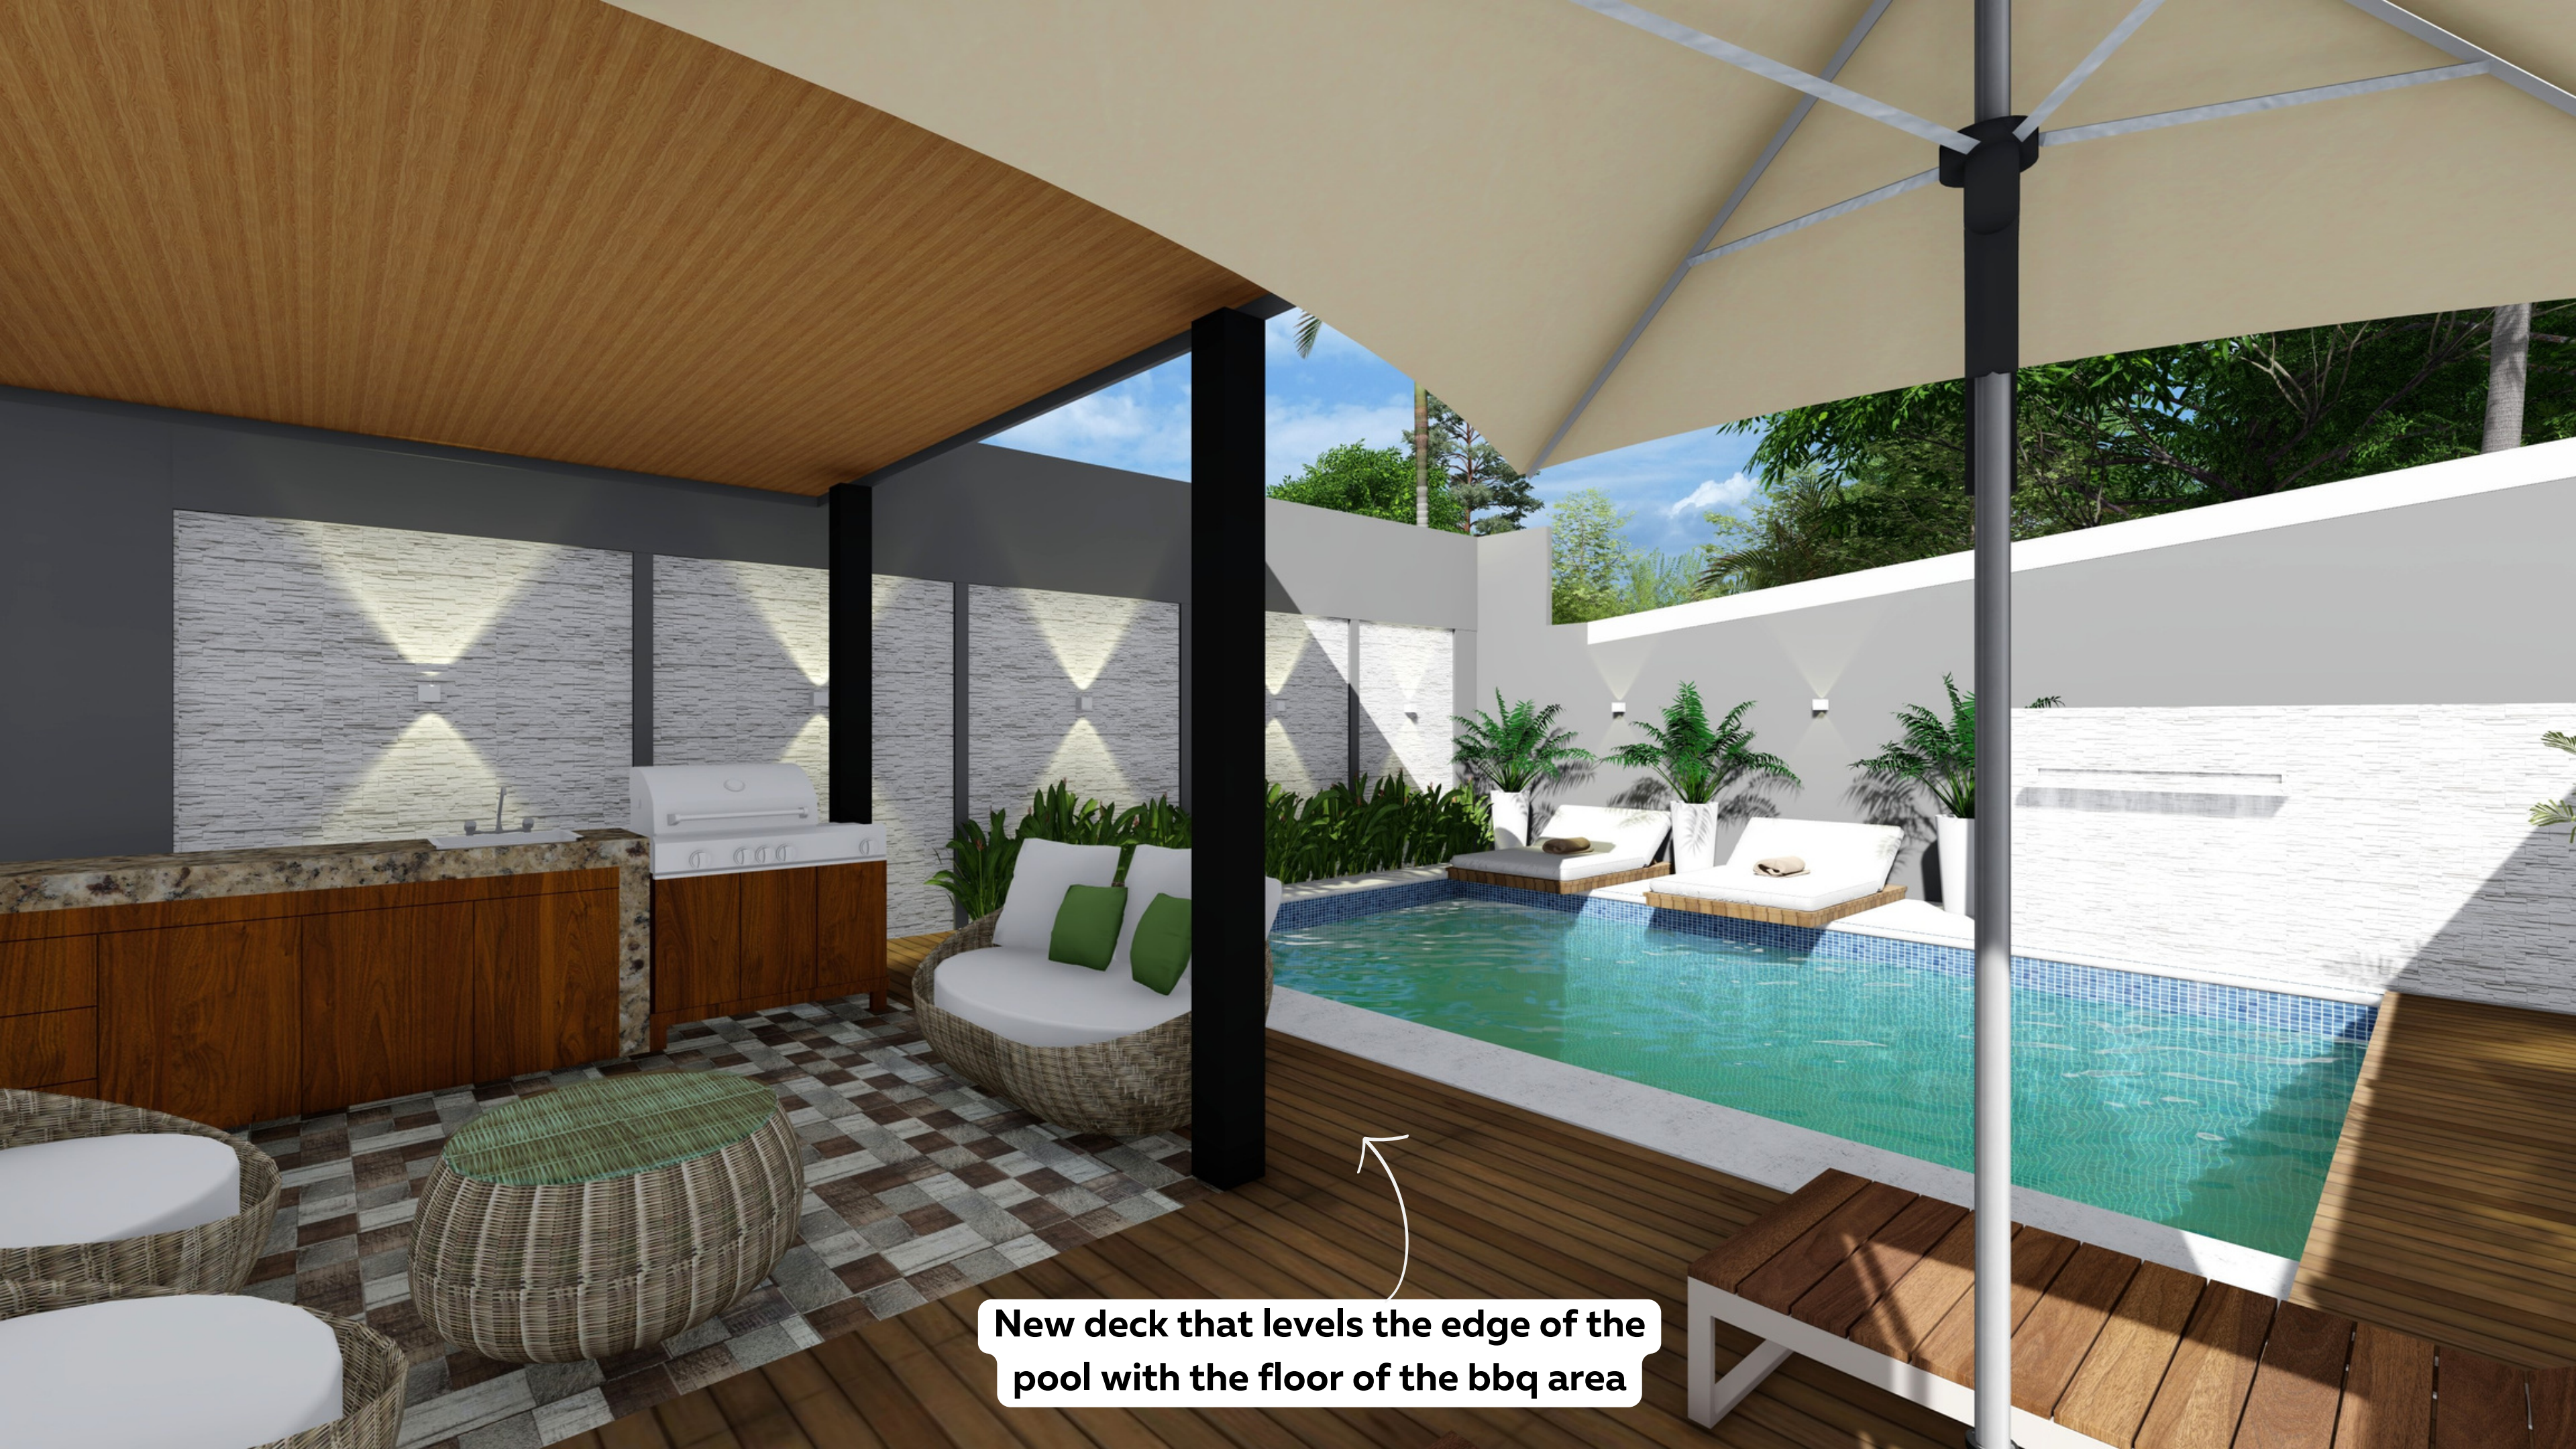
**New lights**

**Decorating with  
large plant pots**

**Waterfall - use the space in the pool motors to  
bring in the pipes to make the waterfall**

**New sun loungers screwed into the floor that overhang  
the pool by 16 inches, can be made from the same  
material as the deck with an upholstered seat on top**
