# POOL AREA REMODELING

La Perla - Jacó, Costa Rica

07/11/2023

julin  
BACK ROSSO  
architecture

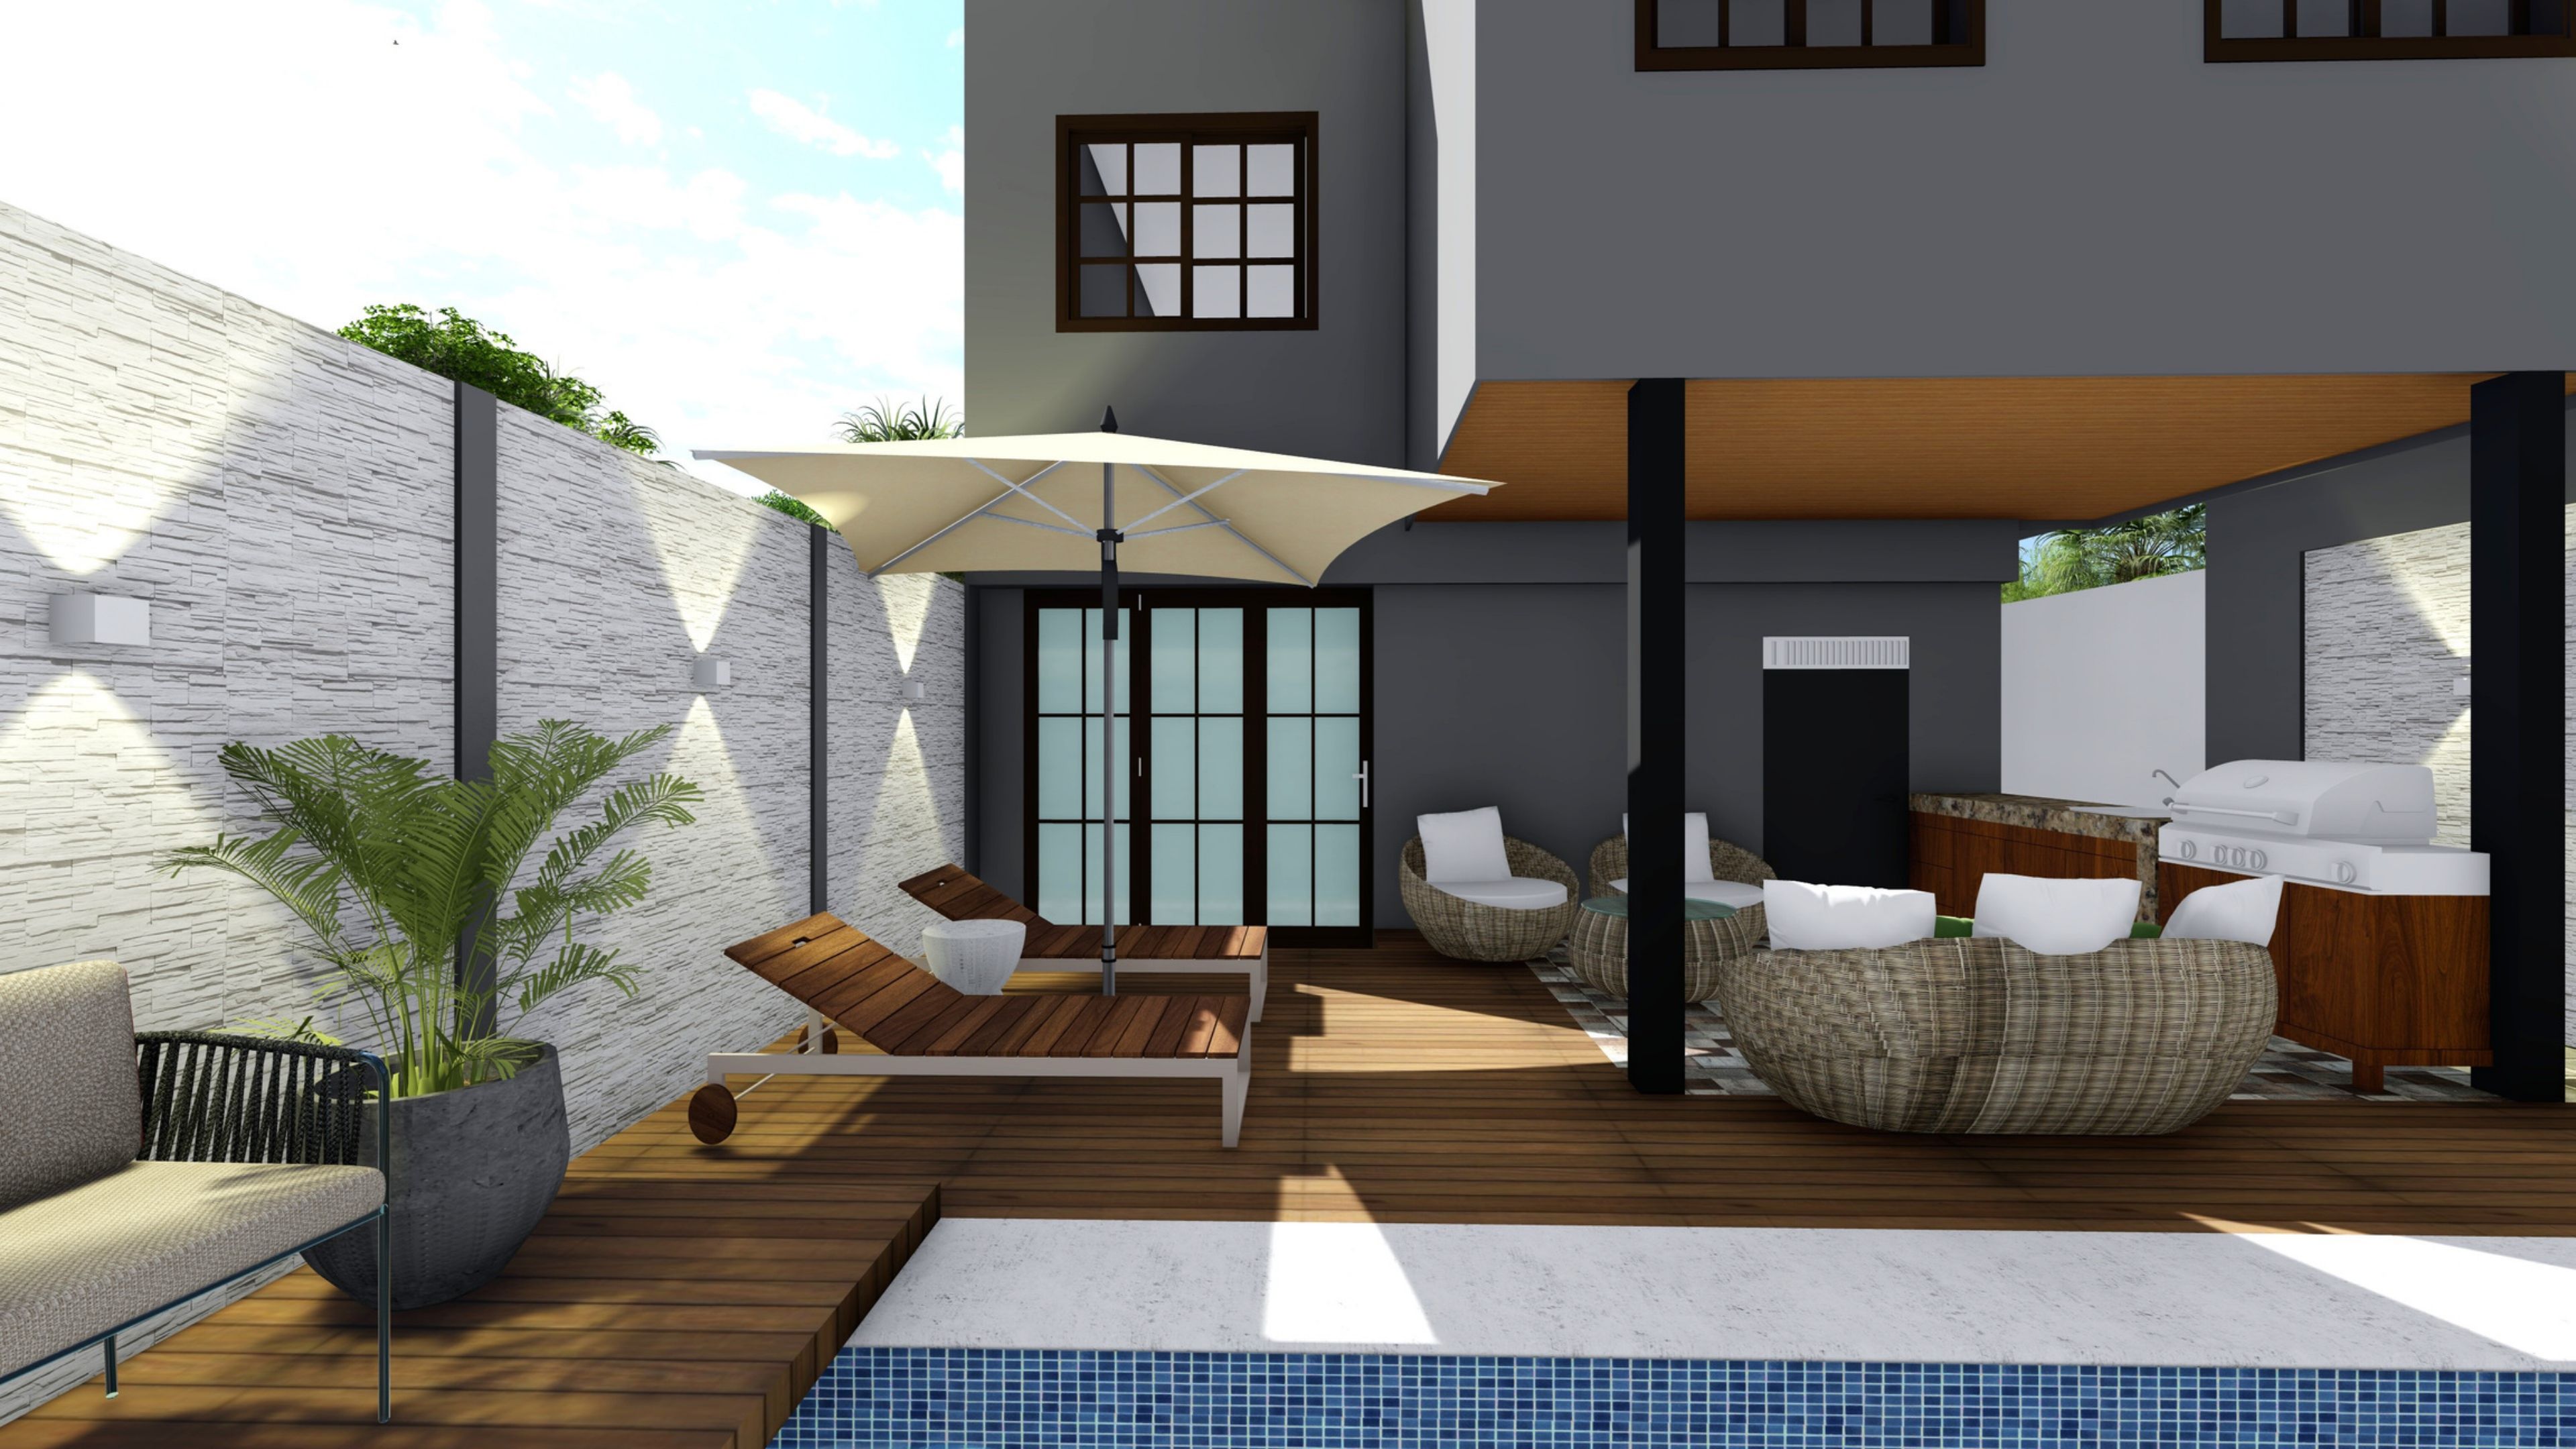
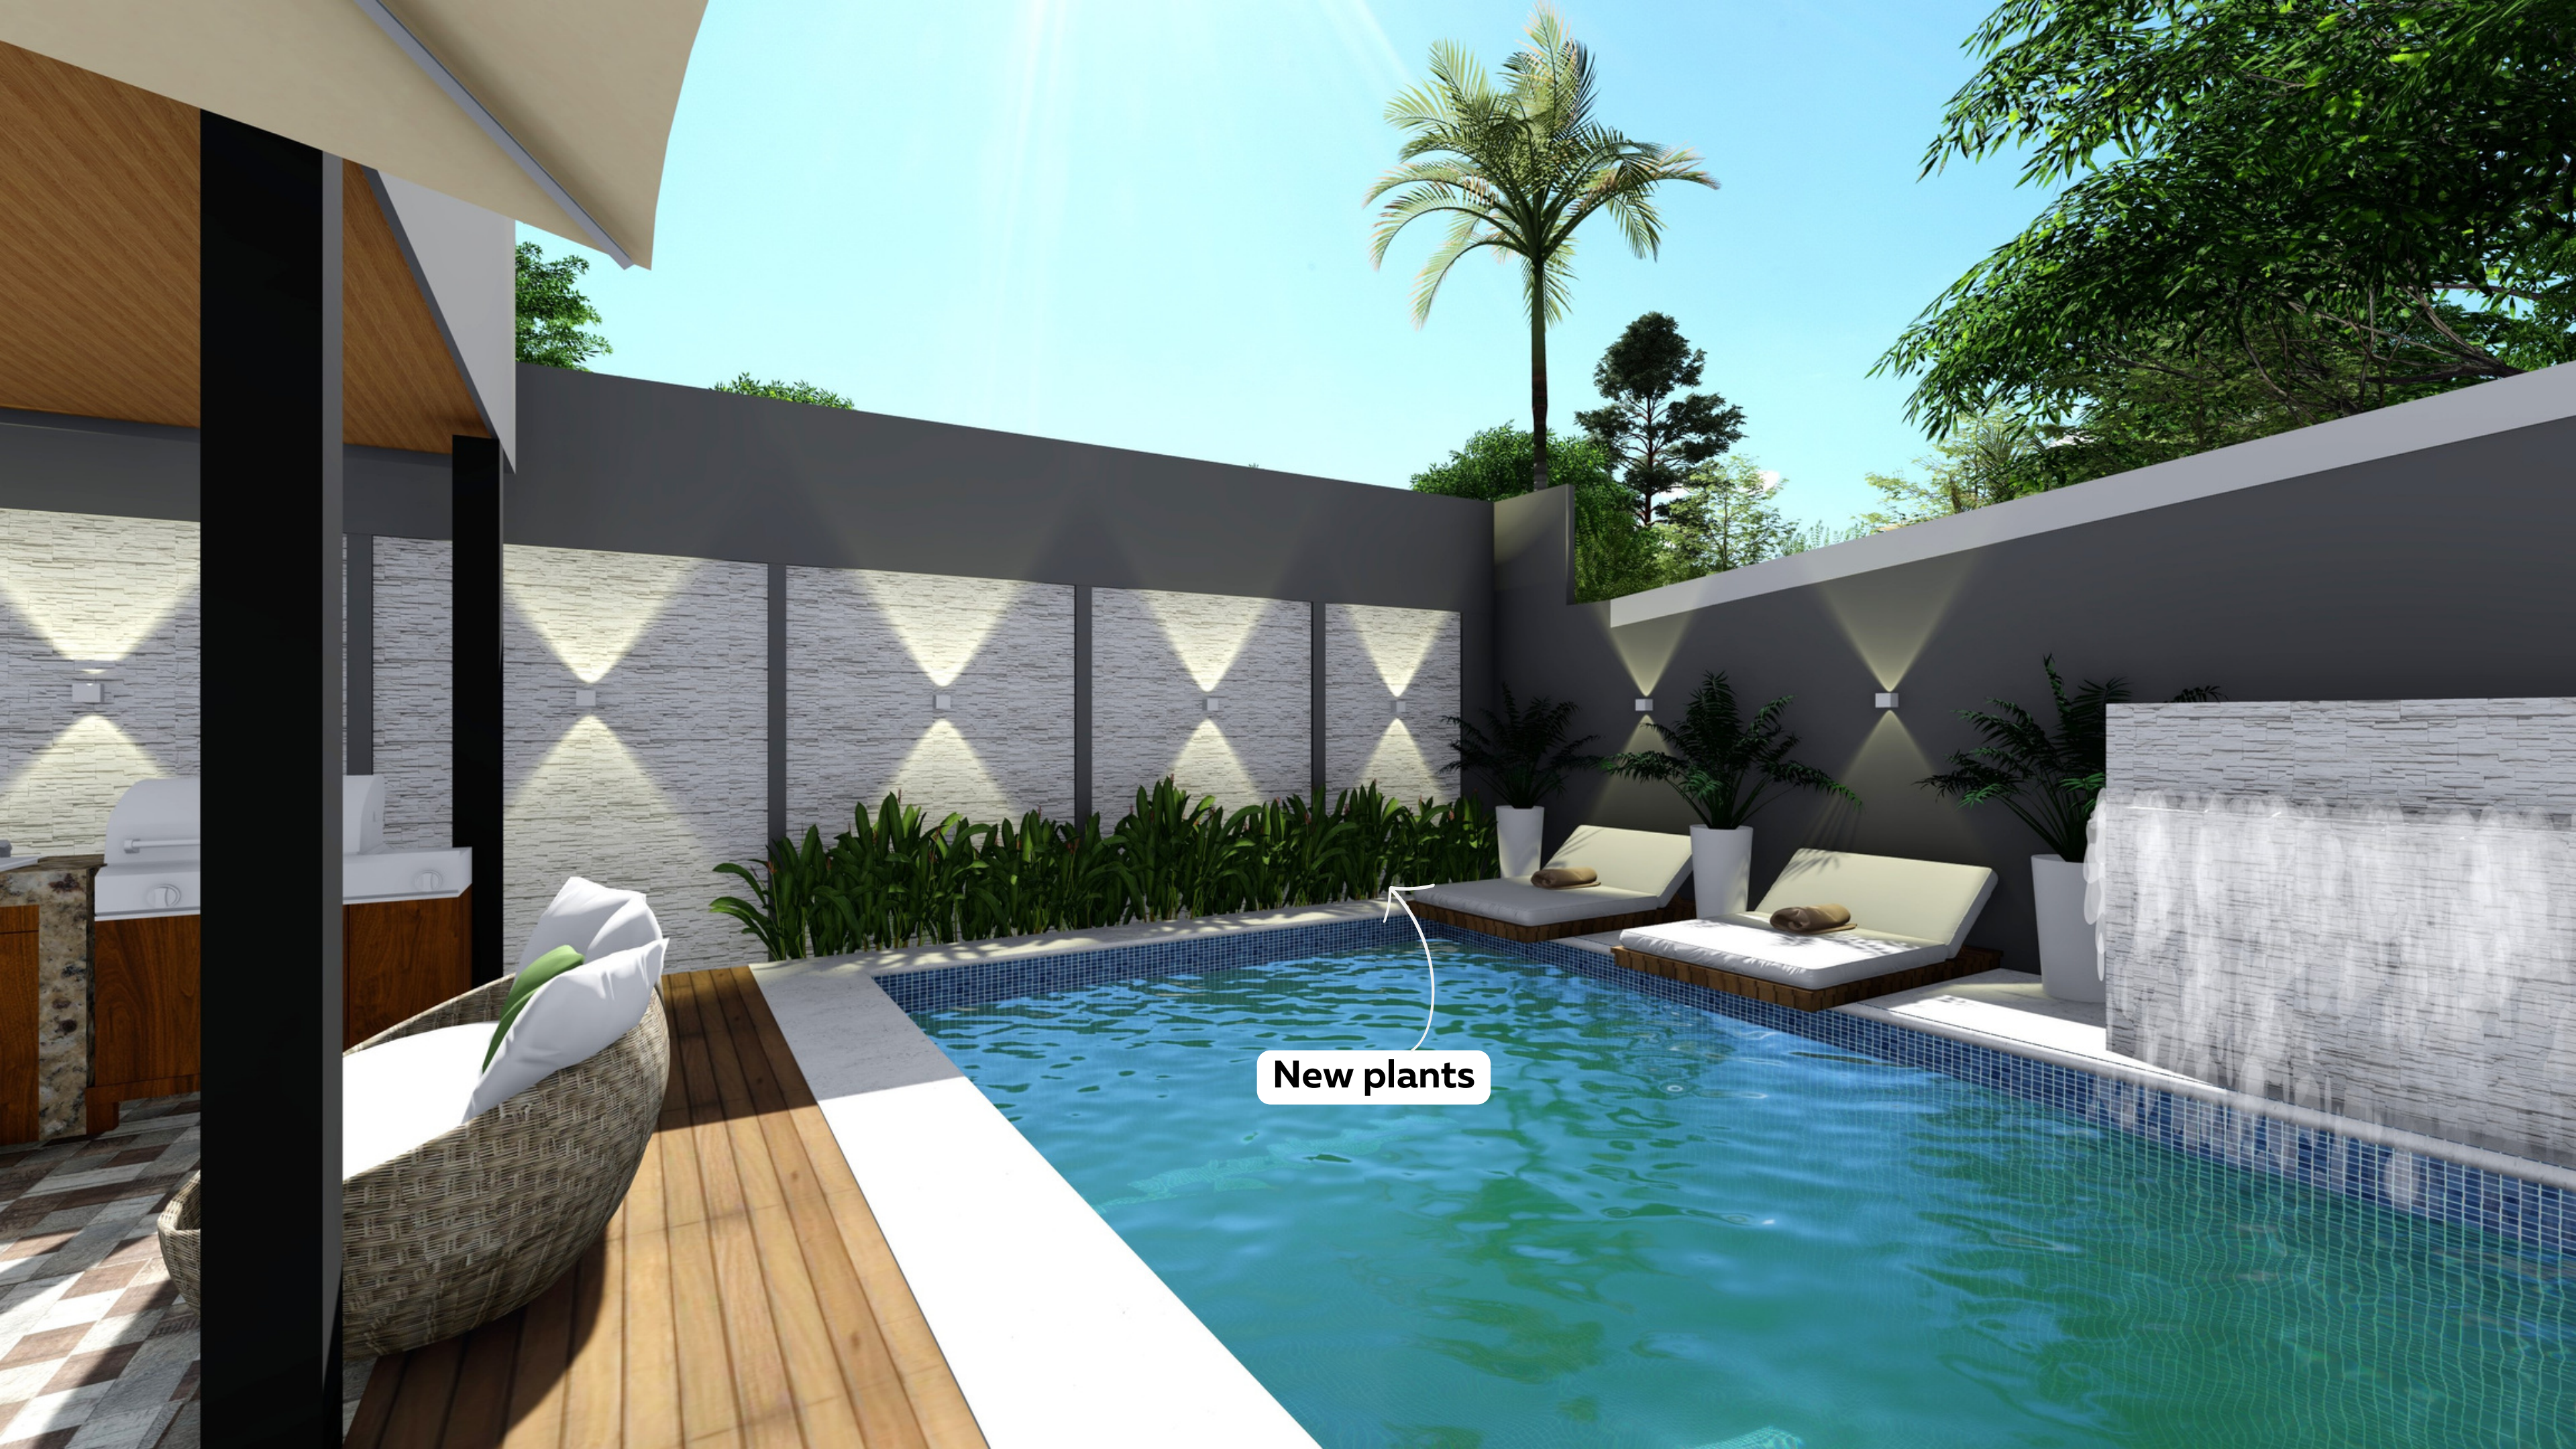
**New deck that levels the edge of the pool with the floor of the bbq area**

New plants
