# Fort Hood sets new standard for mold remediation

by Brad Britain and Christine Luciano

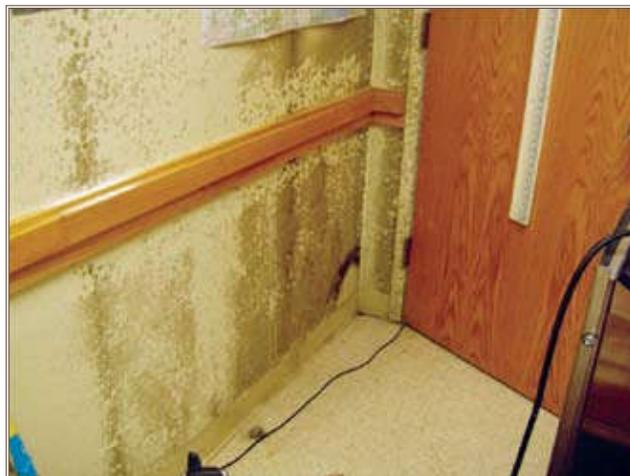
Before treatment, this barracks room wall is covered with mold. Photos courtesy of Pat Fields

At Fort Hood, more than 100 barracks rooms, a dining hall and a section of the Keith Ware Hall have been treated. The process effectively eliminated mold and mildew growth and has never failed. Rooms that were completely covered and looked black with mold are now pristine.

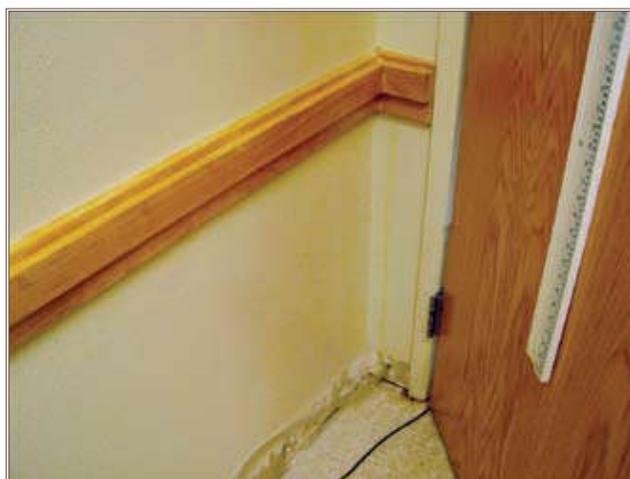
After the room was treated with the hydrogen peroxide gas process, the same wall shows the mold and mildew have been eliminated.
