TOWN OF PORTER

CONSTRUCTION NOTICE REPAIRS TO BICKFORD POND DAM

SYNOPSIS OF WORK TO BE DONE

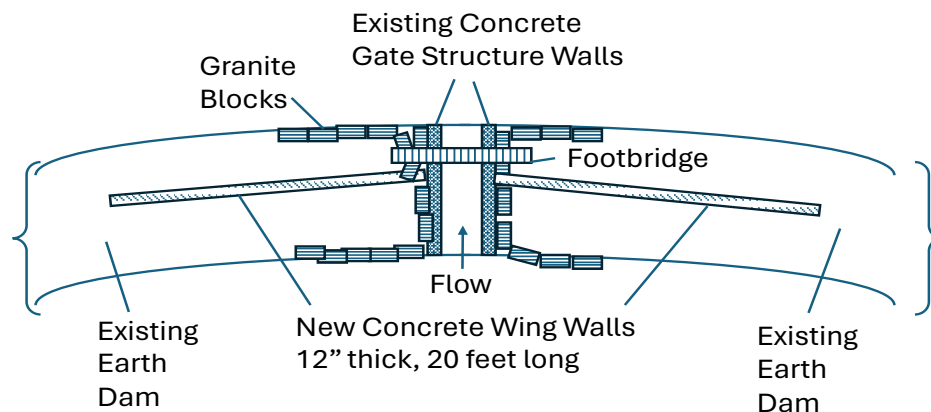
Bickford Pond Wing Wall Sketch

The work is to add a 20' long 12" wide cement wing wall on both sides of the existing structure.

The walls will be built by digging into the center of the current earthen dam down to the existing base with a straight edged digging bucket in order to create minimal soil disturbance under a footer.

Then 20' long wing walls will be set on footers. Drilling and pinning will need to be done to attach the new walls to the existing concrete gate structure. Rebar will be used in the 20' wing walls as well the footer.

Backfilling will be done on both sides of each wall with a dense material to prevent leakage. French drains will be installed to monitor for water leakage.
