Lac qui Parle River Floodway near Canby, MN

Background

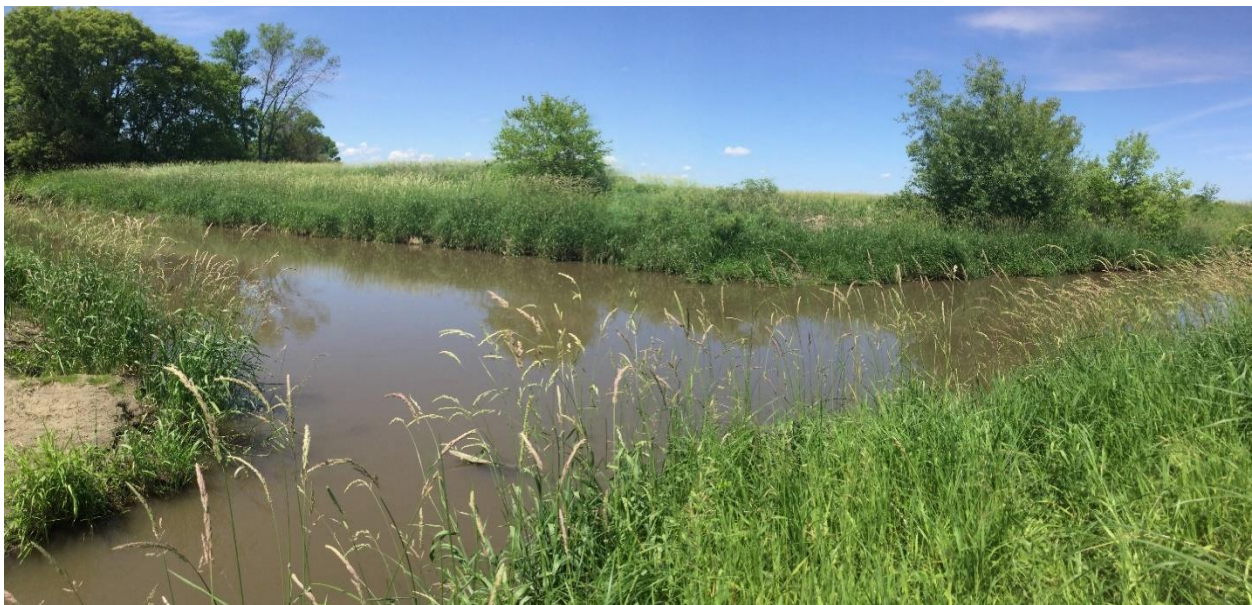
Photo showing the existing Lac qui Parle River flowing from left to right towards the floodway. The abandoned natural channel is much narrower from sediment accumulation.

- The project is not functioning as intended, due to continued sedimentation. Recent flooding has caused significant erosion and damage to the floodway, requiring many locations to be stabilized.
- Local landowners and public officials want to restore the floodway's intended function—to only convey flows above the 2 year flood event.
- DNR surveys in fall 2019 found approximately 1.5-2.5 feet of sediment accumulation throughout the entire original river channel. The deepest sediment areas were at the beginning, end, and upstream of where beaver dams were present.

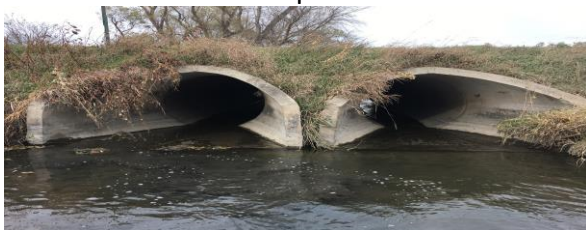
An example of one crossing in the historic channel that is undersized and set too high for water and sediment transport.

- There are three public crossings and one private crossing on the historic channel. Only one crossing has the required span (~30-40 feet) to pass unrestricted bankfull flows of the Lac qui Parle River. The other three crossings range from four to eleven feet of span.
- All of the crossings are set too high and will need to be lowered to allow sediment transport.
