Products: PIR Insulation, VCL & PUMA Waterproofing

Resiprufe Waterproof the Mornflake Factory Roof

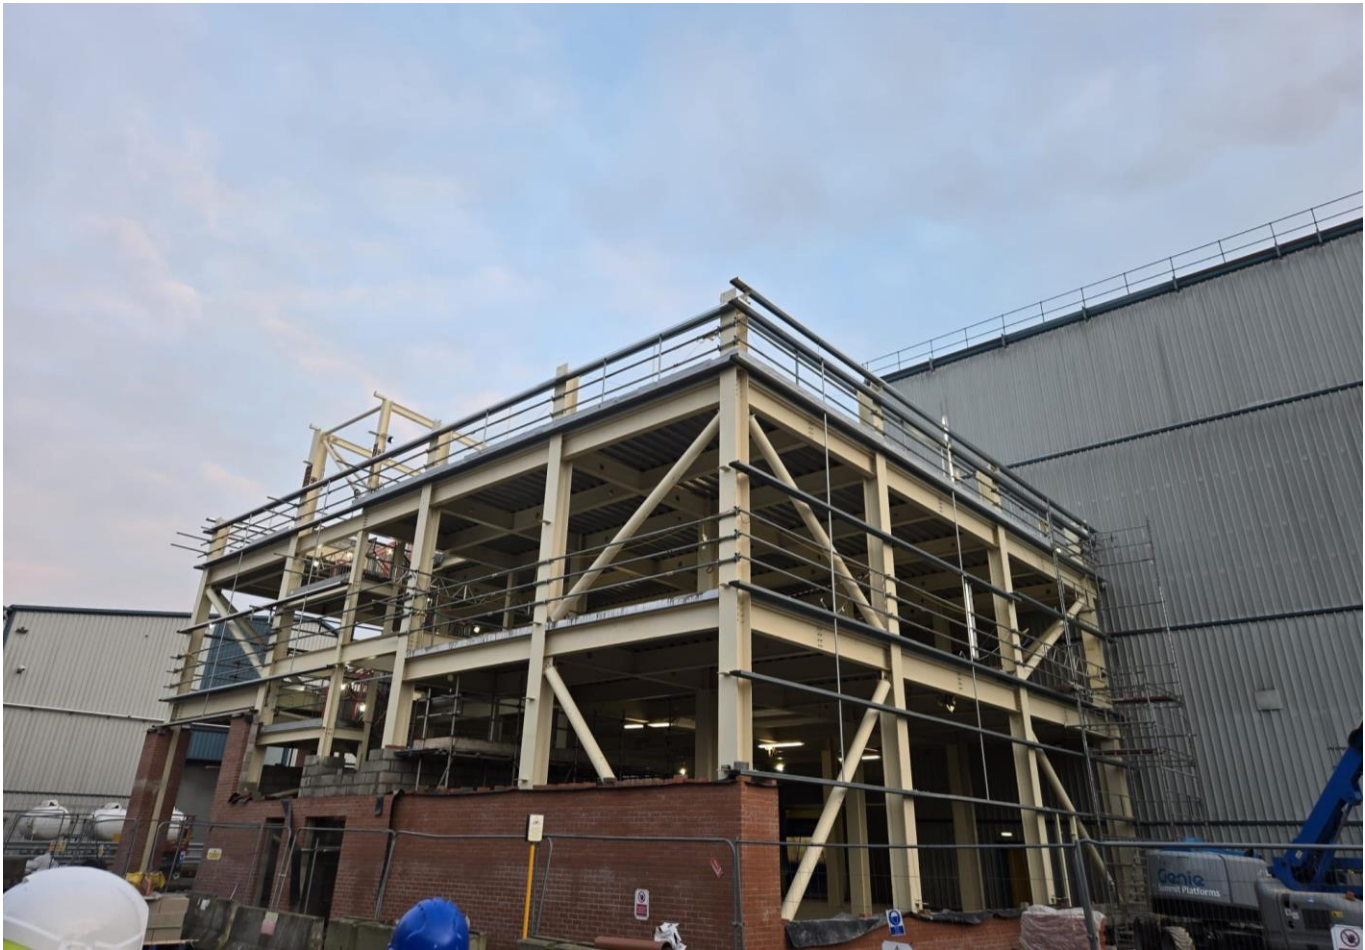
Resiprufe worked with the client and the manufacturer of the waterproofing PCP to manage the project which was a roof on a brand new concrete structure. Unusual in its nature, the roof deck was flat not tapered, because in 3-5 years it will most likely be turned into a floor and a further storey adding. The challenge was to do complex detailing in the dead of winter, and to create drainage channels on a flat concrete floor. The system specified was MMA Damp Primer/PU bonded tissue faced insulation, VCL, PUMA, MMA Top Coat.

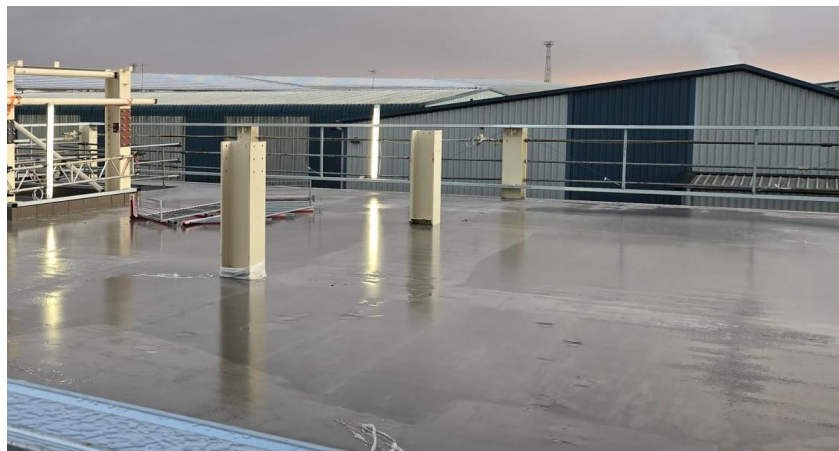
Commencing on the first week of January, the concrete literally had 5mm of pure ice over the whole deck. The first step was to start working on the edge detailing by melting the ice and flashing the concrete dry.

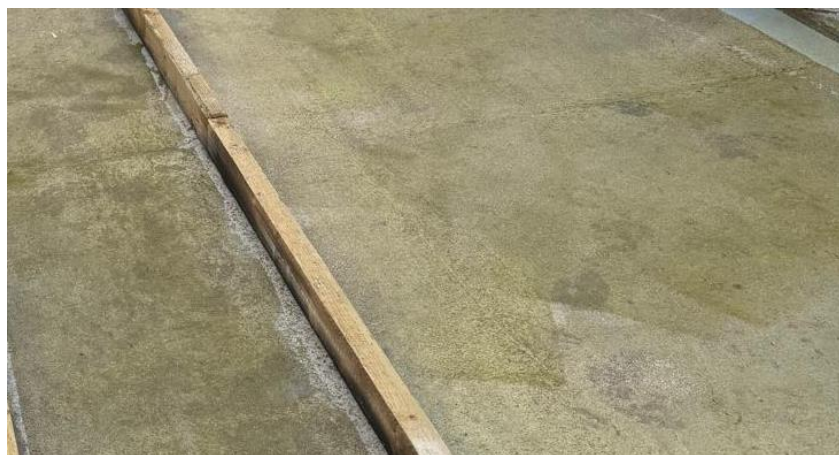
The next step was to apply EleRoof MMA Damp Prime to the surface, this works to seal in residual construction moisture from the concrete and providing a low MVT rate. The surface was aggregate blinded to enhance adhesion of the PU foam adhesive.

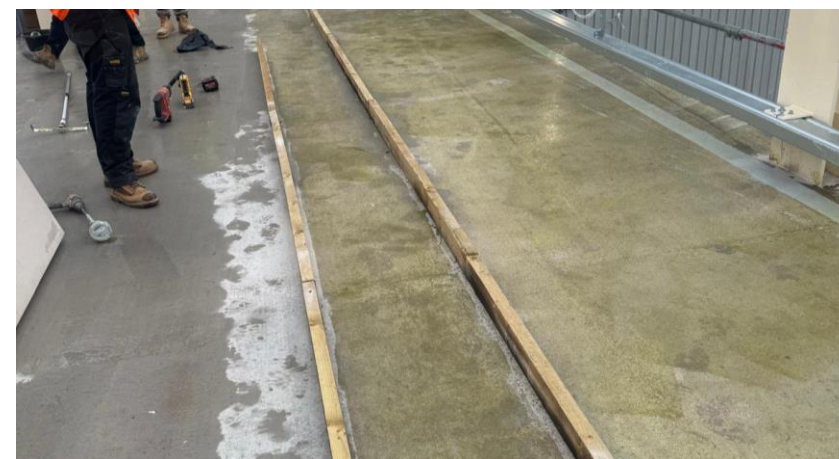
Three drainage channels were created, using insulation 40mm lower than the surrounding areas to reduce the chance of water pooling on the main roof, and to help aid the water filtering into the channel. We used tannelised wood to create edge protection to prevent damage between the transition of 100mm and 60mm insulation.

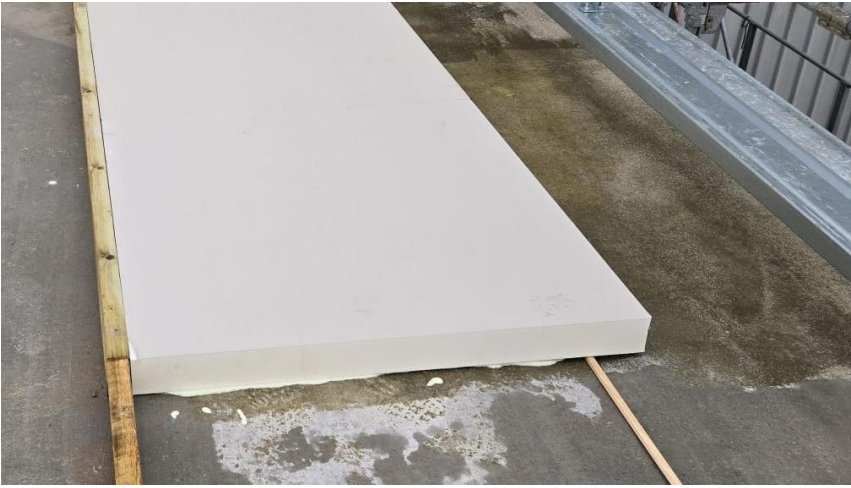
The insulation was started at the outer edge and we created a slight fall from the outer edge inwards to aid any flow of water in the future towards the drainage channels. We used PU foam adhesive to bond the insulation.

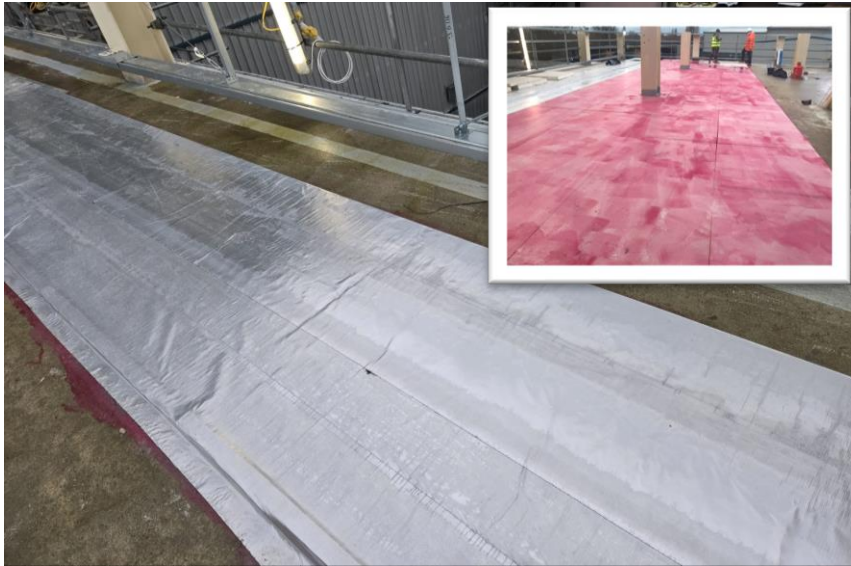
To the insulation, a VCL layer was applied which consists of an aluminium foil facer on top of a bitumen membrane – the Provap has a self adhesive backing.

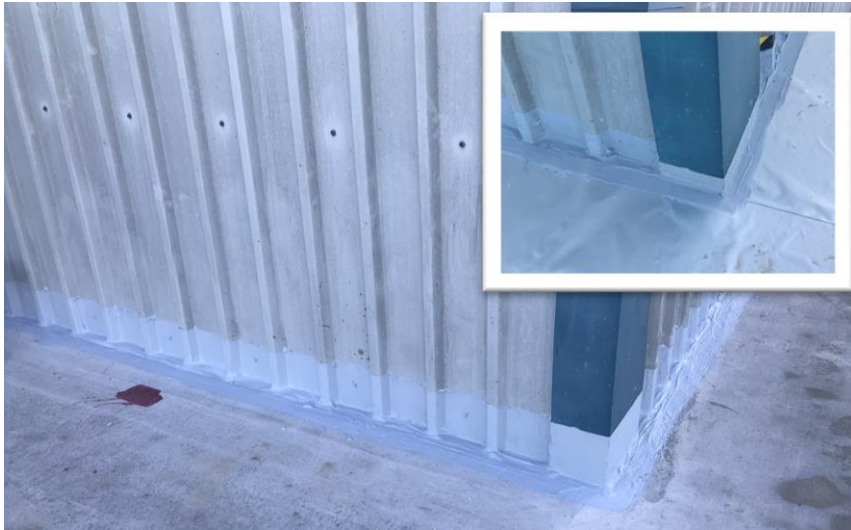
For the back edge connecting to the old building, it was important to waterproof to a high level. The gap was filled with rockwool to give linear gap fire performance vs PU foam or insulation. The rockwool was then coated with the PUMA Thixo membrane tanking up the wall.

We did a second detail on top of the insulation (inset picture)

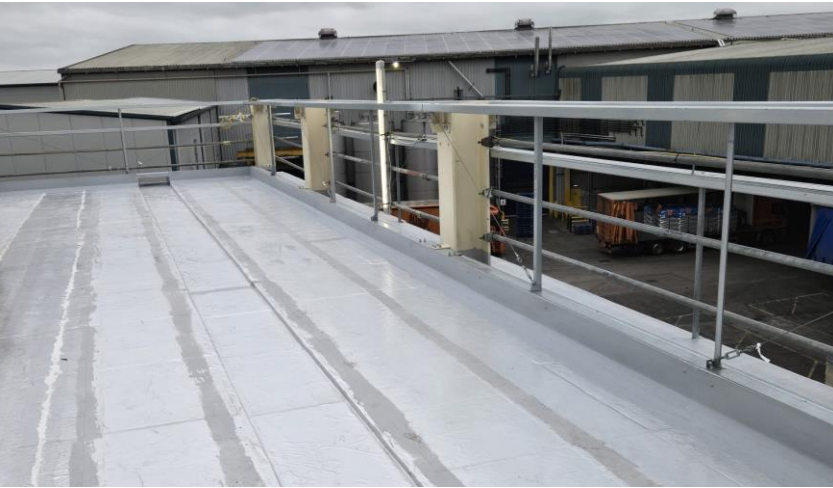
Due to the extreme weather – lots of rain, ice and strong winds during installation, the joints in the Provap VCL were feathered with PUMA Thixo as an effective night seal.

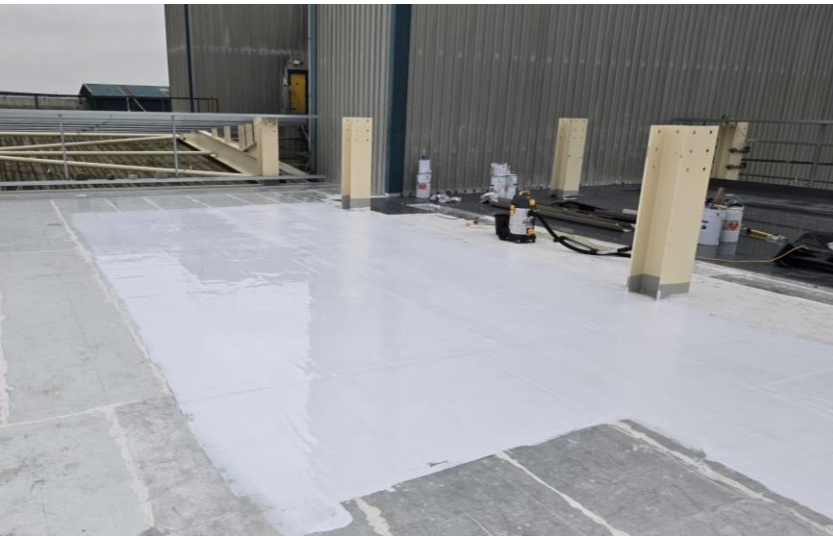
The next step was to start the installation of the 2mm PUMA elastic membrane with polyester fleece reinforcement. This provides the flexible layer in case of any movement.

The PUMA sets in only 30 minutes allowing rapid installation even in adverse weather.

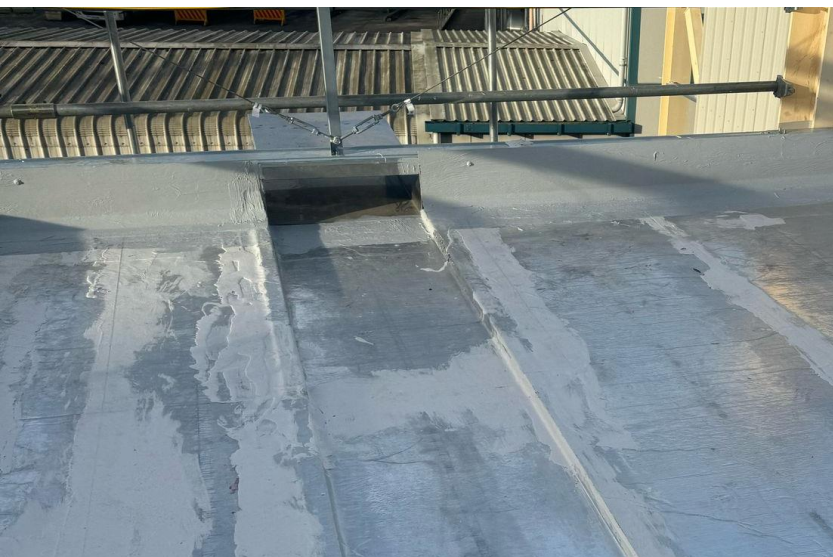
The façade goes up and over the metal perlins at the side and the client wanted a special detail around the perimeter – install a 200mm flexible GRP trim screwed to the metal (and later the cladding will be fixed through the top). The GRP was connected to the deck with a band of PUMA thixo under it and also 100mm fleece reinforced PUMA was applied to overlap the trim and the deck.

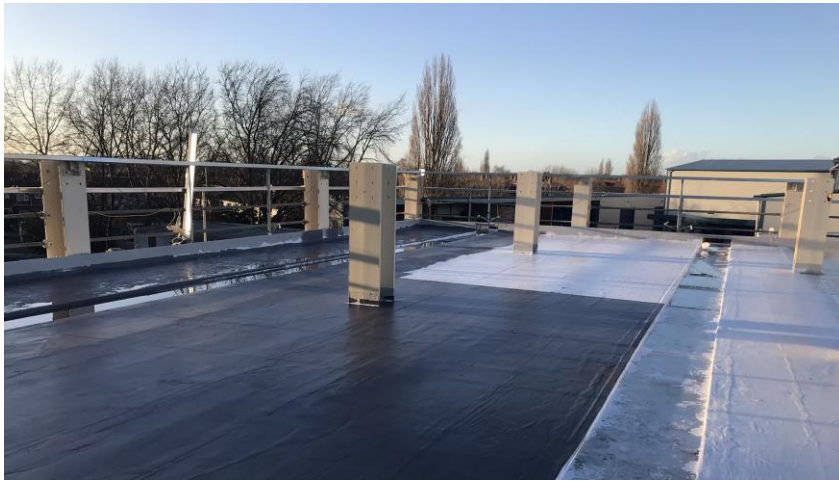
Once the PUMA membrane was installed, it is necessary to apply the 0.5kg/m² EleRoof MME Top Coat FR to provide maximum fire performance and weather resistance.

The top coat is MMA technology and was pigmented RAL 7015

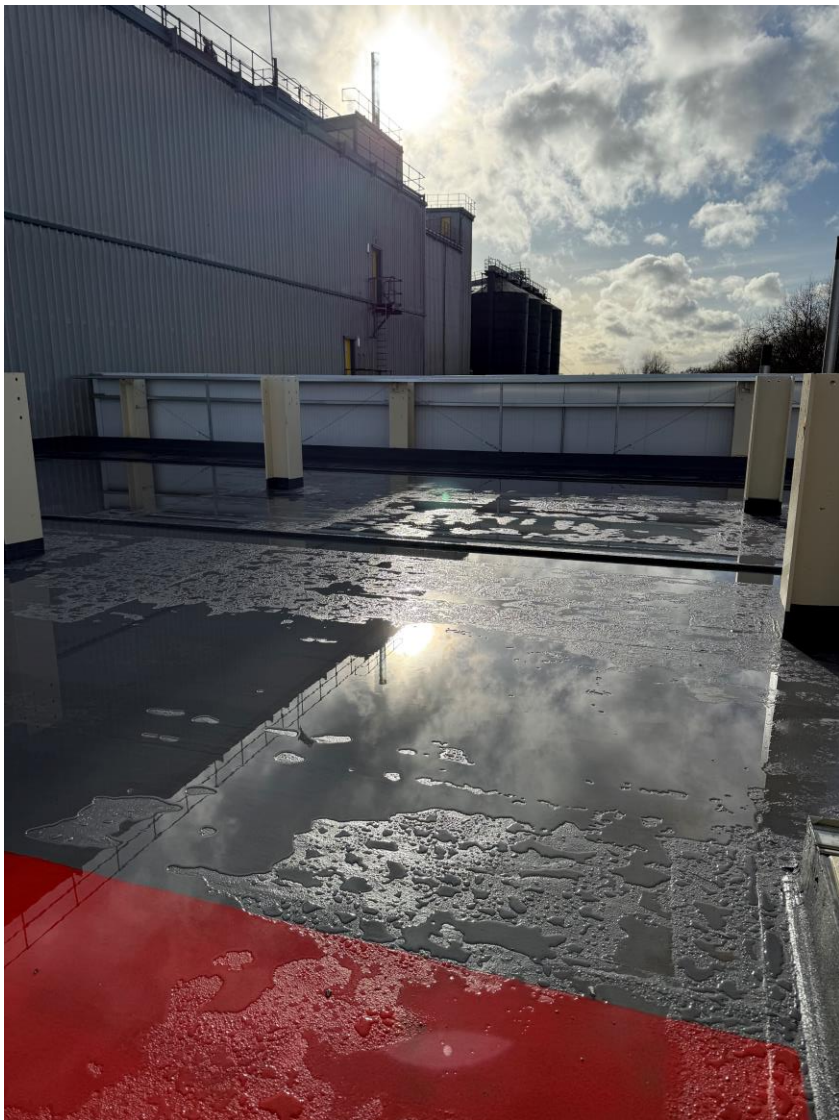
A red walkway was added for a fire exit (stairs to be installed later). This was using the MMA Top Coat pigmented traffic red and whilst wet aggregate was scattered and backrolled to provide a non-slip surface.

You can see the resulting roof at work a week after completion resisting water and the channels were functioning and providing an exit for the water.
