Is SDC a Toxic Time Bomb?

The Dangers of Demolition

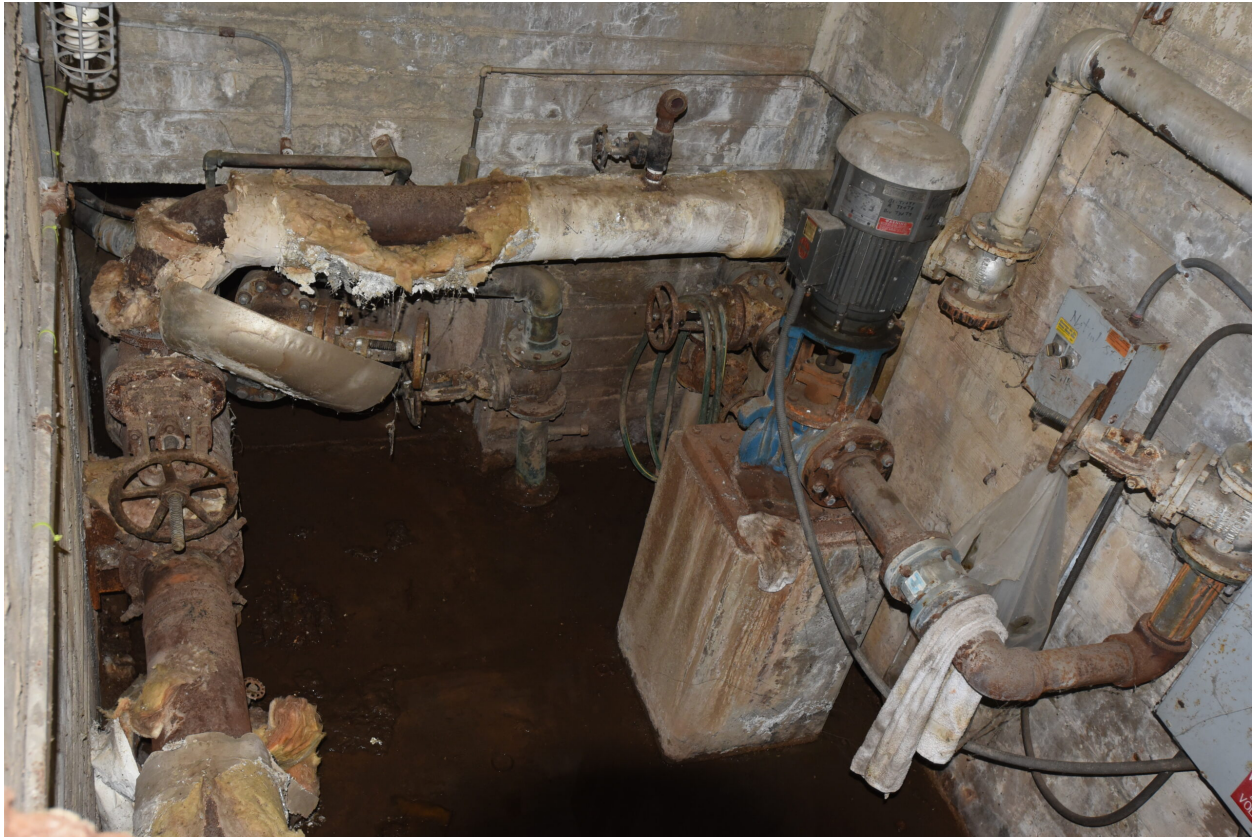
Main Photo: The entrance to the main tunnel carrying steam and hot water pipes through the SDC campus. Pipes are wrapped in disintegrating asbestos insulation. Photos by David Bolling

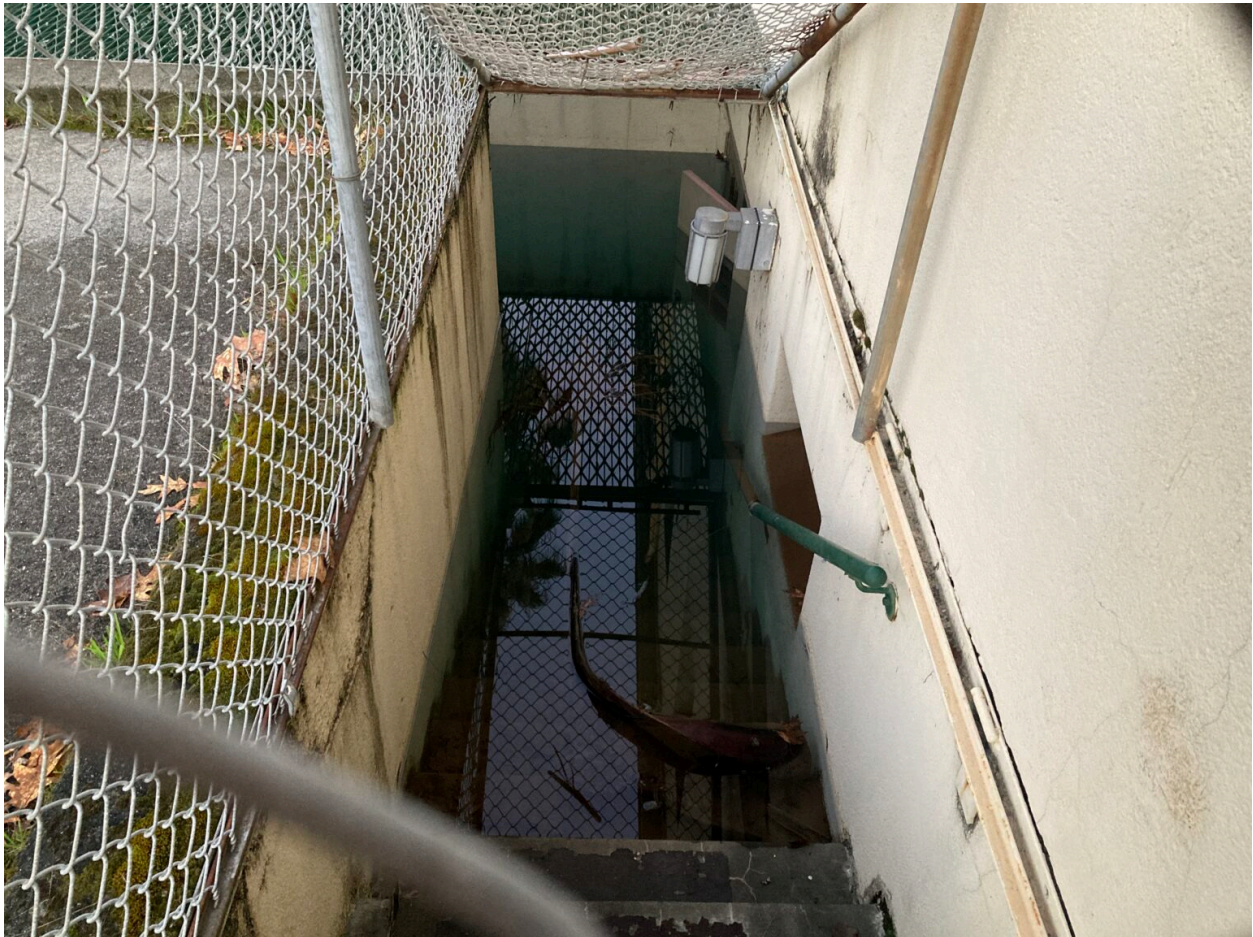
Flooded stairwells lead to flooded basements in SDC, where asbestos-insulated water steam pipes are under water

The asbestos risk was amplified after recent heavy rains flooded the basements of several buildings on the east side of Sonoma Creek, pushing visible standing water up outside stairwells and, according to one former plant supervisor, reaching the level of asbestos-insulated steam pipes in those basements.

Tom Sokoloski, a former stationary engineer and decades-long SDC employee, said steam and hot water pipes wrapped in asbestos insulation were most likely enveloped by water in the flooded basements, potentially resulting in asbestos-contamination in the water and complicating any effort to pump them dry. He said he contacted County officials who had been unaware of the problem. As of the date of this *Sun* issue, the basements remained flooded.

The flooding occurred, Sokoloski said, because power had been cut to the buildings, precluding the automatic intervention of sump pumps in each basement. That failure reflects a general sense that the entire campus has been abandoned to incremental decay. Examination of some of the former residence halls reveals ceiling tiles littering floors, mold taking root, roofing tiles falling away exposing bare expanses of roof.
