## Unitary Products Technical Services Service Tips Letter

Letter: **ST-002-2018**

Subject: **Ignition control board defect**

Product: Residential single stage PSC gas furnaces.

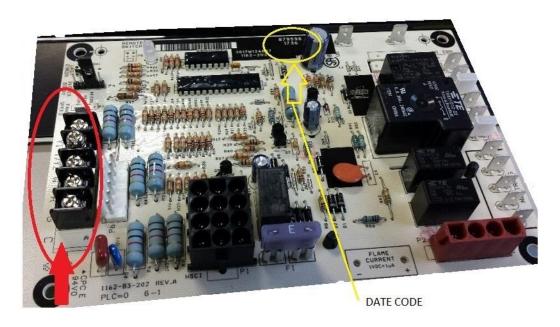
It was recently discovered that the control board low voltage terminal block has inadvertently been shifted over one space leaving the field wired COMMON connection to the control with no terminal to connect the field supplied thermostat wiring to. According to the control board manufacturer, the affected date code of the board is 1736. This defect is limited to a very small number of control boards. We have received reports of only **TWO** incidents to date of this defective board issue. Below is a photo of a defective board.

Note the red circle and arrow. This illustrates the missing 24VAC thermostat common connection. The location of control board date code is circled in yellow.

If a control board defect of this type is found, please report it to the Residential Distributor Support team as we will require the control be returned to us for vendor analysis. The control board can be replaced with S1-33103010000 and claim one hour labor using the standard unit warranty. If further information becomes available, it will be provided with an update to this letter.

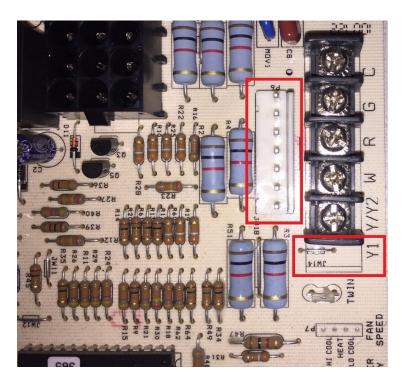
Note the red rectangle outline with the wire jumper inside it. It is labeled Y1. This is correct for the single stage PSC model control board.

Each and every furnace goes through a factory run test and must pass it prior to being packaged and shipped out. In the photo above there is a red rectangle outline around a plastic low voltage connection header labeled "P6." The run test station on the assembly line connects to this P6 connector in lieu of connecting to the field thermostat wiring connection screw terminals. Since run test does not connect to the screw terminals, the furnace control was able to pass run test.
