*Ducted Systems
Technical Services
Service Tips Letter*

Letter: **ST-009-2018**

Subject: **New Burner Box Shoot Thru Plate**

Product: All 33" 90% Condensing Model Furnaces

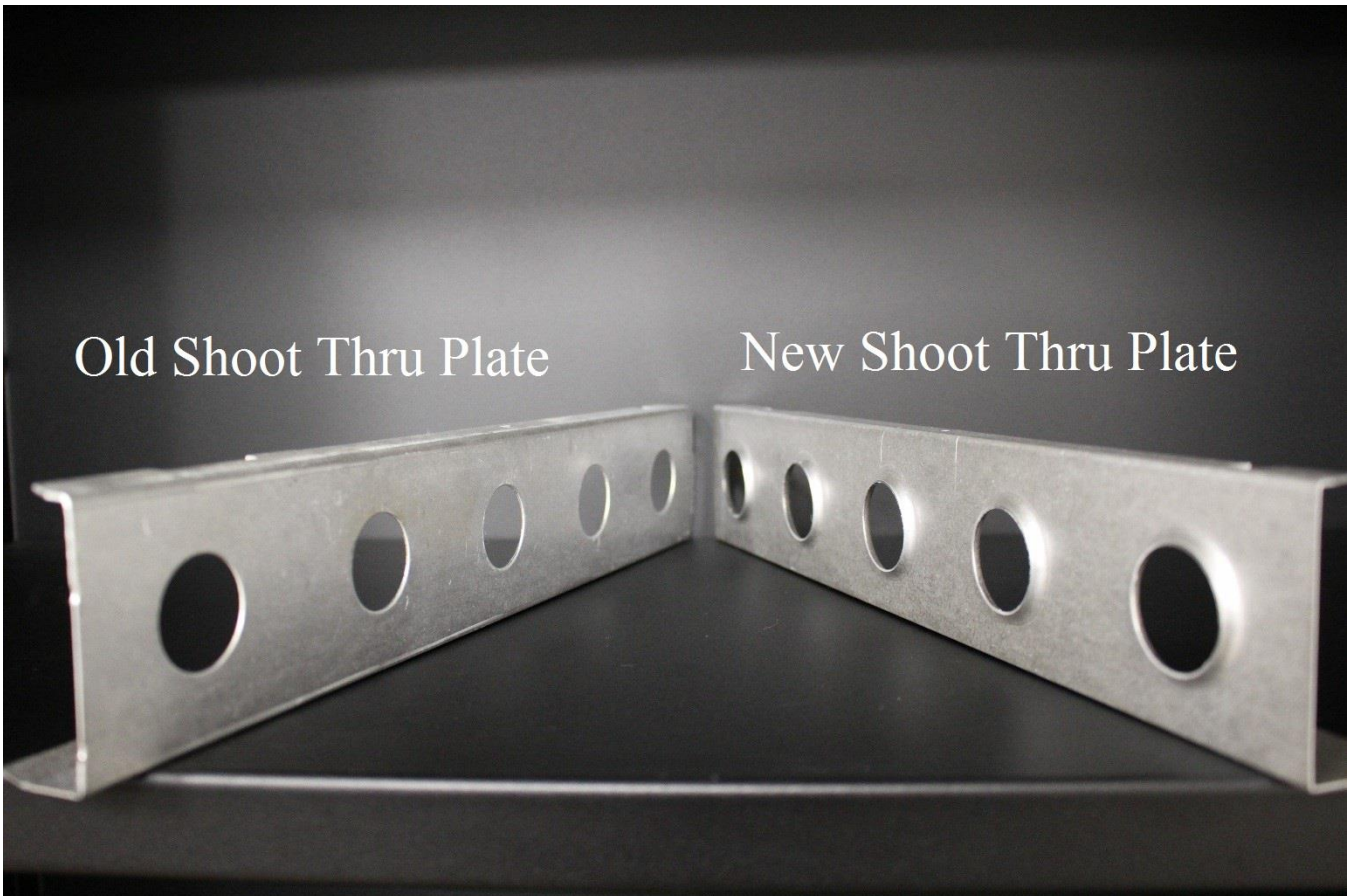
Old Shoot Thru Plate

New Shoot Thru Plate
