CASE STUDY

This 100-barrel production water truck in Grand Junction, Colorado, had been protected with a conventional epoxy coating. The harsh driving conditions imposed on the truck had caused the original coating to fail. Conventional epoxies generally have limited or no retained flexibility so vibrations and torquing can rapidly lead to microcracking which allows corrosive chemicals contained in the production water to directly attack the tank's interior. One of the serious corrosive chemicals is sulfuric acid produced from the sulfur content.

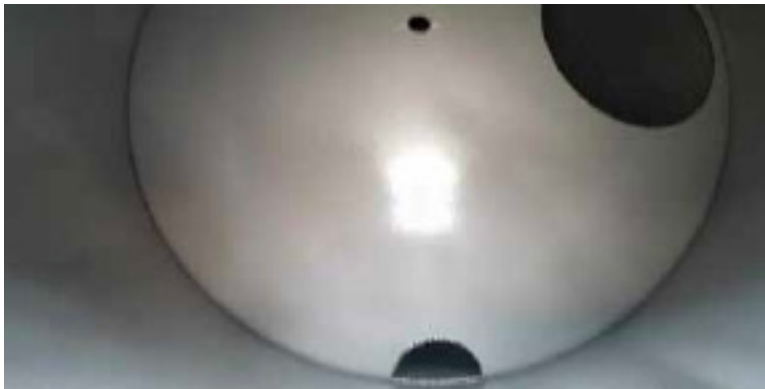
As can be seen from the photos, the quality of the spray finish was excellent. Using pressure spraying allows the coating to penetrate into the tiniest anomalies such as cracks and gaps in welds and behind bolt heads. Full cure was achieved within 24 hours at which time the truck was released for full usage. The client reported complete satisfaction with the results

Castagra's SG1 does not have any solvents in content, application, nor are they required for clean-up. In this case, the coating was sprayed onto a clean, dry surface to a depth of 30 mils. With no VOCs, the sprayer only required standard protective clothing and equipment. This was after an inspection to confirm there was adequate fresh air flow.
