City of Sprague, Washington Nonstructural Flood Mitigation Assessment

January 2020

USACE Walla Walla District in support of the Washington Silver Jackets Program

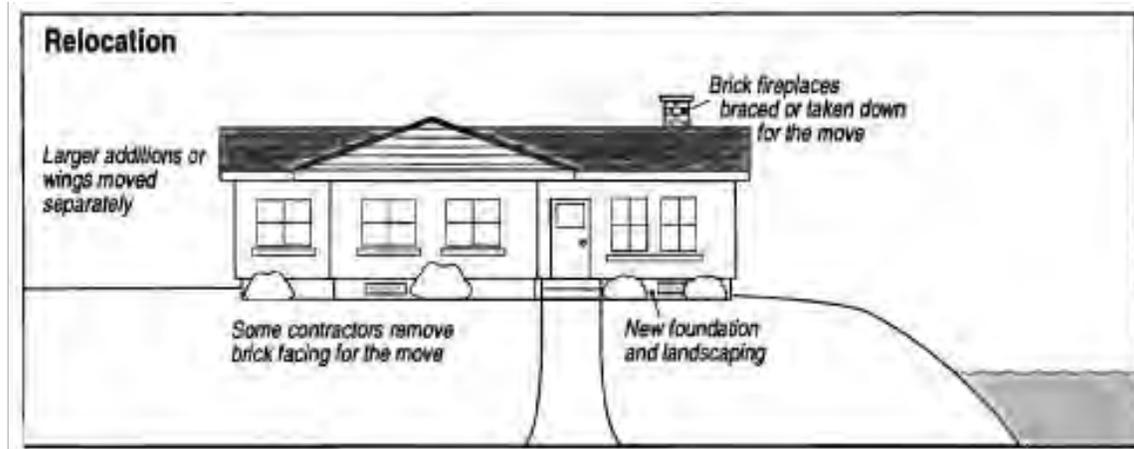
Figure 3. Relocation of a Structure (Diagrammatic Detail)

3.3.2 Relocation of a Structure. This NS measure involves physically moving a structure that is subject to a significant flood risk to an area outside of the floodplain. This measure also requires both the acquisition of new property to place the moved structure on, and acquisition of the existing flood-prone property to prevent future development that would incur flood risk. This measure provides a high level of flood risk mitigation as at-risk structures are moved to a location with no flood risk. Development of relocation sites where structures could be moved to allows a community to achieve both flood risk reduction and maintaining a community tax base, maintaining neighborhood cohesion, and maintaining cultural or historic values that exist in a community. This measure can be applicable across the study area.

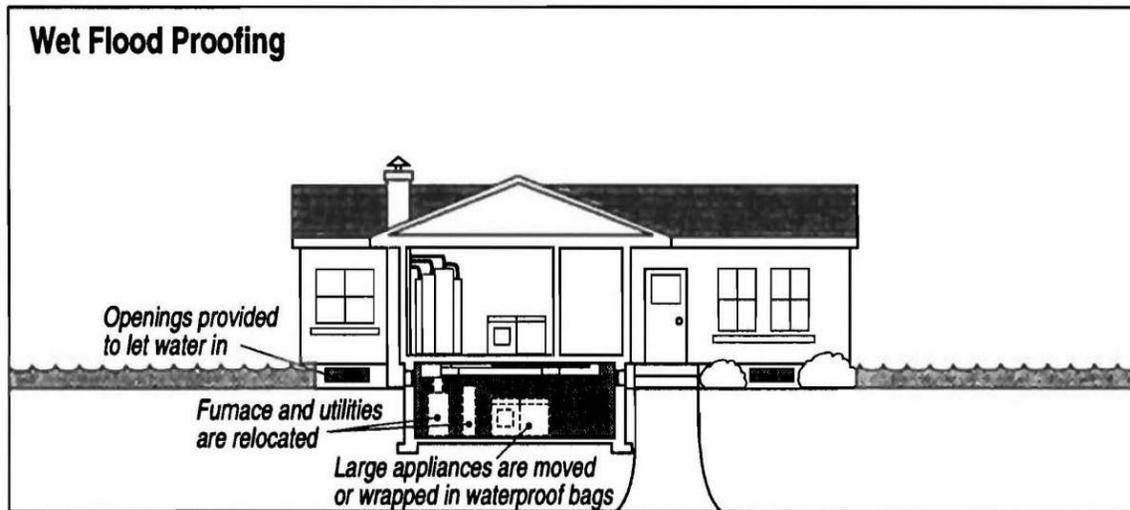
Figure 6. Wet Flood Proofing (Diagrammatic Detail).

3.3.6 Wet Floodproofing. Wet floodproofing is essentially making a structure resilient to flooding through the use of waterproof building materials up to the specified flood height, as shown in Figure 5. In wet floodproofing, water is allowed to enter and interact with a structure without damage. This NS measure can be a stand-alone measure, or combined with other measures such as elevation or dry floodproofing. All utilities and mechanical equipment must be elevated above the design flood elevation. Generally, wet floodproofing is not applicable to residential structures. It may, however, be able to provide commercial and industrial structures with a level of protection as long as the contents can be managed in such a way as to not be damaged during a flood. This measure is generally not applicable to large flood depths or high velocity flows due to the potential structure failure of walls.

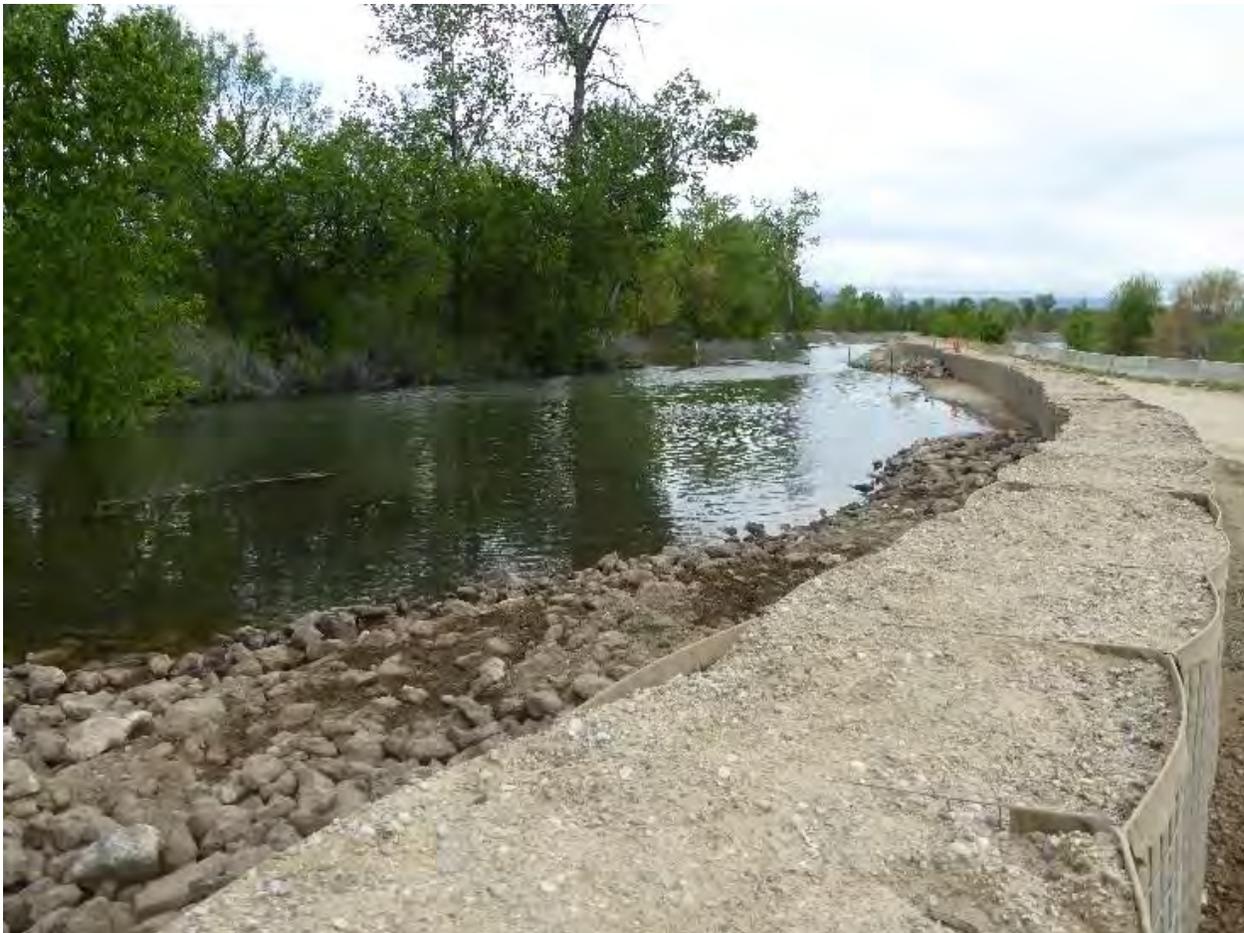
Figure 8. HESCO Barriers Deployed on the Boise River, Idaho, 2017.

HESCO barriers can also be effective in forming long flood barriers relatively quickly, as shown in Figure 7. The barriers are fabric-lined wire baskets that are linked together and filled with sand. They can be placed and filled with small equipment, including a skid steer loader. If placed correctly, they do not need to be wrapped in plastic. These are a specialty product, however, and may not be readily available locally. However, if the city, the county, or the state desired to create a stockpile of HESCO barriers that could be readily accessed, they can be purchased. The U.S. Army Corps of Engineers also has HESCO barriers in the national flood materials stockpile, which may be accessible if a Direct Assistance mission is authorized. The lead time required for the Corps to deliver materials may be slower than the speed with which a flood develops in the Negro Creek drainage, however.

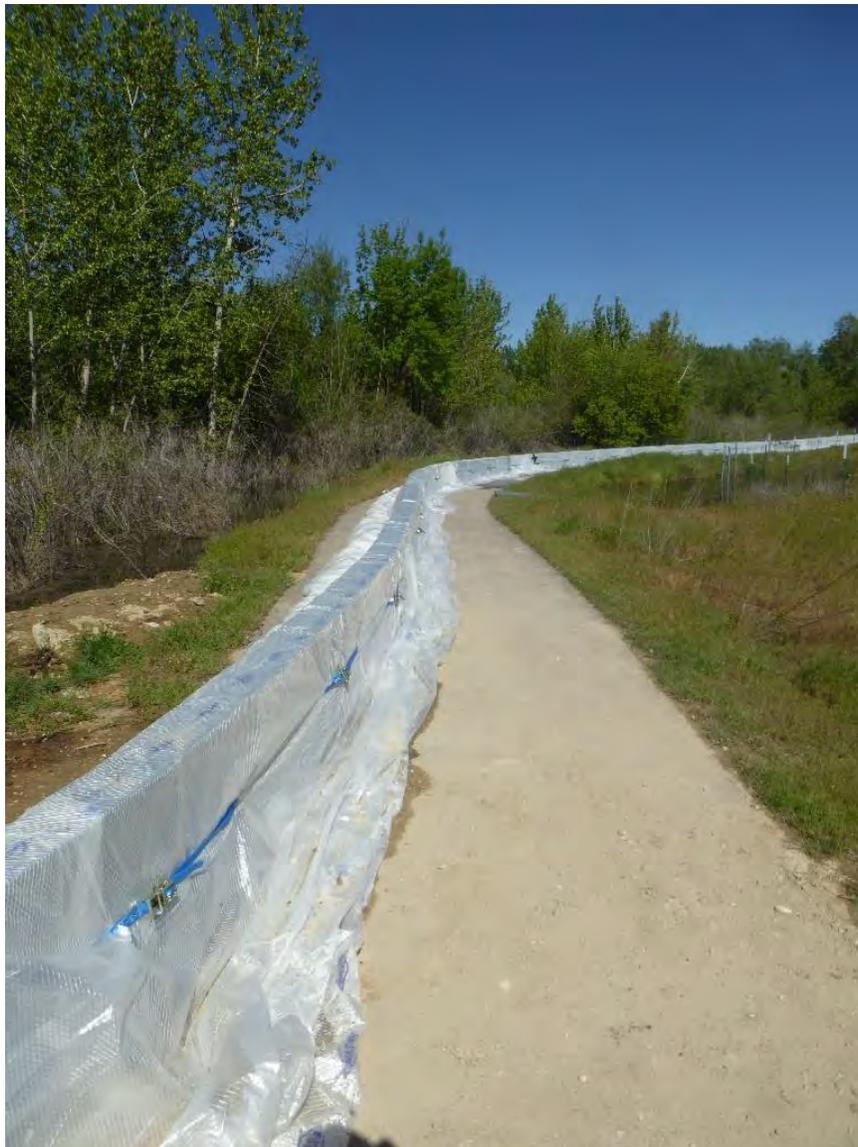
Figure 9. Muscle Wall Flood Barrier Deployed on the Boise River, Idaho, 2017.

There are a number of proprietary flood barrier products on the market that can be effective as well. Some can even be placed directly into moving water. While the Corps cannot recommend any one particular product over another, a general list and description is included here for further research and consideration. Water filled, linked flood control tubes such as Tiger Dams, AquaDams, or other similar products can be very effective at forming a temporary flood barrier and can be filled by the ready supply of water available during a flood. Harder barrier products, such as Muscle Walls, Aqua Fence, and others can also be highly effective when deployed. The Muscle Wall branded barriers are shown in Figure 8. Some of the harder barriers are water-filled and plastic-wrapped, and some are simply deployable walls that rely on water pressure on the wet side for stability.
