Eliminating Severe Water Hammer Issues with Proco ProFlex™ Style 750

Rubber duckbill design of Proco check valve solves water hammer problems for town of Boone, N.C.

Project: Check Valve Replacement and Water Hammer Elimination

Location: Jimmy Smith Water Treatment Plant

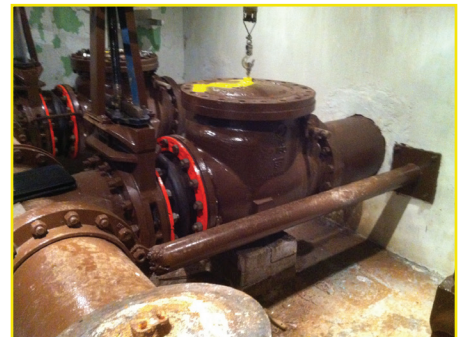
Prior to installation of the ProFlex™ Style 750 valve, water hammer had been a consistent and severe issue with this header assembly.

The three influent pumps at the plant feed into a common header that goes uphill for about 80 ft before discharging into an aeration basin. The plant uses traditional 16-in. AWWA swing check valves, which have experienced sometimes violent pressure resulting in water hammer and equipment damage.

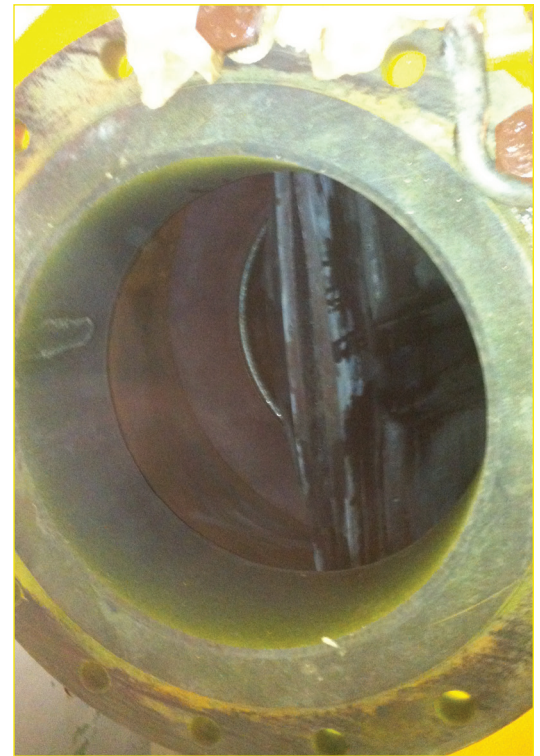
Shown here is the rubber valve inside the metal housing, viewed from the discharge end of the valve.

Needing to find a new check valve to replace the one that was destroyed, Moody contacted Cain. Cain recommended the Proco ProFlex™ Style 750, which eliminates water hammer issues with its rubber duckbill design.

"Rubber does a lot to absorb energy," he said. "Even if you have a high elevation discharging reverse flow and another pump in the header system coming on, you're forcing two rubber faces to come back to one another rather than slamming metal on metal."

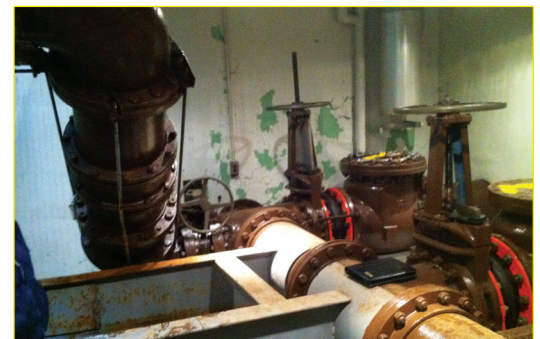
A severe water hammer event in the late 1990s ruptured the piping and caused the pump room to be filled with raw sewage, said Cain. Because of this, large structural beams were added in the plant's pump room to connect the header pipe to the walls.

Shown here is the extensive bracing (light gray beams and saddles) connecting the piping to the wall that had been installed after a catastrophic water hammer event had occurred 10 years or so prior to the new valve installation.
