## September 2011 Update

## 2009 Willow Planting Site Update!

## Branches and Banks - Wattle Fence - Bank Erosion Site-Update!

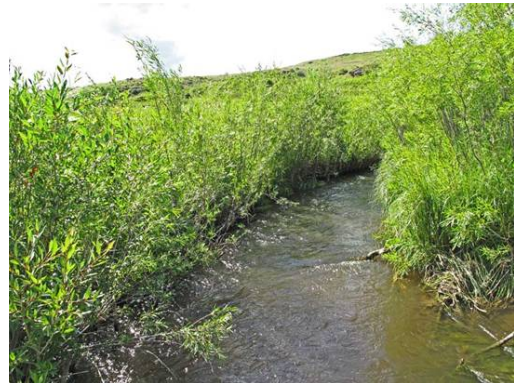
**Above:** This is a 2011 photo of the wattle fence (left side of the stream channel) that was constructed along the outside bank of a meander on Bighill Creek, in 2008. The project was completed by volunteers from the Branches and Banks Organization, based out of Cochrane, Alberta.

The fence is constructed entirely from willow cuttings, so there are no nails, bolts or brackets. This fence consists of vertical willow stakes being driven into the streambed along the waters edge and then lengths of willow trunks are woven on the inside and outside of the vertical stakes to create a retaining wall that will prevent soil from the bank, from slipping into the stream channel.

Because all of the materials used to build this fence are live cuttings or stakes, they will develop roots and start to grow. The photo above, shows how well the site has grown into a crop of willows along the waters edge!
