**Le Ciel Venetian Tower Condominium Association  
Wind Mitigation Inspection**

**3971 Gulf Shore Blvd. N.  
Naples, FL 34103  
Collier County  
January 13, 2024**

## Uniform Mitigation Verification Inspection Form

**CITIZENS PROPERTY INSURANCE CORPORATION  
BUILDING TYPE II AND III MITIGATION INSPECTION FORM**

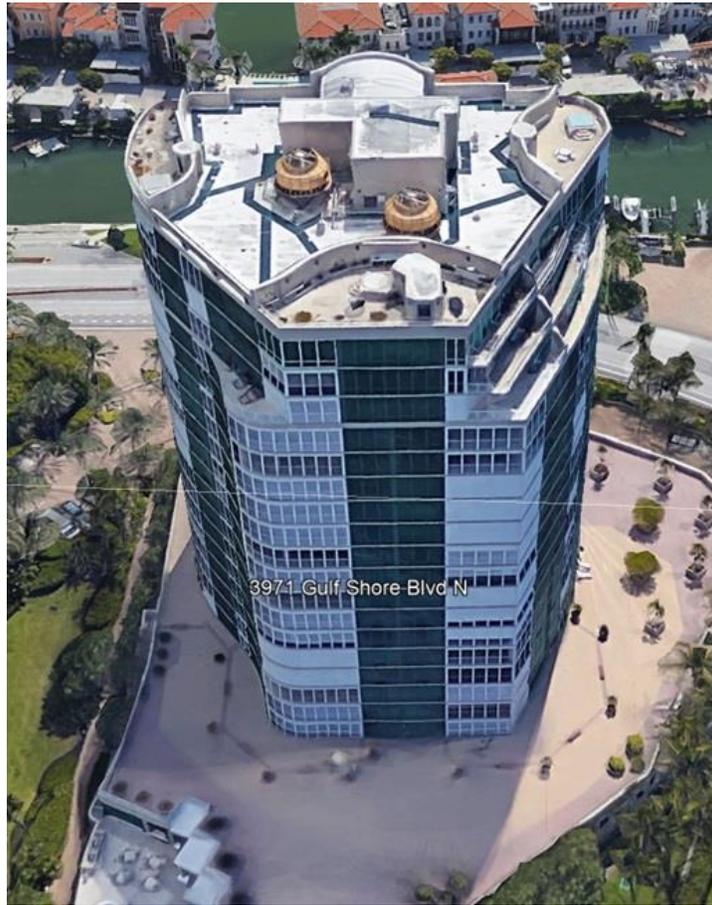
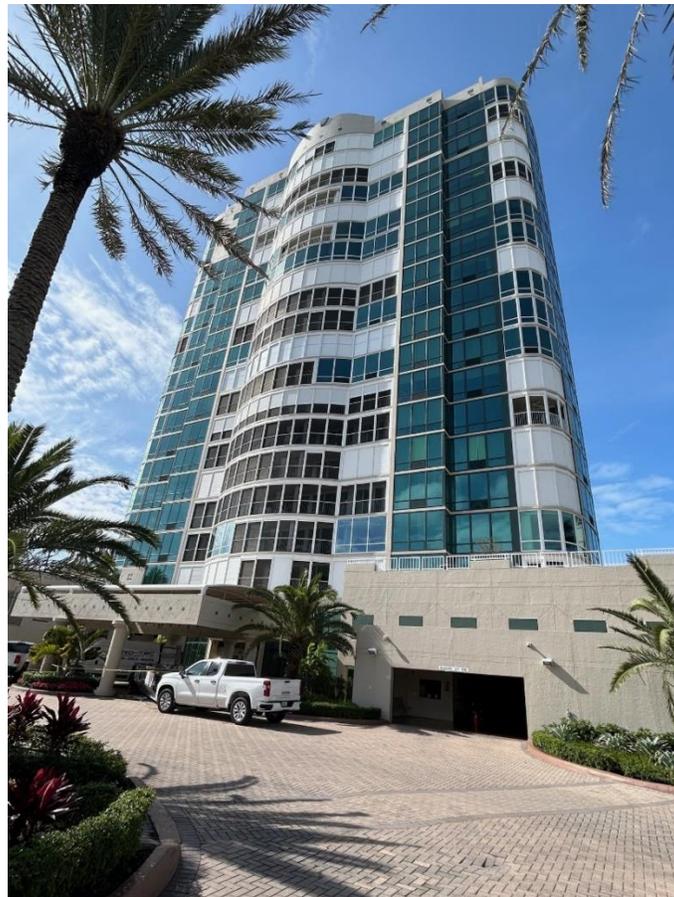
**Roof System:** The roof system is a single ply membrane system that was installed in 2005. This roof is 19 years old. The roof is inspected and repaired on a yearly basis by the designated roofing Contractor. This roof has an estimated remaining life of 5 to 7 years.

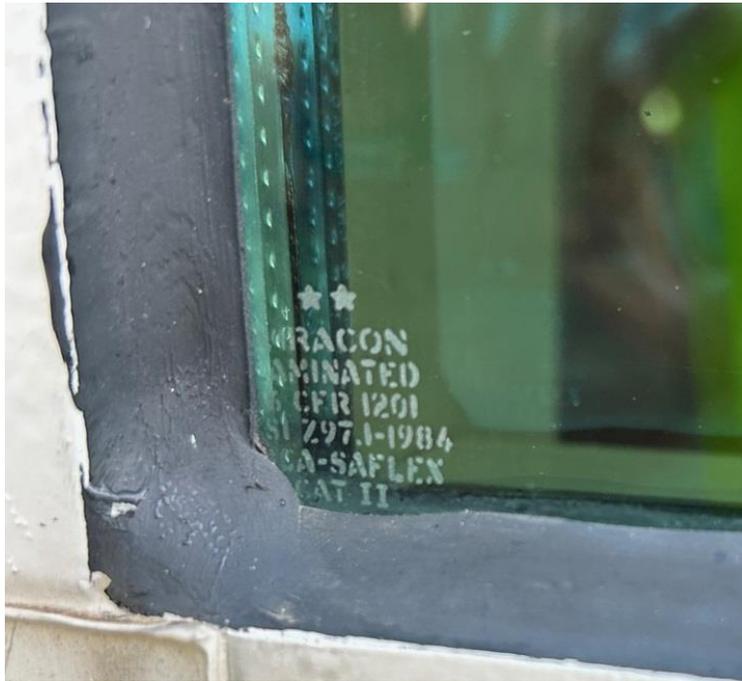
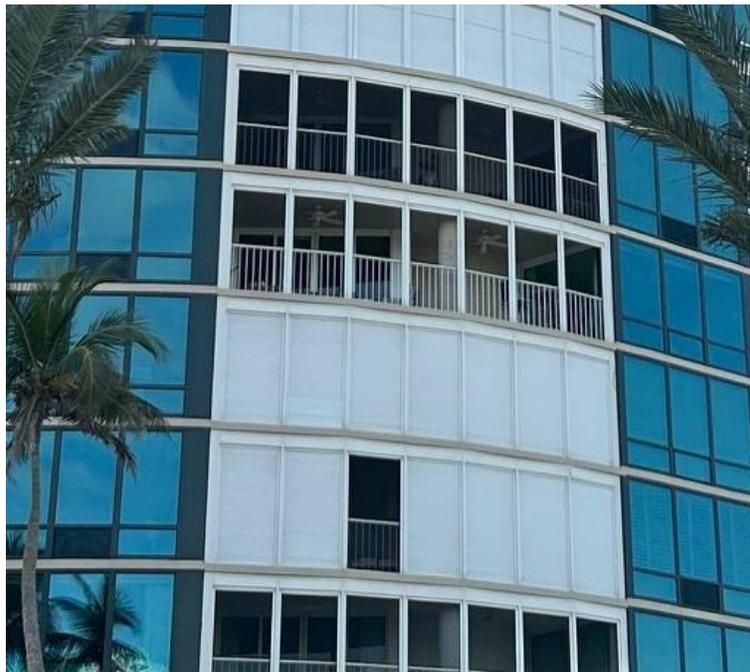
**Opening Protection:** All openings are protected by either impact windows or in the case of lanais, storm screens. The opening protection products appear to meet the the large missile and cyclic pressure as indicated by the laminated glazing meeting CFR 1201 Catt II.
