ASHPs in Cold Climates

Concord, Massachusetts

PROJECT OVERVIEW

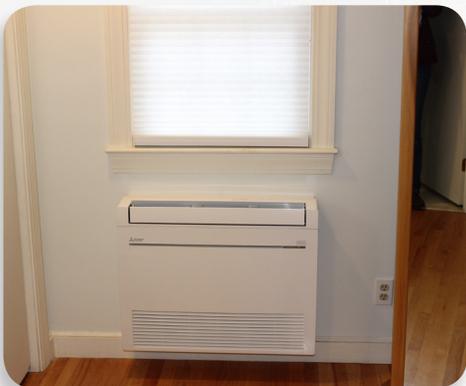
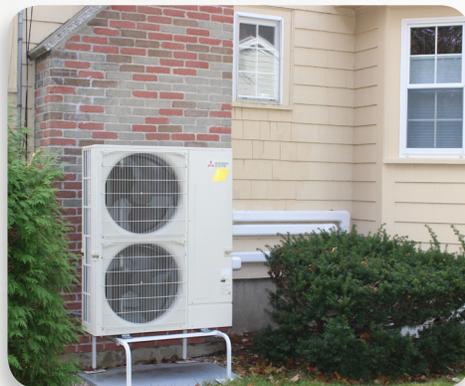
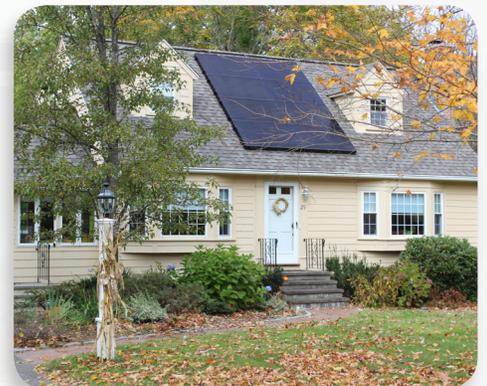
Kim and Amanda chose to condition their home's 2,200 square feet of livable space by installing a Mitsubishi ductless hyper heat ccASHP system. This ductless system includes two outdoor units (one in the rear of the home and one on the side) that serve six indoor air handlers (one in the basement, three on the first floor, and two on the second floor). The homeowners found that installation was quick and easy, taking just two days. The indoor units are sleek and blend in with the home's aesthetics. The homeowners have kept the existing radiators in place though they are not in use, as they bring classic character to the home's interior.
