Sustainable**Solutions**  
CORPORATION

**APRIL 2017**

## **LIFE CYCLE ASSESSMENT OF PVC WATER AND SEWER PIPE AND COMPARATIVE SUSTAINABILITY ANALYSIS OF PIPE MATERIALS**

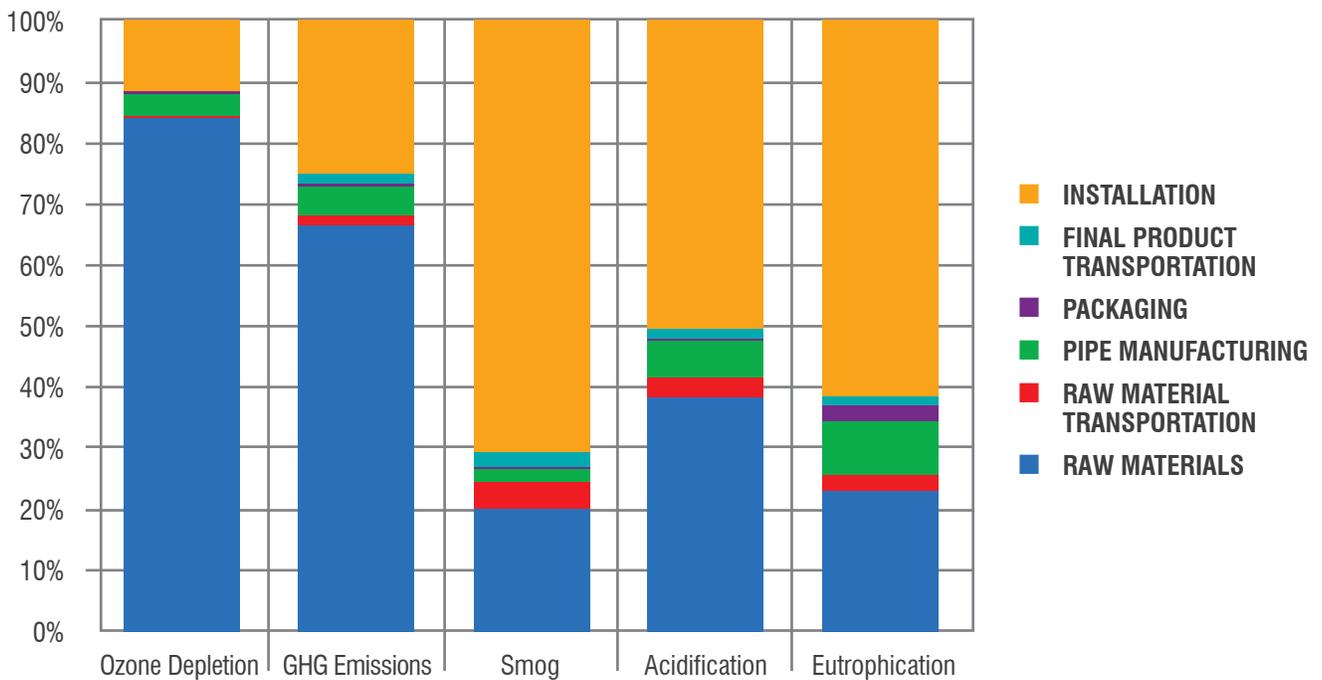
**FIGURE 4.3 : ENVIRONMENTAL IMPACTS OF 8" PVC DR25 PC165 C900 PRESSURE PIPE (TRACI IMPACT ASSESSMENT METHODOLOGY)**

- INSTALLATION
- FINAL PRODUCT TRANSPORTATION
- PACKAGING
- PIPE MANUFACTURING
- RAW MATERIAL TRANSPORTATION
- RAW MATERIALS

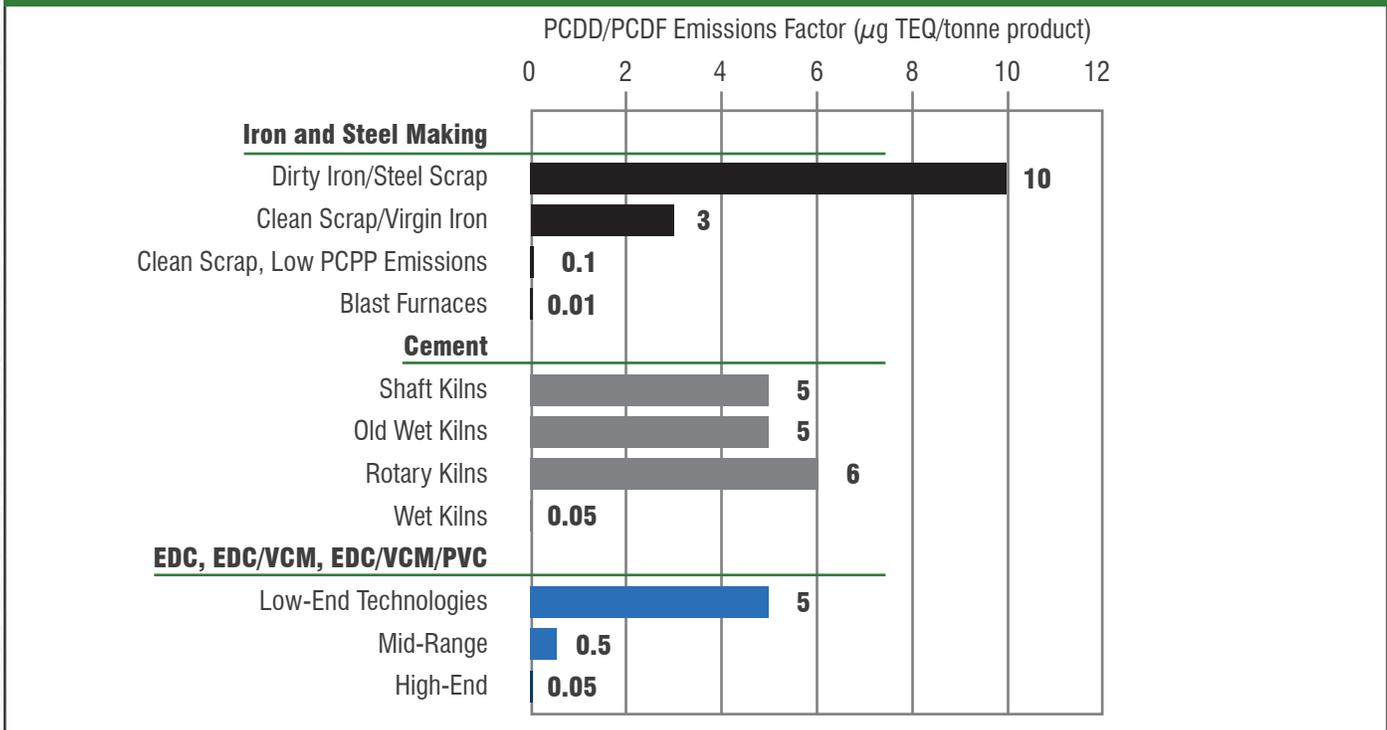
**FIGURE 5.1 : UNEP ESTIMATED DIOXIN EMISSIONS FACTORS FROM GIVEN PRODUCTION SOURCES**

According to the EPA and the United Nations Environment Programme (UNEP), metal sintering and magnesium production (both used in steel and iron production) and coal-fired electricity production are also major sources of dioxin emissions.<sup>30 31 32</sup> UNEP has standard emissions factors for facilities that are major sources of dioxin emissions.<sup>33</sup> A sample of these factors is shown in Figure 5.1. GreenSpec® has removed cast-iron drain pipe from their listings because of the high embodied energy and pollution emissions from coking plants.<sup>34</sup>

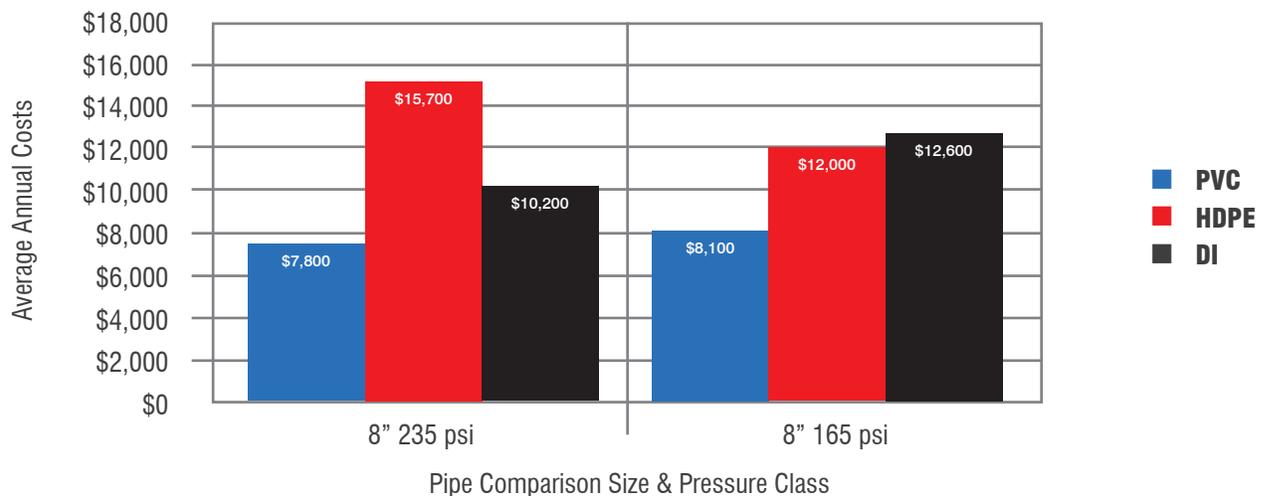
**FIGURE 10.4 : COMPARISON OF AVERAGE ANNUAL 100-YEAR PUMPING ENERGY COSTS PER 1,000 MILES OF PIPE BASED ON 0.4 FPS VELOCITY**

Note: Graph assumes replacement of HDPE and DI pipe at 50 years.

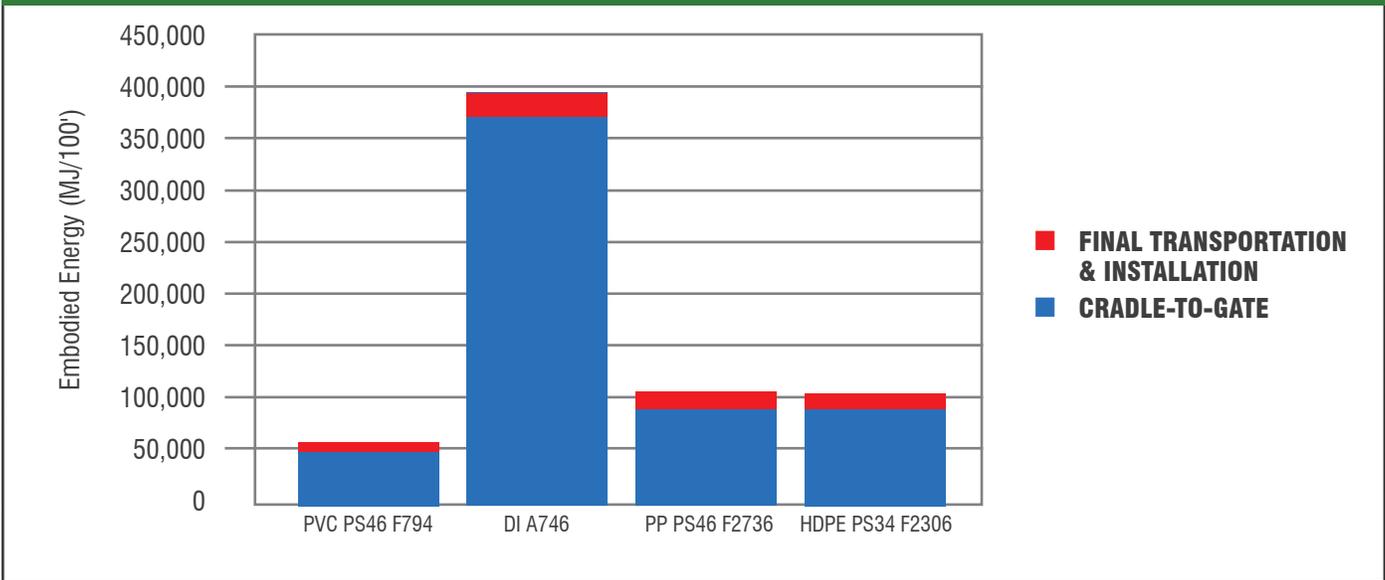
**FIGURE 12.7 : TOTAL 100-YEAR EMBODIED ENERGY FOR 24" PVC PS46 F794 PROFILE-WALL EQUIVALENT GRAVITY PIPES**

Figure 12.7 compares 24-inch PVC profile-wall, DI, PP and HDPE pipes equivalent to PVC PS46 F794 profile-wall pipe. The total 100-year embodied energy of PVC sewer pipe is 85 percent less than equivalent DI sewer pipe; 44 percent less than PP and 43 percent less than HDPE sewer pipes. It should be noted that the equivalent HDPE sewer pipe has a pipe stiffness that is 26 percent less than the pipe stiffness of PVC pipe.
