PROJECT			
	IntegraRack			
TITLE				
IR-45ASAA / ASAB Solar Racking System Data Sheet				
IR-45ASAA0046, IR-45ASAB0047				
APPROVED Paul Budge 2/21/2025	SIZE	CODE	DWG NO	REV
CHECKED Paul Budge 2/21/2025	B			
DRAWN Jeff Glauser 2/21/2025	SCALE 1:20	WEIGHT 16lbs / 24lbs	SHEET 1/4

Subject: Witness of Wind Tunnel Testing on IntegraRack Products at the George E Boeing Aeronautics Department (Kirsten Wind Tunnel) at the University of Washington

Subject: Simulated Wind Load, Snow Load, and Horizontal Racking Load Testing on IR-30 Solar Racking System.

INSPECTION AND TEST REPORT

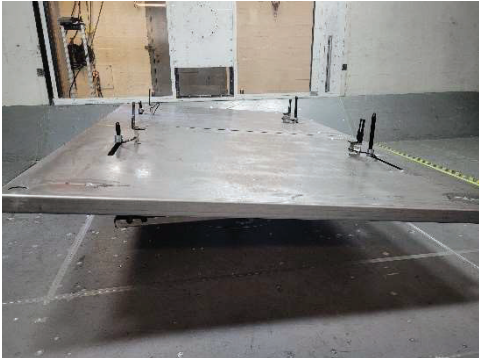
Figure 1: Run 1 through 3 simulated roof setup

A total of 8 runs were performed on IntegraRack products. Test Runs 1 through 3 were performed with the IR-D1 bracket (See Figures 1-4) with an installed 18 SF solar panel on a simulated roof incline. Run 1 was performed to tare KWT's system through the full 0 to 110 degree rotation of the test platform with the simulated roof and panel installed. The roof surface had been installed at an approximate 5 – 6 degree incline (See Figure 1). The solar panel was mounted at 0 degrees relative to the roof surface with a general height of 5 in from the roof surface. at all four corners of the panel. Test Runs 4 and 5 were performed on the same panel and bracket with the panel height adjusted and installed at an angle with the front corners set to 3-1/2 in. and the back corners set to a height of 6 in. from the roof surface.

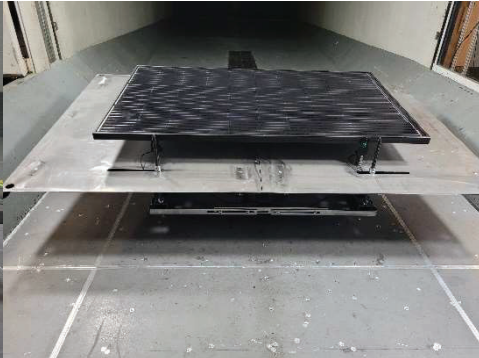
Figure 2: Run 1 through 3 setup with panel

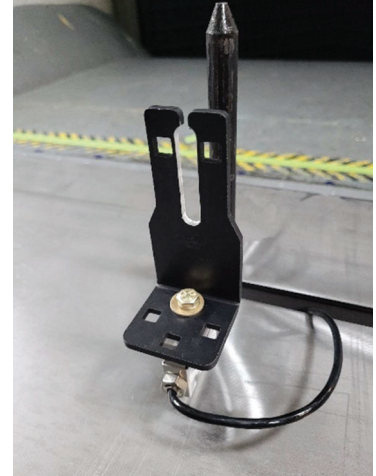
Figure 3: Bracket at leading edge LC0-1, LC0-2

Test Runs 2 through 5 included rotating the test setup from 0 to 110 degrees while KWT instrumentation recorded test data. Wind speed was increased until limitations of KWT instrumentation prevented it from being increased further. Four load cells, Omega model LC103B-250 lb Class N10, were installed between the IntegraRack bracket and the roof surface to monitor and record loads applied to the brackets throughout testing (See Figures 5-10). The load cells were labeled LC0-1, LC0-2, LC5-3, and LC5-4 with LC0 being installed at the leading edge and LC5 being installed at the back edge.

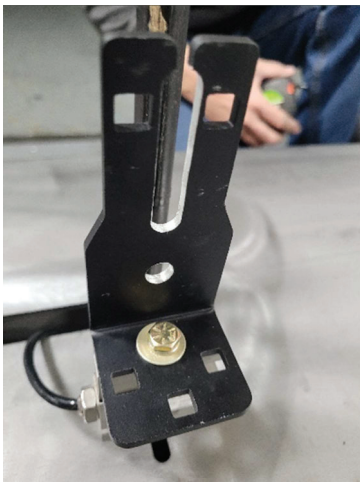
Figure 4: Bracket at back edge LC5-3, LC5-4

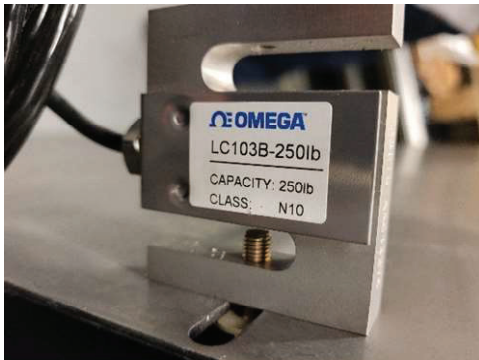
Figure 5: Load Cell Model used for tests

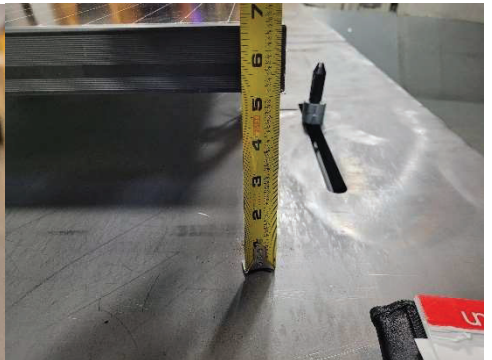
Figure 6: Height from roof to panel, Runs 2 & 3

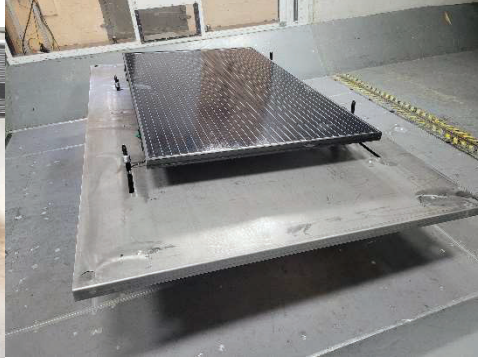
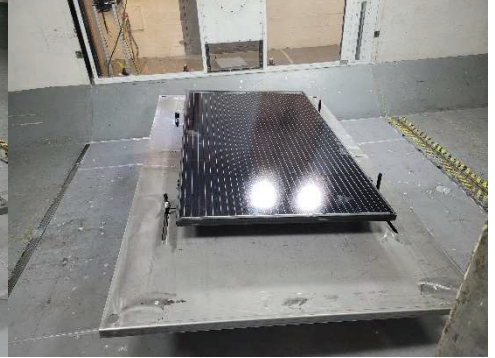
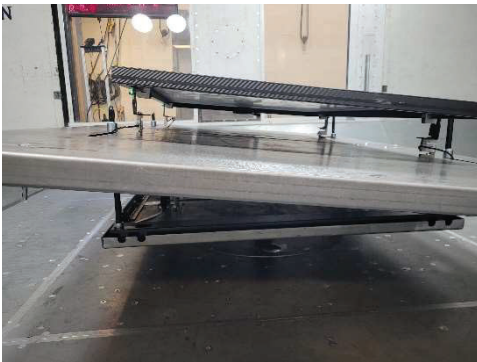
Figure 11: Setup after Run 2, 109 mph winds.
 No damages or loose hardware noted.

Figure 12: Setup after Run 2, 109 mph winds.
 No damages or loose hardware noted

Figure 13: Setup after Run 2, 109 mph winds.
 No damages or loose hardware noted

The maximum load at a bracket recorded during Test Runs 2 and 3 was 75.015 lbf at a wind speed of 157.67 MPH when the panel was at a rotation point of 60 degrees. No damage or deformation was noted

to any bracket during or after the test runs and all hardware was found to be secure upon completion of each test (See Figures 11-13).

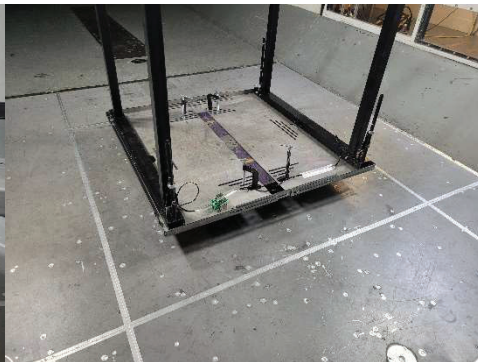
Figure 14: Setup for Run 6 with IR Ballast
 Frame

Test Runs 6 through 8 were performed on the IR Ballast Racks (See Figures 14-32). The simulated roof structure was removed and the frames and panel were mounted directly to the KWT test platform. These runs were performed at a set angle with no platform rotation during the test run. Two load cells were used for the test setups and were mounted at the brackets at the leading edge of the test platform at the wind intake side.

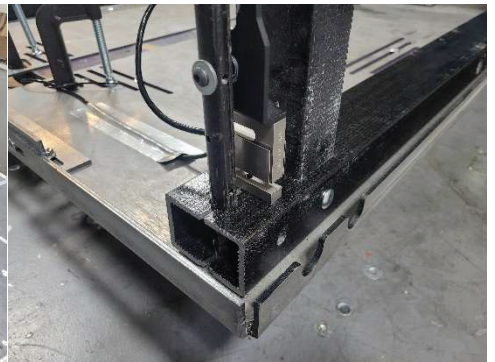
Figure 15: Load cell location at leading edge,
 LC0-1 & LC0-2

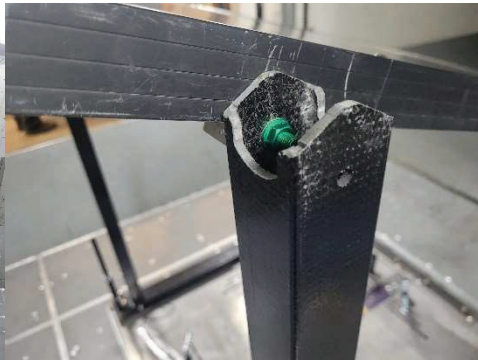
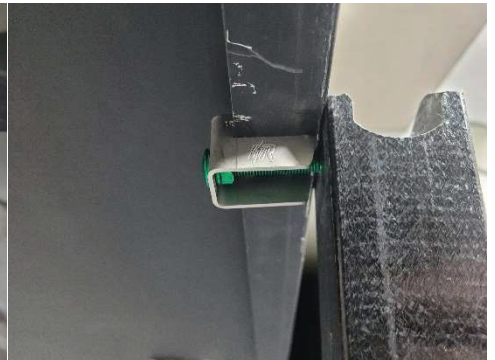
Figure 17: IR Ballast frame connection to solar
 panel

Figure 18: IR Ballast frame connection to solar
 panel

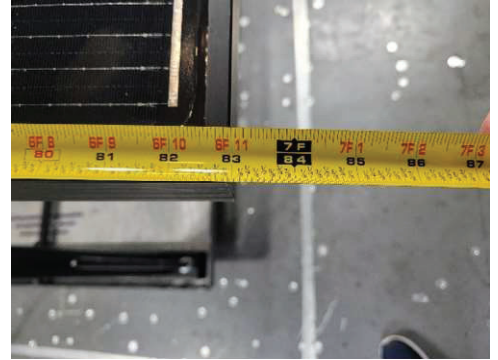
Figure 21: Solar panels total length 83 in.

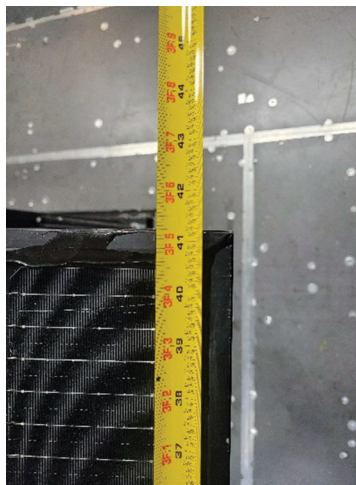
Figure 23: Total width 41-1/4 in.

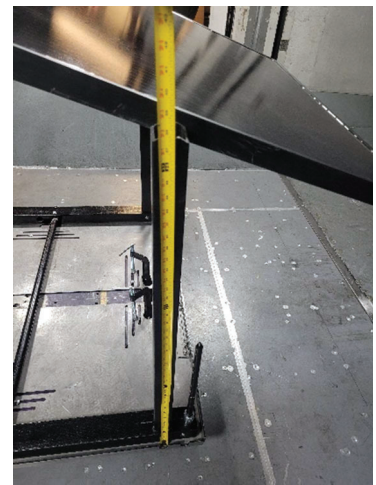
Figure 24: Run 6 trailing edge leg height

Run 6 was performed on the IR18C with the solar panel at an approximate 18 degree angle (Figures 24-25). The maximum load at a bracket recorded during Test Run 6 was 168.59 lbf at a wind speed of 101.59 MPH. Runs 7 and 8 were performed on the IR30C with the solar panel at a 30 degree angle (Figures 30-32) with Run 7 having the solar panel mounted and aligned with the wind direction to produce maximum forces on the frame and Run 8 being run in an orientation 90 degrees offset from Run 7. The maximum load at a bracket was during Test Run 7 and was 183.38 lbf at a wind speed of 81.138 MPH. Run 7 was stopped when the drag limit of the KWT test apparatus was reached. The solar frame experienced shaking under wind load but no damage was found to any part and all bolts were found to still be tight and in place after the test run. Run 8 was pitch limited by the KWT test apparatus. Similar to Run 7 the frame and solar panel had experienced shaking under load but no damage to the frame or panel was noted and all bolts and connections remained tight.

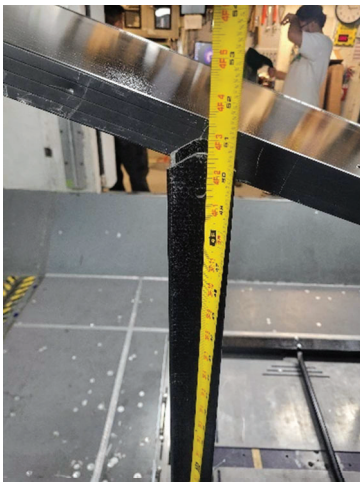
Figure 25: Run 6 leading edge leg height

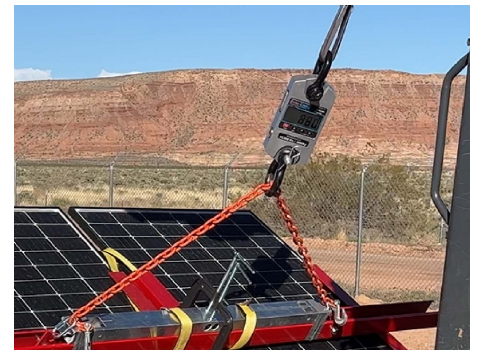
PHOTO 6: Test 1 - Load at ballast shift

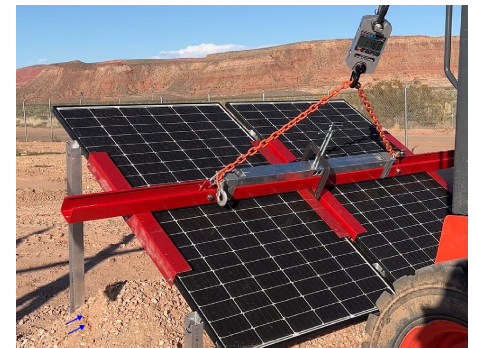
PHOTO 9: Test 2 - Evidence of ballast shift

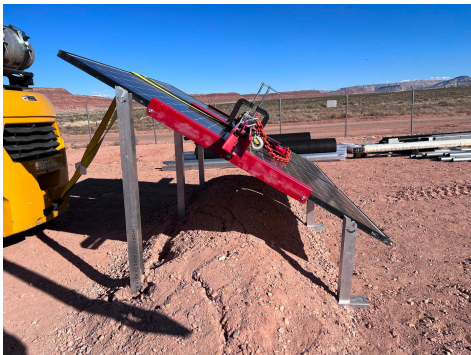
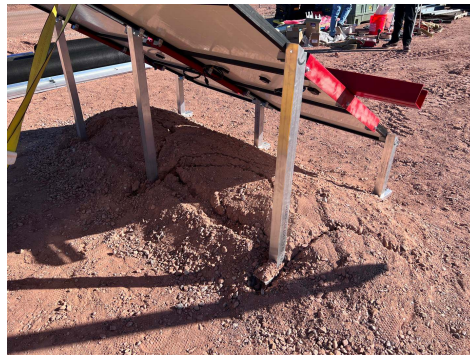
PHOTO 13: Ballast after completion of testing

PHOTO 14: Ballast and frame after completion of testing

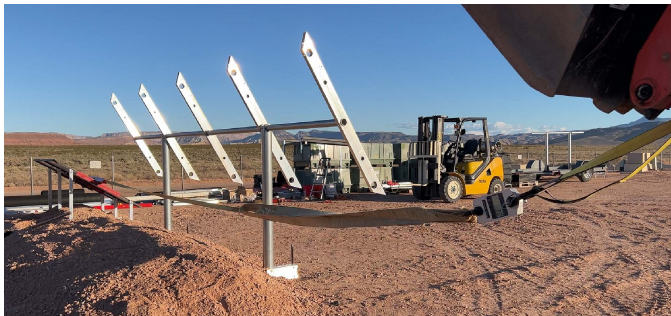
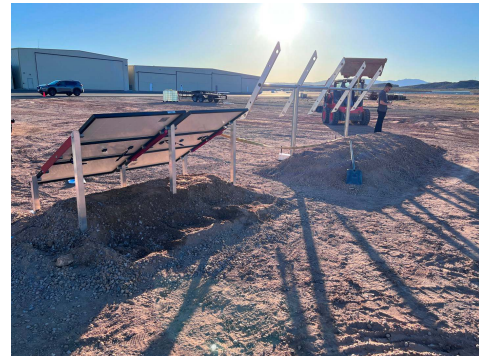
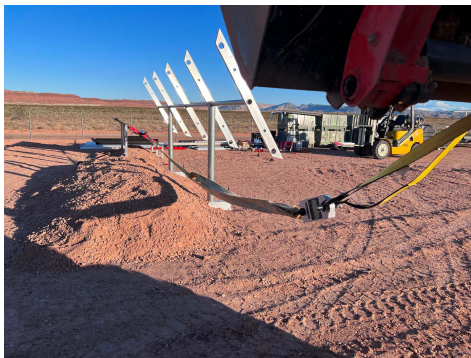
PHOTO 1: Horizontal force test setup

PHOTO 2: Horizontal force test setup

PHOTO 3: Horizontal force test setup

The IR-30 Solar Racking System Ground Frame was installed with the IR EarthBallast System and two solar panels. The EarthBallast system utilizes a mesh that is epoxied to the frame which is then loaded with loose dirt fill (ballast) that supports and holds down the frame. The horizontal load test was performed after the vertical uplift tensile load test. The system was tested with 3 loads of dirt from a Kubota SSV75 skid steer. The skid steer dirt loads were estimated at ~ 500 lbf each using an estimate of 100 lb/ft³ for the density of soil. A lifting strap was wrapped around the panel lengthwise and run parallel to the frame in order to apply a horizontal force to the system (Photos). Force was applied using the skid steer and load was monitored with the digital dynamometer. The test was stopped at a load of 645 lbf. No movement or damage was visually noted during or after the test.

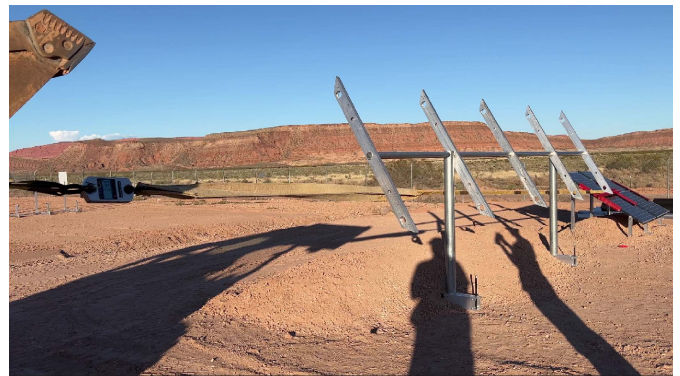
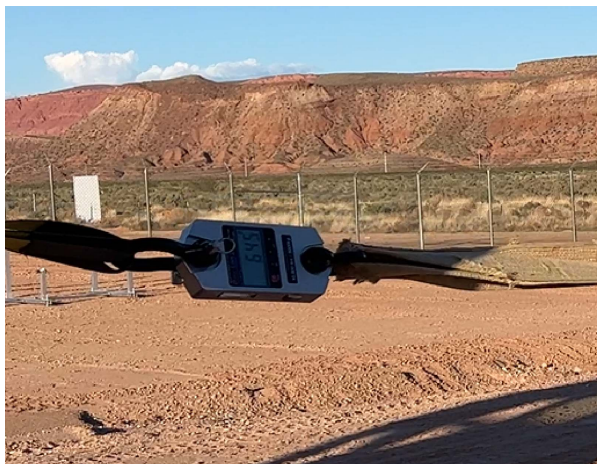
Photo 4: Horizontal force test at max load

Photo 4: Horizontal force test max load

TEST NO.	BALLAST DETAILS		MAX. HORIZONTAL FORCE (lbf)	OBSERVATIONS
	SIZE (LxWxH) (in.)	WEIGHT (lbf)		
1	90 in. x 42 in. x 14 in. (14 CF)	~ 1400 lbf (3 skid steer buckets)	645	Test was stopped at 645 lbf. No damage or movement was visually noted.

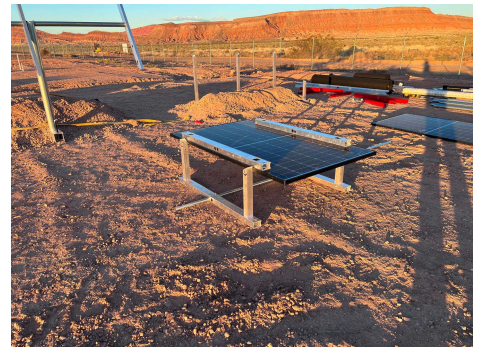
PHOTO 3: IR-30 Solar Racking System setup for test

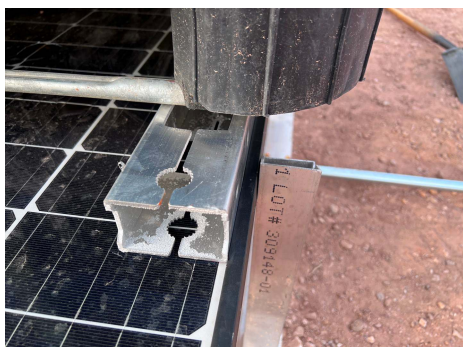
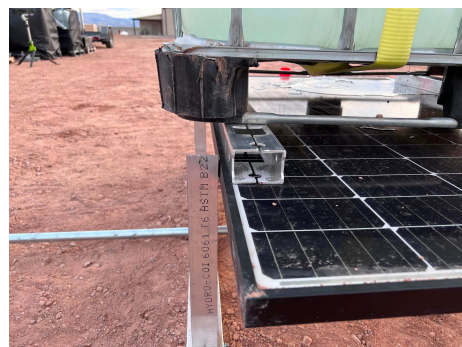
PHOTO 7: Slight deflections noted under load

PHOTO 8: Slight deflection noted under load

SIMULATED SNOW LOAD (COMPRESSIVE LOAD) INSPECTION DETAILS				
	COMPRESSIVE FORCE		OBSERVATIONS	
	DESCRIPTION	WEIGHT (lbf)		
1	Large water tank	2410	Solar panel held load overnight (> 10 h).	
2	Large water tank + (12) five gallon jugs	2950	Solar panel held load, ~ 10 -15 minutes under observation. Slight deflections noted under load (See Photos). Minor permanent deformation noted after load removal (See Photos). The alignment tabs in the vertical uprights were no longer flat with the uprights.

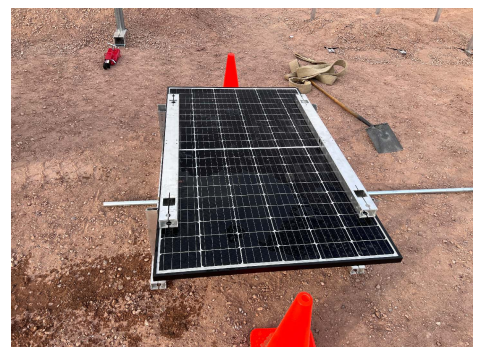
PHOTO 9: IR-30 system after compressive load tests

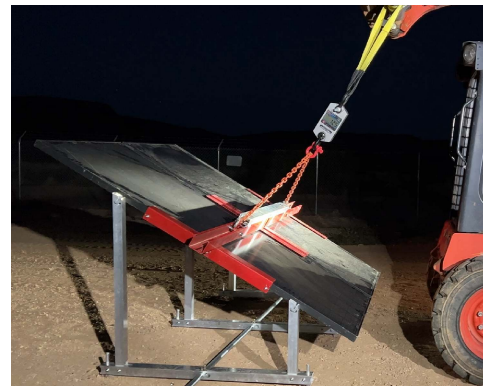
PHOTO 6: Test setup - IR-30 Solar Racking System with AnchorSpikes

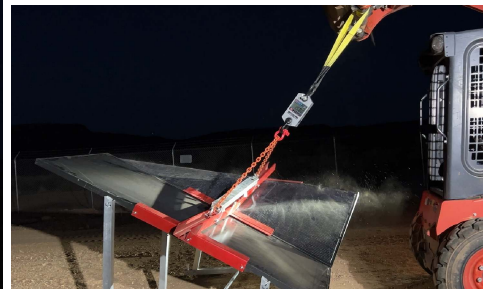
PHOTO 9: IR-30 Solar Racking System right after max load when panel failed

SIMULATED WIND LOAD (TENSILE UPLIFT) FORCE INSPECTION DETAILS		
TEST NO.	MAX. FORCE (lbf)	OBSERVATIONS
1	2385	At 1500 lbf the frame visibly shifted and started to roll forward. At 2385 lbf one of the solar panels failed and shattered (Photos 7-9). The frame and brackets holding the solar panel kept it in place and were permanently deformed. The aluminum tube upright had bent forward and outward causing the seam of the tube to tear and it allowed the through bolt to come free. Two mounting brackets permanently deformed and there was additional permanent deformation in the base frame (Photos 10-15)

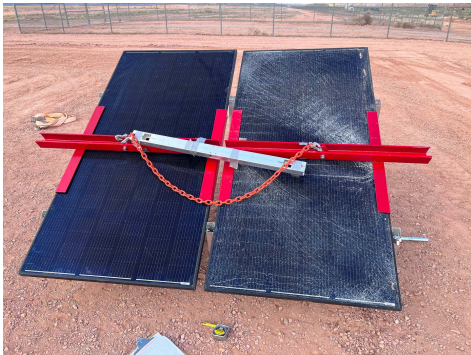
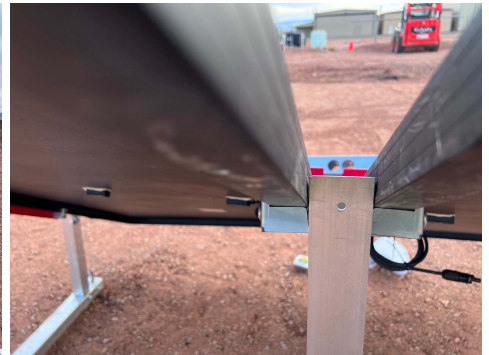
PHOTO 10: Solar panels after testing

PHOTO 11: Frame after testing

PHOTO 12: Middle brackets after testing

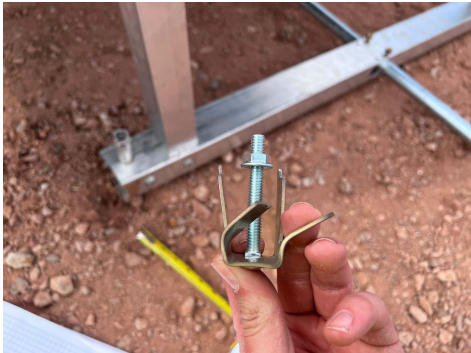
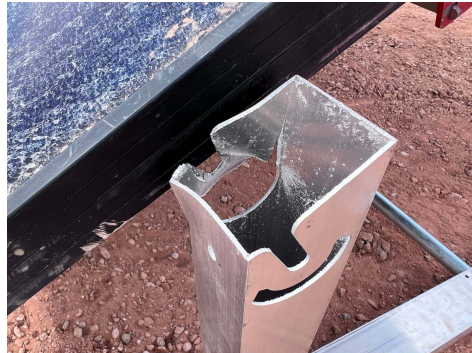
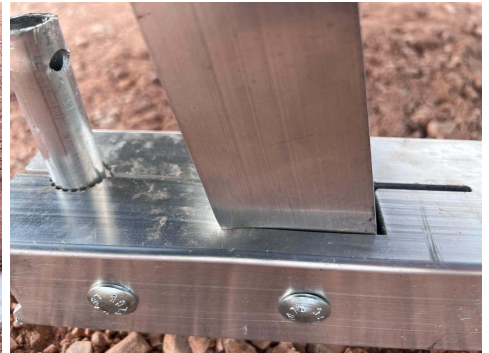
PHOTO 13: Bracket deformation after testing

PHOTO 14: Upright mount deformation after testing

PHOTO 15: Upright deformation after testing

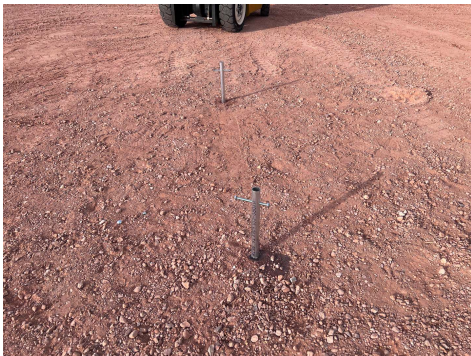
PHOTO 4: Anchor before test

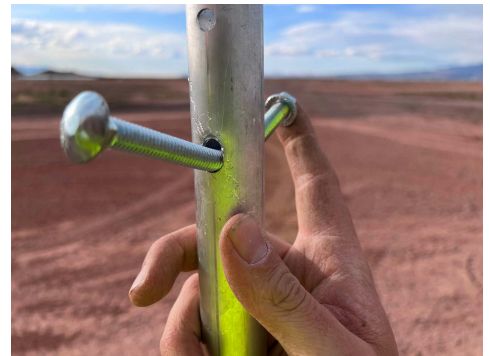
PHOTO 6: First anchor pullout with drilled thru hole deformed

TENSILE UPLIFT FORCE INSPECTION DETAILS					
NO.	MAX FORCE REACHED (lbf)	OBSERVATIONS			
1	1,950	Anchor pulled out of the ground (See Photos 2, 4-6)			
2a	2,990	The bolt installed through the anchor for the purpose of the test bent and the load strap slipped off the anchor (See Photos 3, 7). The drilled thru hole had elongated.			
2b	790	The load strap was reattached and test load was applied to the same anchor tested in test 2a. The drilled thru hole failed under load (Photo 8).

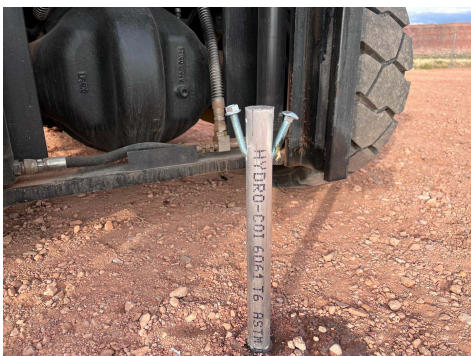
PHOTO 7: Second anchor - first pull where the thru bolt bent and load strap slipped off

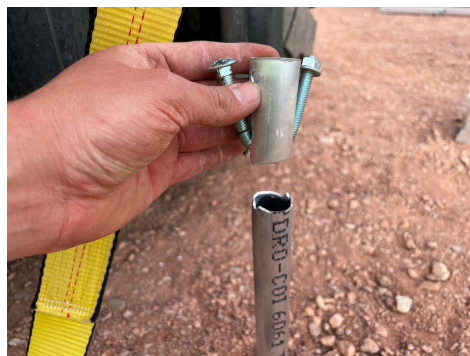
PHOTO 8: Second anchor - second test where anchor failed at drilled thru hole
