PROJECT			
	<b>IntegraRack</b>			
	TITLE			
	<b>IR-15 Solar Racking System Data Sheet</b>			
IR-15RF1015				
APPROVED Paul Budge 7/22/2024	SIZE	CODE	DWG NO	REV
CHECKED Paul Budge 7/22/2024	B		0722-010	
DRAWN Jeff Glauser 7/22/2024	SCALE 1:20	WEIGHT 10lbs per frame	SHEET 1/4

Subject: Witness of Wind Tunnel Testing on IntegraRack Products at the George E Boeing Aeronautics Department (Kirsten Wind Tunnel) at the University of Washington

**Subject:** Simulated Wind Load, Snow Load, and Horizontal Racking Load Testing on IR-30 Solar Racking System.

# INSPECTION AND TEST REPORT

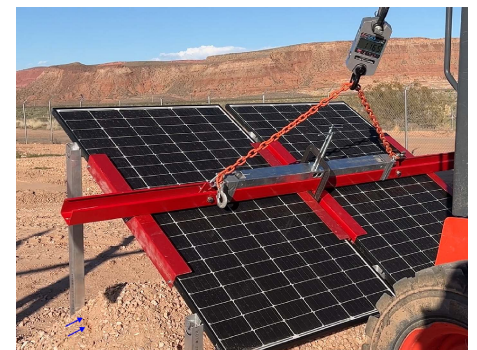
PHOTO 9: Test 2 - Evidence of ballast shift

SYSTEM COMPONENT 4:	IR-30 Base Tube		PART NO. 4:	IRP-30BT1000-T	
SYSTEM COMPONENT 5:	Connecting Rod		PART NO. 5:	None - 1" EMT pipe	
SIMULATED WIND LOAD (TENSILE UPLIFT FORCE) TEST PROCEDURE/DESCRIPTION					
<p>The IR-30 Solar Racking System Ground Frame was installed with two solar panels and the IR EarthBallast System. The system utilizes a mesh that is epoxied to the frame which is then loaded with dirt (ballast) that supports and holds down the frame (Photo 3). The system was tested with 2 Kubota SSV75 skid steer loads of dirt loaded for Test 1 and 3 loads for Test 2. Load was applied via a red crossbar that was fastened to the edges of the solar panel frames that was connected to the ground frame via the IRF2 Under Mount Flange Clamp Bracket. The skid steer dirt loads were estimated at approximately 500 lbf each using an estimated 100 lb/ft<sup>3</sup> for the density of the soil. The actual density of the soil is unknown.</p> <p>The solar panels were set at an approximate 30° angle. The tensile force was applied upwards and away, at a perpendicular angle from the solar panels using the skid steer (Photo 4). Load was monitored with the digital dynamometer. Load was recorded when an initial shift of the solar panel frame was noted and when the shift was large enough to cause visual changes to the frame and in the ballast surface (Photos 5-13).</p>

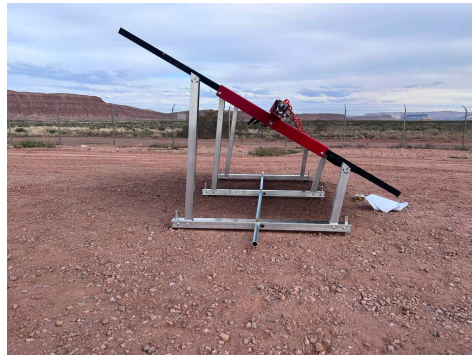
PHOTO 10: Solar panels after testing

PHOTO 11: Frame after testing

PHOTO 12: Middle brackets after testing

SIMULATED WIND LOAD (TENSILE UPLIFT) FORCE INSPECTION DETAILS		
TEST NO.	MAX. FORCE (lbf)	OBSERVATIONS
1	2385	At 1500 lbf the frame visibly shifted and started to roll forward.  At 2385 lbf one of the solar panels failed and shattered (Photos 7-9). The frame and brackets holding the solar panel kept it in place and were permanently deformed. The aluminum tube upright had bent forward and outward causing the seam of the tube to tear and it allowed the through bolt to come free. Two mounting brackets permanently deformed and there was additional permanent deformation in the base frame (Photos 10-15)
