PROJECT			
	IntegraRack			
	TITLE			
	IR-30 Solar Racking System Data Sheet			
IR-30RF1030				
APPROVED Paul Budge 3/29/2024	SIZE	CODE	DWG NO	REV
CHECKED Paul Budge 3/29/2024	B		1010	
DRAWN Jeff Glauser 3/29/2024	SCALE 1:25	WEIGHT 10lbs/frame section	SHEET 1/3

IR-30 Solar Racking System		
	Module size up to 24 sqft	Module size up to 34 sqft
Maximum Snow Load		
	100psf	65psf
Maximum Wind Speed		
Base Frame Ballasted	80mph	70mph
IR EarthBallast™	120mph	100mph
IR AnchorSpike™/ EarthScrew™	120mph	100mph
Base Frame Bolted	150mph	120mph

Subject: Witness of Wind Tunnel Testing on IntegraRack Products at the George E Boeing Aeronautics Department (Kirsten Wind Tunnel) at the University of Washington

Subject: Simulated Wind Load, Snow Load, and Horizontal Racking Load Testing on IR-30 Solar Racking System.

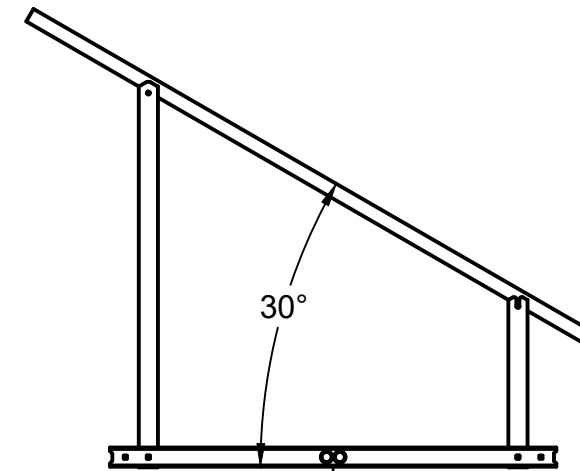
REQUIRED SPACING BETWEEN ROWS

30 degrees

13 feet 6 inches / 4.1 meters
ON CENTER

13 feet 6 inches
4.1 meters

Row spacing provided is a general guideline only. Please check sun angles in your local region.

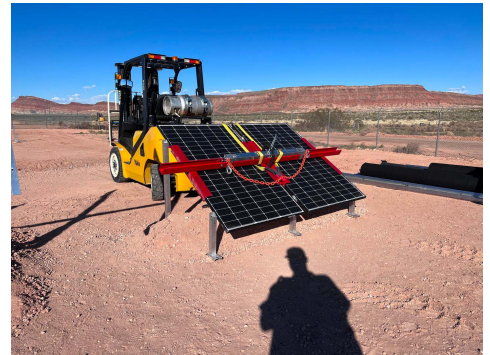
PHOTO 3: Test setup - IR-30 Solar Racking System with red test cross frame

The first simulated wind load test was performed on the IR-30 Solar Racking System Ground Frame that had two solar panels installed at a 30 ° angle and utilized the EarthBallast System. The load was applied via a crossbar connected to the solar panels which were then connected to the ground frame using the IR-F2 Under Mount Flange Clamp Bracket. The test was performed in two parts with the first part used ballast of two loose fill dirt loads from a skid steer, approximately 11 ft³ total volume, and then the second part used a total of three loads for a total volume of approximately 14 ft³. The IR-30 Solar Racking system was monitored for movement as the simulated wind load tensile force was applied. Test loads were measured using a calibrated Dyna-Link 2 Dynamometer (SN 100326, Cal. Date 10/13/2023). Test run details are shown in the table below.

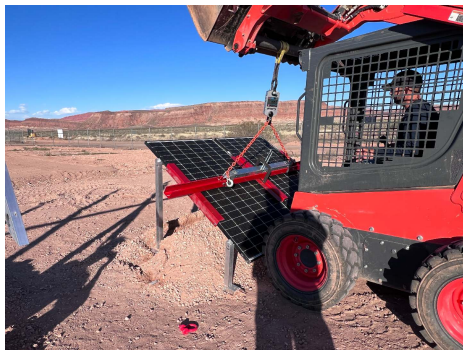
PHOTO 4: Test setup with dynamometer and chains connected

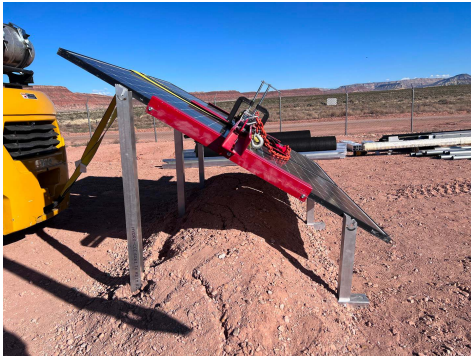
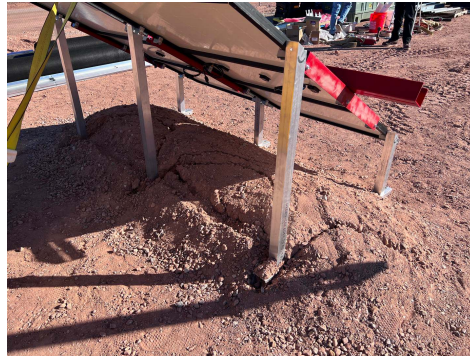
PHOTO 13: Ballast after completion of testing

PHOTO 14: Ballast and frame after completion of testing

PHOTO 13: IR-F2 Clamp bracket after completion of testing

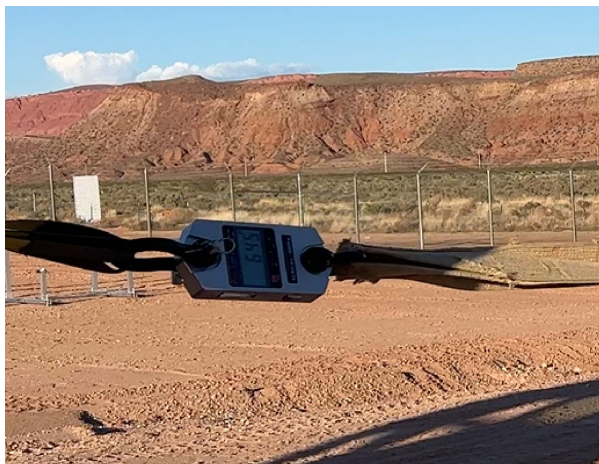
PHOTO 1: Horizontal force test setup

PHOTO 2: Horizontal force test setup

PHOTO 3: Horizontal force test setup

Photo 4: Horizontal force test at max load

Photo 4: Horizontal force test max load

The IR-30 Solar Racking System Ground Frame was installed with the IR EarthBallast System and two solar panels. The EarthBallast system utilizes a mesh that is epoxied to the frame which is then loaded with loose dirt fill (ballast) that supports and holds down the frame. The horizontal load test was performed after the vertical uplift tensile load test. The system was tested with 3 loads of dirt from a Kubota SSV75 skid steer. The skid steer dirt loads were estimated at ~ 500 lbf each using an estimate of 100 lb/ft³ for the density of soil. A lifting strap was wrapped around the panel lengthwise and run parallel to the frame in order to apply a horizontal force to the system (Photos). Force was applied using the skid steer and load was monitored with the digital dynamometer. The test was stopped at a load of 645 lbf. No movement or damage was visually noted during or after the test.

TEST NO.	BALLAST DETAILS		MAX. HORIZONTAL FORCE (lbf)	OBSERVATIONS
	SIZE (LxWxH) (in.)	WEIGHT (lbf)		
1	90 in. x 42 in. x 14 in. (14 CF)	~ 1400 lbf (3 skid steer buckets)	645	Test was stopped at 645 lbf. No damage or movement was visually noted.

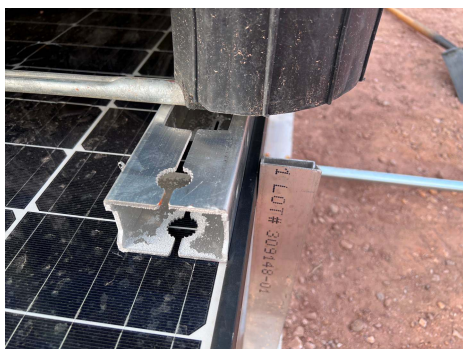
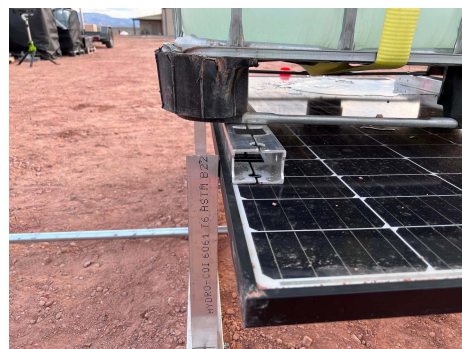
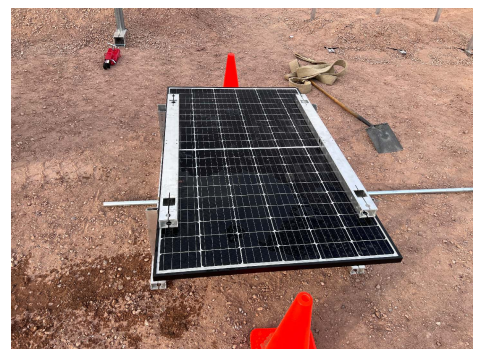
PHOTO 7: Slight deflections noted under load

PHOTO 8: Slight deflection noted under load

PHOTO 9: IR-30 system after compressive load tests

SIMULATED SNOW LOAD (COMPRESSIVE LOAD) INSPECTION DETAILS			
	COMPRESSIVE FORCE		OBSERVATIONS
	DESCRIPTION	WEIGHT (lbf)	
1	Large water tank	2410	Solar panel held load overnight (> 10 h).
2	Large water tank + (12) five gallon jugs	2950	Solar panel held load, ~ 10 -15 minutes under observation. Slight deflections noted under load (See Photos). Minor permanent deformation noted after load removal (See Photos). The alignment tabs in the vertical uprights were no longer flat with the uprights.

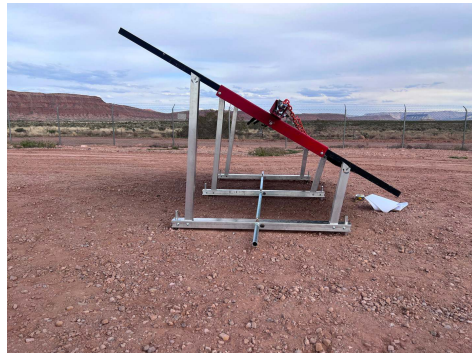
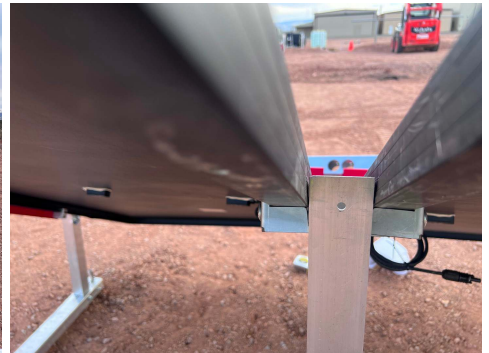
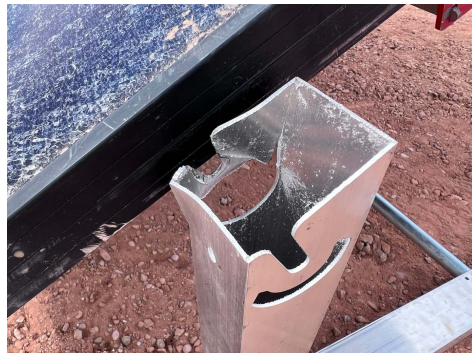
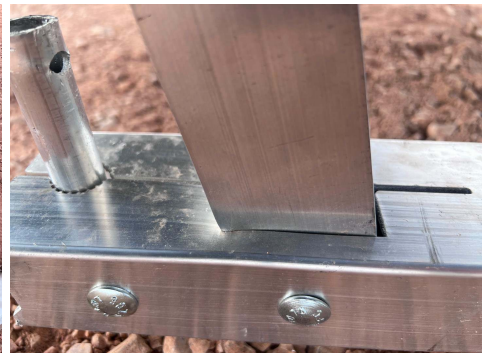
PHOTO 10: Solar panels after testing

PHOTO 11: Frame after testing

PHOTO 12: Middle brackets after testing

PHOTO 13: Bracket deformation after testing

PHOTO 14: Upright mount deformation after testing

PHOTO 15: Upright deformation after testing

SIMULATED WIND LOAD (TENSILE UPLIFT) FORCE INSPECTION DETAILS		
TEST NO.	MAX. FORCE (lbf)	OBSERVATIONS
1	2385	At 1500 lbf the frame visibly shifted and started to roll forward. At 2385 lbf one of the solar panels failed and shattered (Photos 7-9). The frame and brackets holding the solar panel kept it in place and were permanently deformed. The aluminum tube upright had bent forward and outward causing the seam of the tube to tear and it allowed the through bolt to come free. Two mounting brackets permanently deformed and there was additional permanent deformation in the base frame (Photos 10-15)

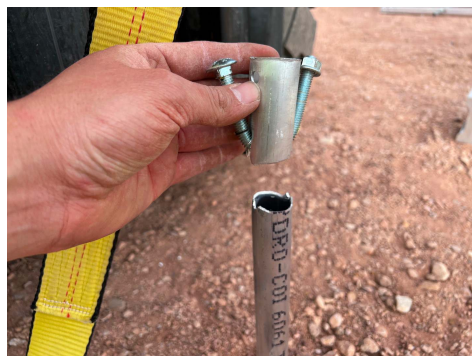
PHOTO 4: Anchor before test

PHOTO 6: First anchor pullout with drilled thru hole deformed

PHOTO 7: Second anchor - first pull where the thru bolt bent and load strap slipped off

PHOTO 8: Second anchor - second test where anchor failed at drilled thru hole

LARGE EPOXY EARTH ANCHOR TENSILE UPLIFT FORCE INSPECTION DETAILS		
NO.	MAX FORCE REACHED (lbf)	OBSERVATIONS
1	1,950	Anchor pulled out of the ground (See Photos 2, 4-6)
2a	2,990	The bolt installed through the anchor for the purpose of the test bent and the load strap slipped off the anchor (See Photos 3, 7). The drilled thru hole had elongated.
2b	790	The load strap was reattached and test load was applied to the same anchor tested in test 2a. The drilled thru hole failed under load (Photo 8).

TENSILE UPLIFT FORCE INSPECTION DETAILS					
NO.	MAX FORCE REACHED (lbf)	OBSERVATIONS			
1	1,950	Anchor pulled out of the ground (See Photos 2, 4-6)			
2a	2,990	The bolt installed through the anchor for the purpose of the test bent and the load strap slipped off the anchor (See Photos 3, 7). The drilled thru hole had elongated.			
2b	790	The load strap was reattached and test load was applied to the same anchor tested in test 2a. The drilled thru hole failed under load (Photo 8).
