| | TITLE<br>IR-30 BallastRack™ System Data Sheet<br>IR-30RF1030 | | | | |

Subject: Lateral Load Mechanical Stress Test on IR-EW15 BallastRack (6061 T6 Aluminum) Solar Module Racking System with IR EarthScrews

# LABORATORY TEST REPORT

Subject: Witness of Wind Tunnel Testing on IntegraRack Products at the George E Boeing Aeronautics Department (Kirsten Wind Tunnel) at the University of Washington

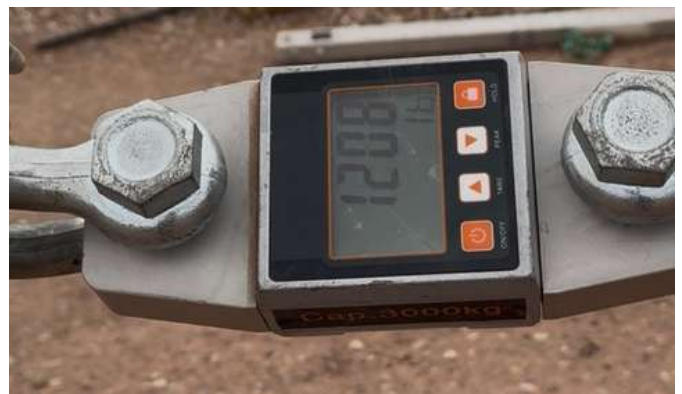
This simulated wind load test was performed on the IR-EW15 BallastRack system with two solar panels installed at a 15° sun angle and utilized the EarthScrew mounting system. The load was applied via a crossbar connected to the solar panels which were then connected to the ground frame using the IR-F2 Undermount Flange Clamp Bonding Bracket. The test was performed with the EarthScrews being anchored into pre-drilled holes that were filled with mixed Portland Cement Powder 24 hours prior to testing. The IR-EW15 BallastRack was monitored for movement and disfiguration as the simulated wind load tension force was applied. Test loads were measured using a calibrated dynamometer. Test results are listed below.

Test: Lateral load test to 1,200 lbs

Result: No visible sign of permanent deformation

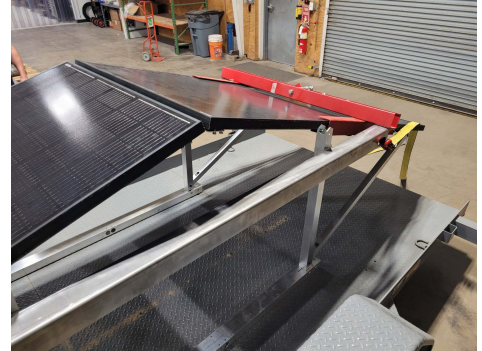
**Photo 3:** IR-EW15 BallastRack with 2 solar panels installed and load application frames (red)

The Integra-Rack East-West 15 BallastRack system (IR-EW15) was bolted down to a flat trailer bed. Two 41 in. solar panels were installed into the frame using two IR-F2 clamps on each side of the solar panel. Red load application frames were installed on each solar panels using three IR-F2 clamps on each side of the panels (Photos 1-11).

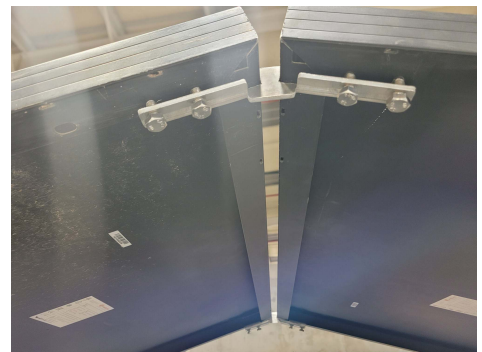
**Photo 6:** Brackets below solar panel at top point of the IR-EW15 frame

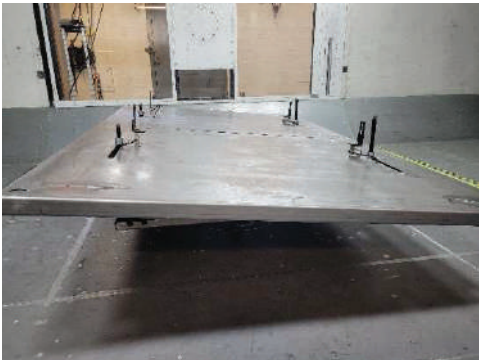
Figure 1: Run 1 through 3 simulated roof setup

A total of 8 runs were performed on IntegraRack products. Test Runs 1 through 3 were performed with the IR-D1 bracket (See Figures 1-4) with an installed 18 SF solar panel on a simulated roof incline. Run 1 was performed to tare KWT's system through the full 0 to 110 degree rotation of the test platform with the simulated roof and panel installed. The roof surface had been installed at an approximate 5 – 6 degree incline (See Figure 1). The solar panel was mounted at 0 degrees relative to the roof surface with a general height of 5 in from the roof surface. at all four corners of the panel. Test Runs 4 and 5 were performed on the same panel and bracket with the panel height adjusted and installed at an angle with the front corners set to 3-1/2 in. and the back corners set to a height of 6 in. from the roof surface.

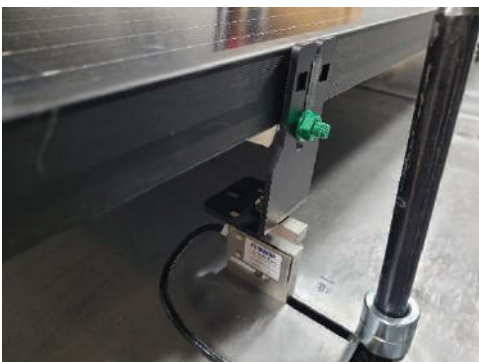
Figure 7: LC0-1 Location

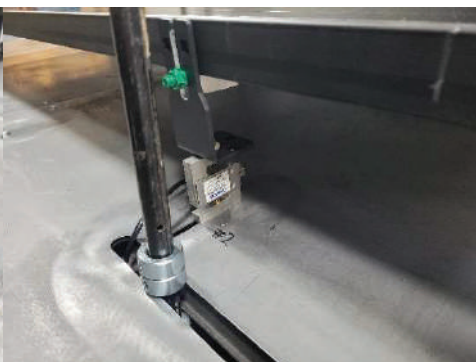
Figure 8: LC0-2 Location

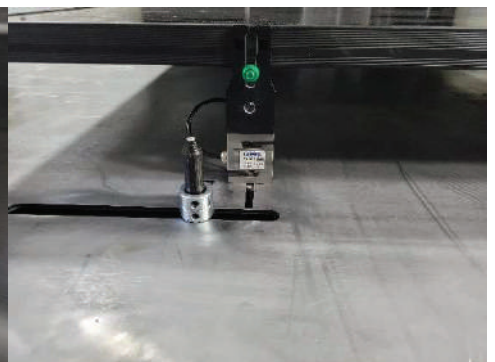
Figure 9: LC5-3 Location

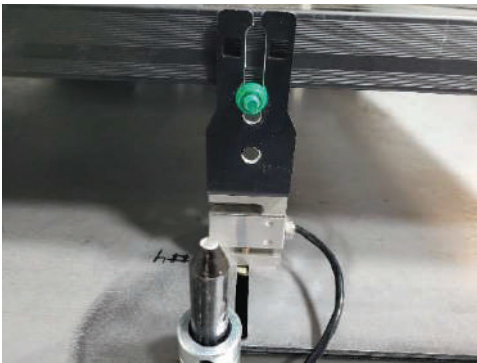
Figure 10: LC5-4 Location

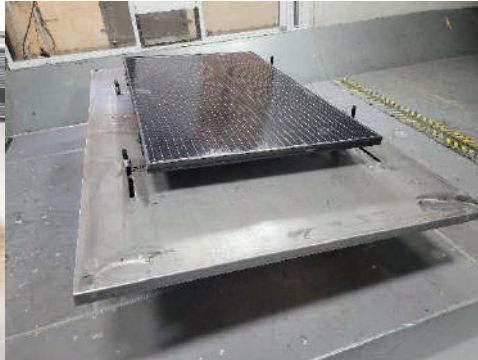
Figure 11: Setup after Run 2, 109 mph winds.  
No damages or loose hardware noted.

to any bracket during or after the test runs and all hardware was found to be secure upon completion of each test (See Figures 11-13).

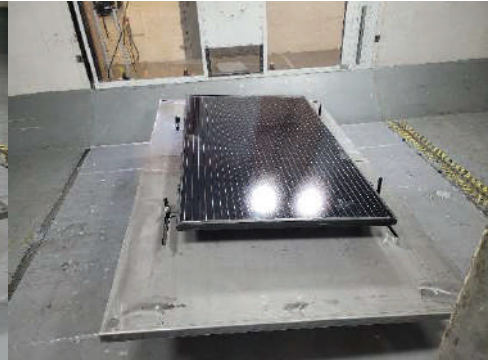
Figure 12: Setup after Run 2, 109 mph winds.  
No damages or loose hardware noted

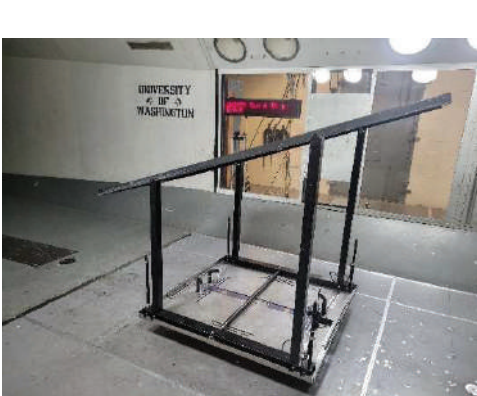
Figure 16: Test setup for Run 6

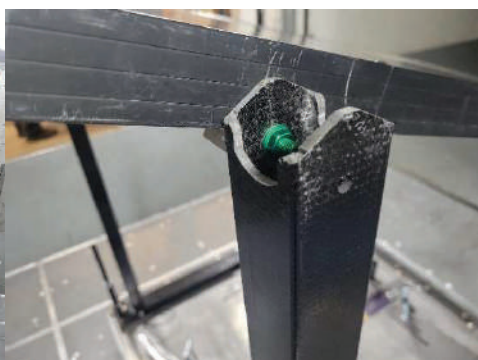
Figure 17: IR Ballast frame connection to solar  
panel

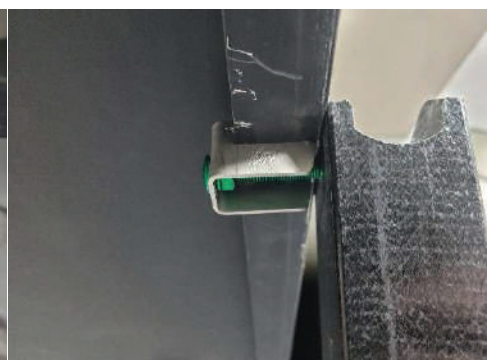
Figure 18: IR Ballast frame connection to solar  
panel

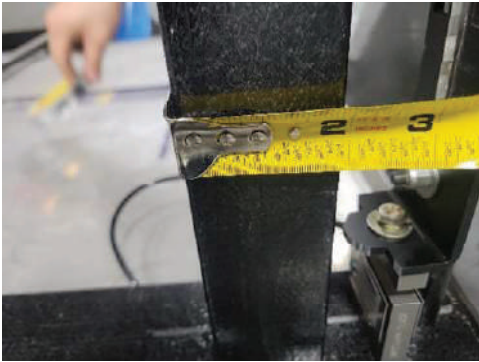
Figure 28: IR Ballast rack leg width 1

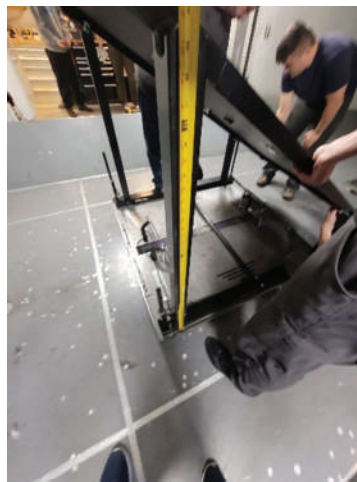
Figure 32: Run 7 Leading edge leg height

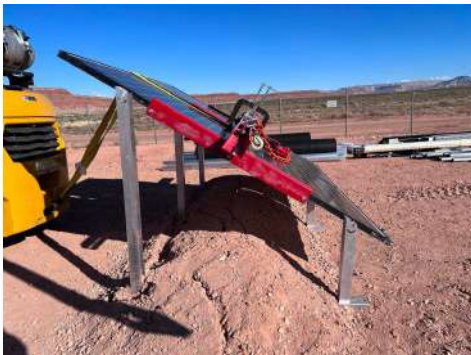
PHOTO 13: Ballast after completion of testing

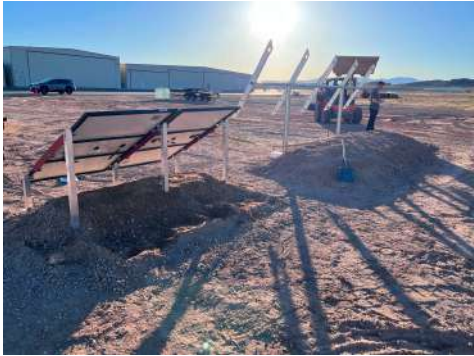
PHOTO 1: Horizontal force test setup

PHOTO 2: Horizontal force test setup

PHOTO 3: Horizontal force test setup

The horizontal racking load test was performed on the same IR-30 Solar Racking System Ground Frame that had two solar panels installed at a 30 ° angle and utilized the EarthBallast System and three loads of loose fill dirt ballast. A lifting strap was used to wrap around the panel and run parallel to the frame in order to apply the horizontal racking force. The system was monitored for movement as the simulated load was applied and the maximum load was recorded. The system held the load and no damage or permanent deformation was noted as detailed in the test observations table below.

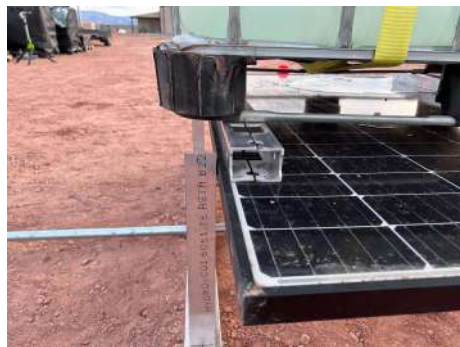
PHOTO 8: Slight deflection noted under load

| SIMULATED SNOW LOAD (COMPRESSIVE LOAD) INSPECTION DETAILS | | | |
|---|---|---|---|
| 2 | Large water tank + (12) five gallon jugs | 2950 | Solar panel held load, ~ 10 -15 minutes under observation. Slight deflections noted under load (See Photos). Minor permanent deformation noted after load removal (See Photos). The alignment tabs in the vertical uprights were no longer flat with the uprights. |

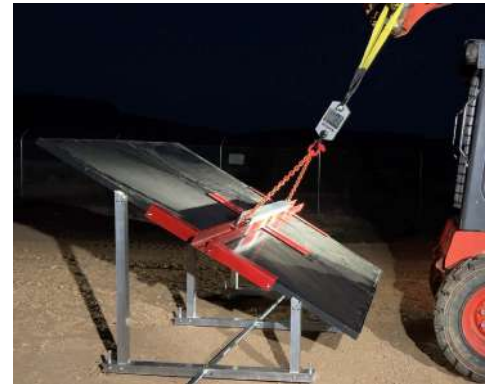
PHOTO 6: Test setup - IR-30 Solar Racking System with AnchorSpikes

The final simulated wind load test was performed on the IR-30 Solar Racking System Ground Frame that had two solar panels installed at a 30 ° angle and utilized the small IR AnchorSpikes and no earth ballast. The load was applied via a crossbar connected to the solar panels which were then connected to the ground frame using the IR-F2 Under Mount Flange Clamp Bracket. The load was applied until failure of a solar panel at 2385 lbf. Visual observations noted that the frame had visibly moved and shifted forward initially at 1500 lbf but continued to hold load as detailed in the table below.

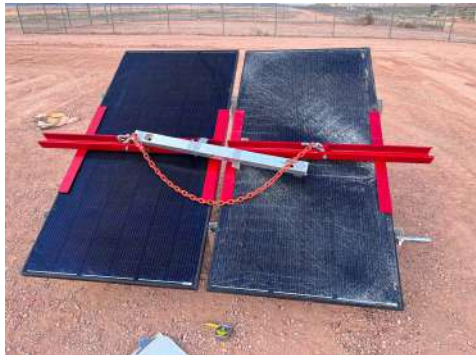
PHOTO 10: Solar panels after testing

| SIMULATED WIND LOAD (TENSILE UPLIFT) FORCE INSPECTION DETAILS | | |
|---|---|---|
| 1 | 2385 | At 1500 lbf the frame visibly shifted and started to roll forward.<br><br>At 2385 lbf one of the solar panels failed and shattered (Photos 7-9). The frame and brackets holding the solar panel kept it in place and were permanently deformed. The aluminum tube upright had bent forward and outward causing the seam of the tube to tear and it allowed the through bolt to come free. Two mounting brackets permanently deformed and there was additional permanent deformation in the base frame (Photos 10-15) |

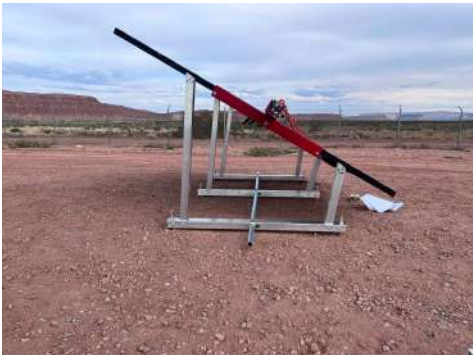
PHOTO 11: Frame after testing

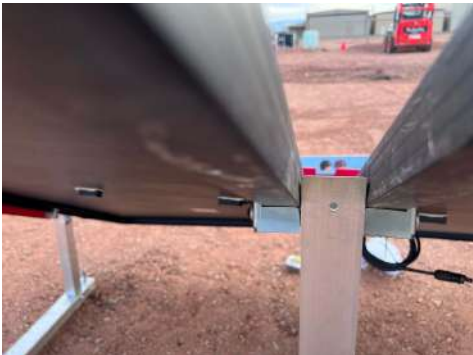
PHOTO 12: Middle brackets after testing

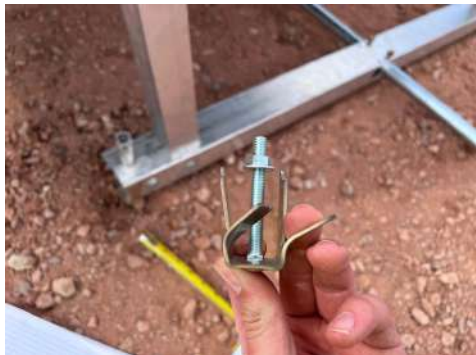
PHOTO 13: Bracket deformation after testing

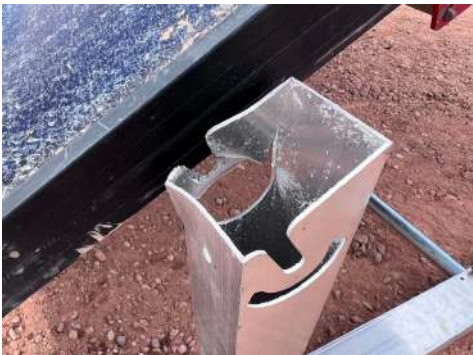
PHOTO 14: Upright mount deformation after testing

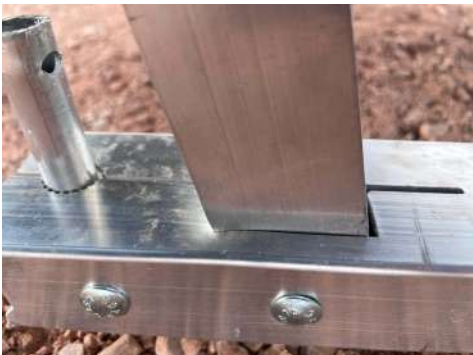
PHOTO 15: Upright deformation after testing
