PROJECT			
	IntegraRack			
	TITLE			
	IR-15 Solar Racking System			
	Data Sheet			
IR-15RF1015				
APPROVED Paul Budge 7/22/2024	SIZE	CODE	DWG NO	REV
CHECKED Paul Budge 7/22/2024	B		0722-010	
DRAWN Jeff Glauser 7/22/2024	SCALE 1:20	WEIGHT 10lbs per frame	SHEET 1/4

Subject: Witness of Wind Tunnel Testing on IntegraRack Products at the George E Boeing Aeronautics Department (Kirsten Wind Tunnel) at the University of Washington

Subject: Simulated Wind Load, Snow Load, and Horizontal Racking Load Testing on IR-30 Solar Racking System.

# INSPECTION AND TEST REPORT

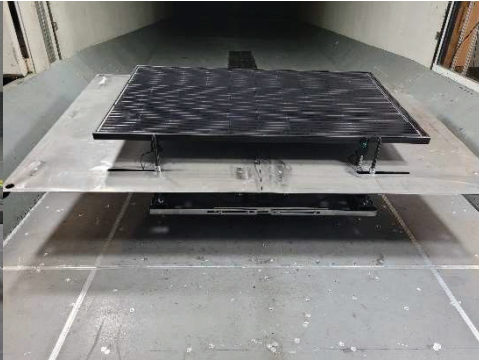
Figure 2: Run 1 through 3 setup with panel

A total of 8 runs were performed on IntegraRack products. Test Runs 1 through 3 were performed with the IR-D1 bracket (See Figures 1-4) with an installed 18 SF solar panel on a simulated roof incline. Run 1 was performed to tare KWT's system through the full 0 to 110 degree rotation of the test platform with the simulated roof and panel installed. The roof surface had been installed at an approximate 5 – 6 degree incline (See Figure 1). The solar panel was mounted at 0 degrees relative to the roof surface with a general height of 5 in from the roof surface. at all four corners of the panel. Test Runs 4 and 5 were performed on the same panel and bracket with the panel height adjusted and installed at an angle with the front corners set to 3-1/2 in. and the back corners set to a height of 6 in. from the roof surface.

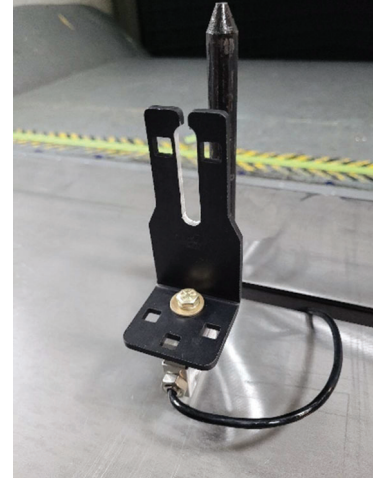
Figure 3: Bracket at leading edge LC0-1, LC0-2

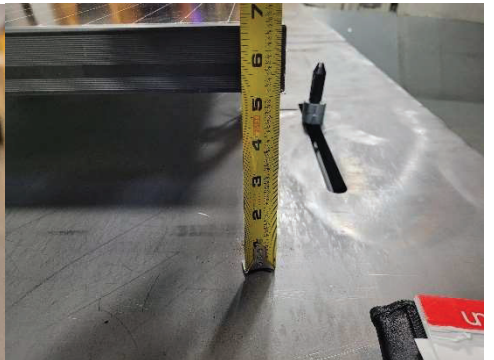
Figure 6: Height from roof to panel, Runs 2 & 3

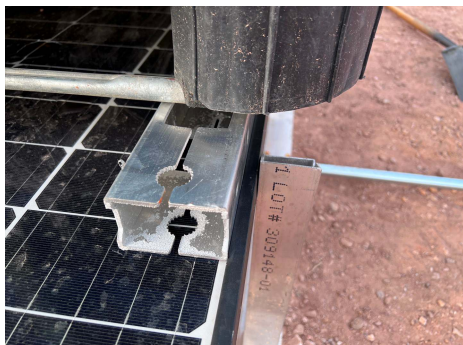
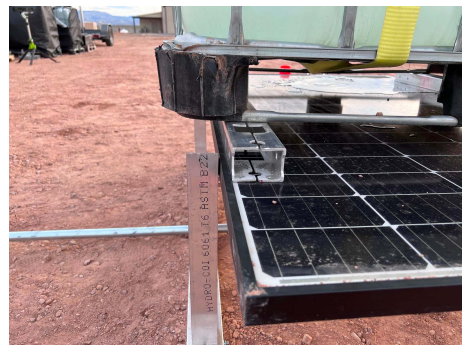
PHOTO 7: Slight deflections noted under load

PHOTO 8: Slight deflection noted under load

SIMULATED SNOW LOAD (COMPRESSIVE LOAD) INSPECTION DETAILS				
	COMPRESSIVE FORCE		OBSERVATIONS	
	DESCRIPTION	WEIGHT (lbf)		
1	Large water tank	2410	Solar panel held load overnight (> 10 h).	
2	Large water tank + (12) five gallon jugs	2950	Solar panel held load, ~ 10 -15 minutes under observation. Slight deflections noted under load (See Photos). Minor permanent deformation noted after load removal (See Photos). The alignment tabs in the vertical uprights were no longer flat with the uprights.

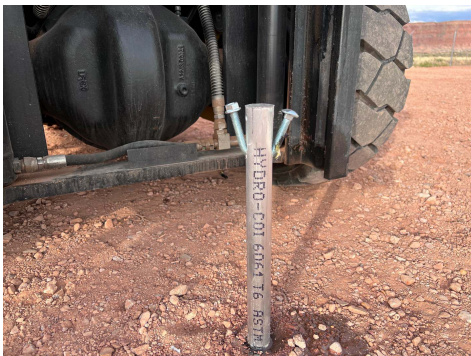
PHOTO 7: Second anchor - first pull where the thru bolt bent and load strap slipped off

TENSILE UPLIFT FORCE INSPECTION DETAILS					
NO.	MAX FORCE REACHED (lbf)	OBSERVATIONS			
1	1,950	Anchor pulled out of the ground (See Photos 2, 4-6)			
2a	2,990	The bolt installed through the anchor for the purpose of the test bent and the load strap slipped off the anchor (See Photos 3, 7). The drilled thru hole had elongated.			
2b	790	The load strap was reattached and test load was applied to the same anchor tested in test 2a. The drilled thru hole failed under load (Photo 8).
