| | | IntegraRack | | | |
| | | IR-40FSAA / FSAB / FSAC Solar Racking System Data Sheet | | | |

Subject: Lateral Load Mechanical Stress Test on IR-EW15 BallastRack (6061 T6 Aluminum) Solar Module Racking System with IR EarthScrews

Subject: Witness of Wind Tunnel Testing on IntegraRack Products at the George E Boeing Aeronautics Department (Kirsten Wind Tunnel) at the University of Washington

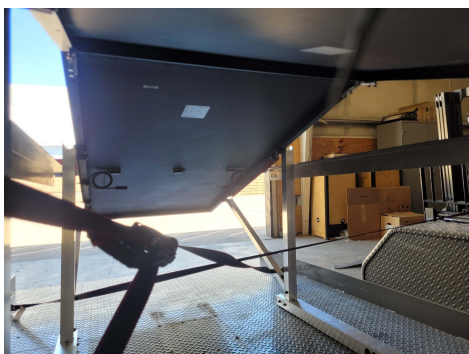
**Photo 15:** Underside solar panel at top ridgeline after 1500 lbf test load. Solar panel has started deforming at bolts and lifting off the attachment

- **After a 1010 lbf test load there was no visual damage**, bending, or any other yielding or failure indications noted.
- **After a 1540 lbf test load the solar panel frame, not the IR-EW15, was permanently deformed.** There was no observed bending or yielding of the Integra-Rack EW15 frame.

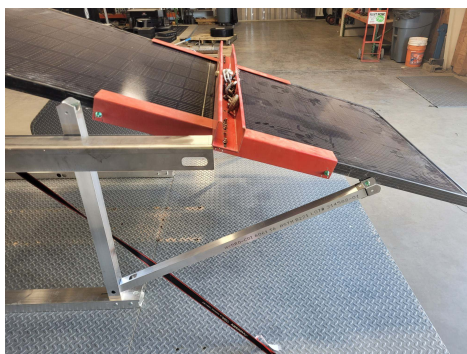
**Photo 16:** Underside of the rest of the solar panel and frame after 1500 lbf load. No other deformation observed.

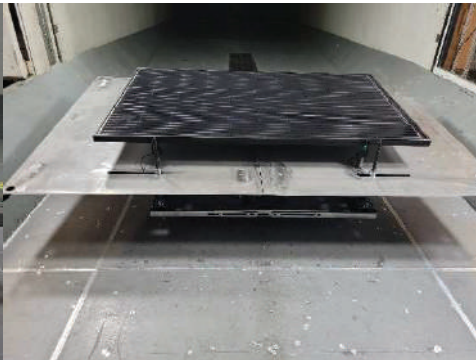
Figure 2: Run 1 through 3 setup with panel

A total of 8 runs were performed on IntegraRack products. Test Runs 1 through 3 were performed with the IR-D1 bracket (See Figures 1-4) with an installed 18 SF solar panel on a simulated roof incline. Run 1 was performed to tare KWT's system through the full 0 to 110 degree rotation of the test platform with the simulated roof and panel installed. The roof surface had been installed at an approximate 5 – 6 degree incline (See Figure 1). The solar panel was mounted at 0 degrees relative to the roof surface with a general height of 5 in from the roof surface. at all four corners of the panel. Test Runs 4 and 5 were performed on the same panel and bracket with the panel height adjusted and installed at an angle with the front corners set to 3-1/2 in. and the back corners set to a height of 6 in. from the roof surface.

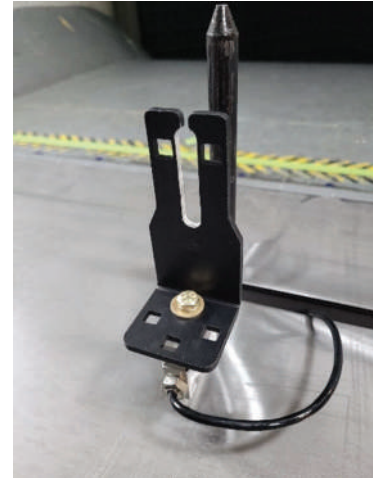
Figure 3: Bracket at leading edge LC0-1, LC0-2

Test Runs 2 through 5 included rotating the test setup from 0 to 110 degrees while KWT instrumentation recorded test data. Wind speed was increased until limitations of KWT instrumentation prevented it from being increased further. Four load cells, Omega model LC103B-250 lb Class N10, were installed between the IntegraRack bracket and the roof surface to monitor and record loads applied to the brackets throughout testing (See Figures 5-10). The load cells were labeled LC0-1, LC0-2, LC5-3, and LC5-4 with LC0 being installed at the leading edge and LC5 being installed at the back edge.

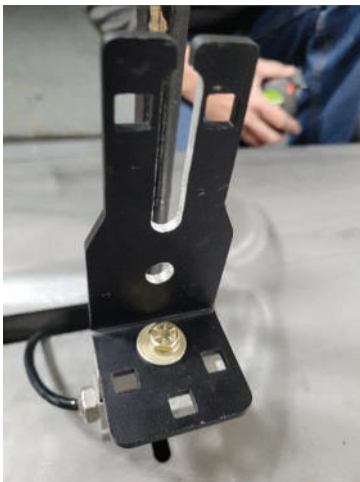
Figure 4: Bracket at back edge LC5-3, LC5-4

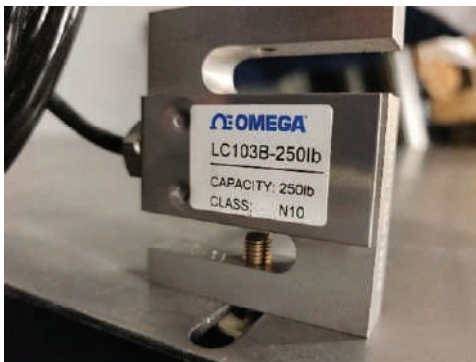
Figure 5: Load Cell Model used for tests

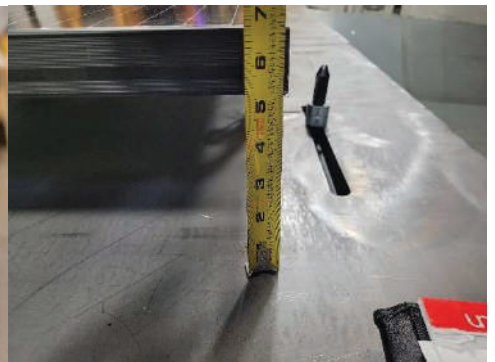
Figure 6: Height from roof to panel, Runs 2 & 3

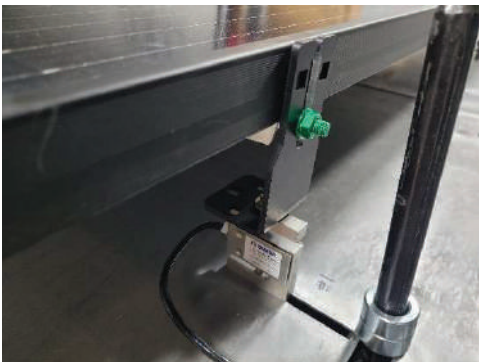
Figure 7: LC0-1 Location

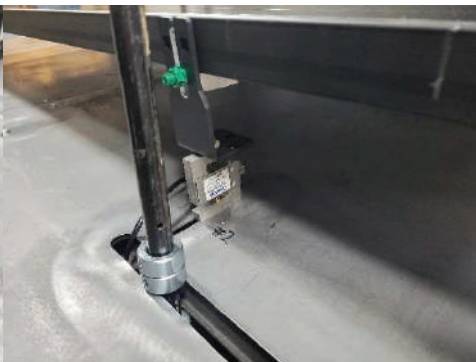
Figure 8: LC0-2 Location

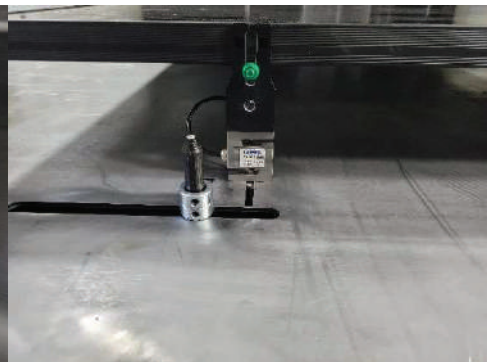
Figure 9: LC5-3 Location

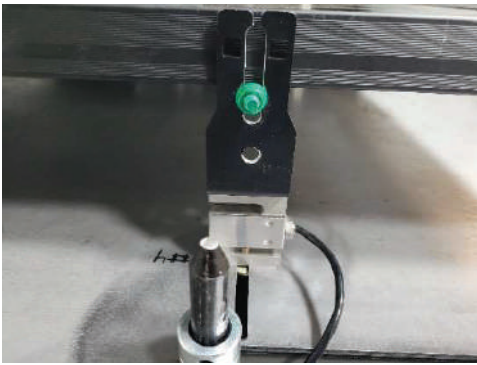
Figure 10: LC5-4 Location

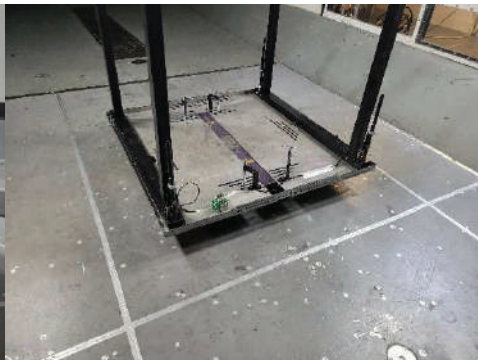
Figure 14: Setup for Run 6 with IR Ballast  
 Frame

Test Runs 6 through 8 were performed on the IR Ballast Racks (See Figures 14-32). The simulated roof structure was removed and the frames and panel were mounted directly to the KWT test platform. These runs were performed at a set angle with no platform rotation during the test run. Two load cells were used for the test setups and were mounted at the brackets at the leading edge of the test platform at the wind intake side.

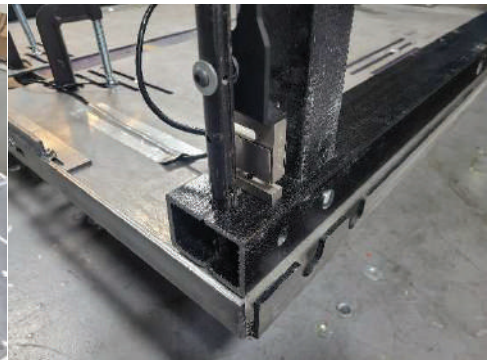
Figure 15: Load cell location at leading edge,  
 LC0-1 & LC0-2

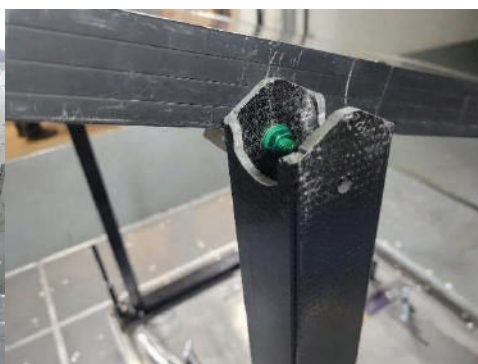
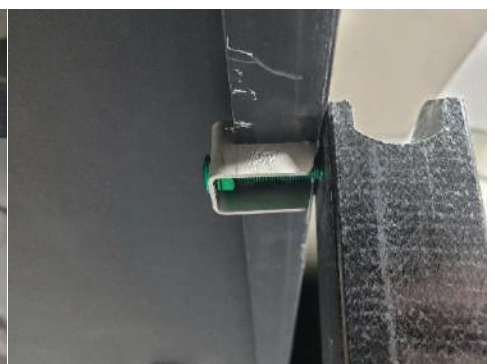
Figure 17: IR Ballast frame connection to solar  
 panel

Figure 18: IR Ballast frame connection to solar  
 panel

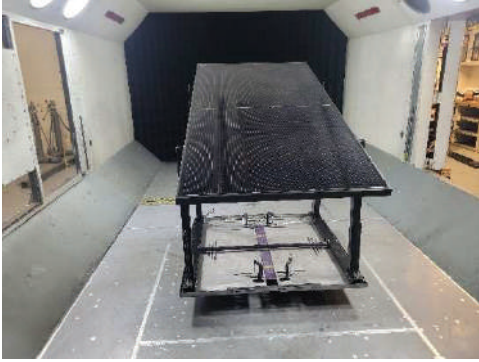
Figure 16: Test setup for Run 6

Figure 19: Test setup for Run 6

Run 6 was performed on the IR18C with the solar panel at an approximate 18 degree angle (Figures 24-25). The maximum load at a bracket recorded during Test Run 6 was 168.59 lbf at a wind speed of 101.59 MPH. Runs 7 and 8 were performed on the IR30C with the solar panel at a 30 degree angle (Figures 30-32) with Run 7 having the solar panel mounted and aligned with the wind direction to produce maximum forces on the frame and Run 8 being run in an orientation 90 degrees offset from Run 7. The maximum load at a bracket was during Test Run 7 and was 183.38 lbf at a wind speed of 81.138 MPH. Run 7 was stopped when the drag limit of the KWT test apparatus was reached. The solar frame experienced shaking under wind load but no damage was found to any part and all bolts were found to still be tight and in place after the test run. Run 8 was pitch limited by the KWT test apparatus. Similar to Run 7 the frame and solar panel had experienced shaking under load but no damage to the frame or panel was noted and all bolts and connections remained tight.

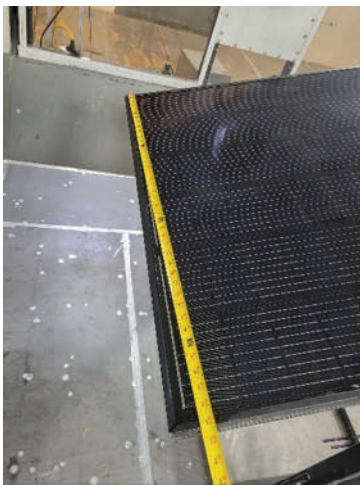
Figure 22: Solar panels width, Run 6 through 8

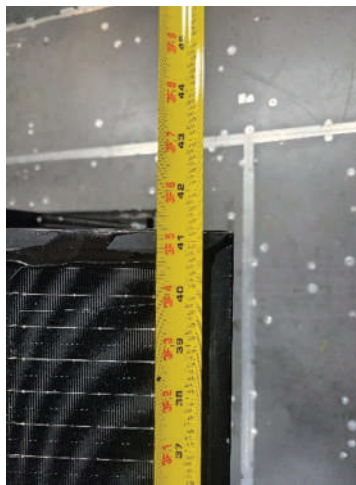
Figure 23: Total width 41-1/4 in.

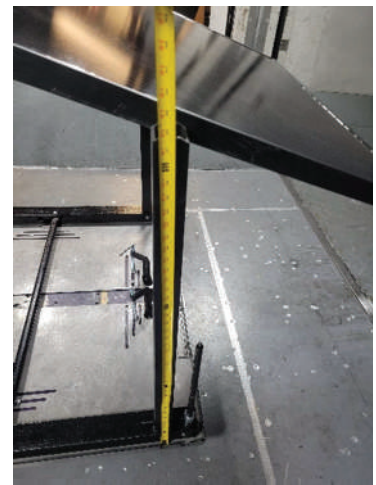
Figure 24: Run 6 trailing edge leg height

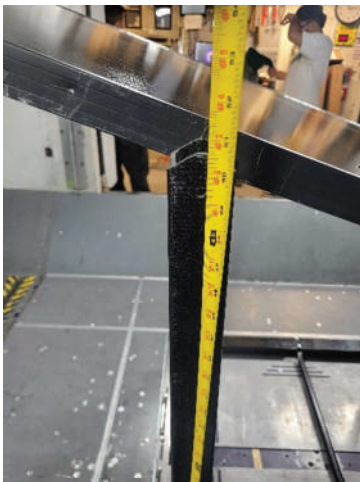
Figure 25: Run 6 leading edge leg height

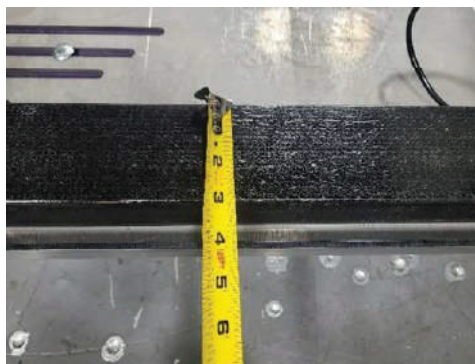
Figure 26: Frame base support width

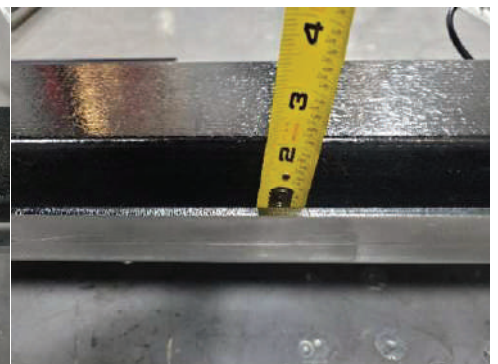
Figure 27: Frame base support height

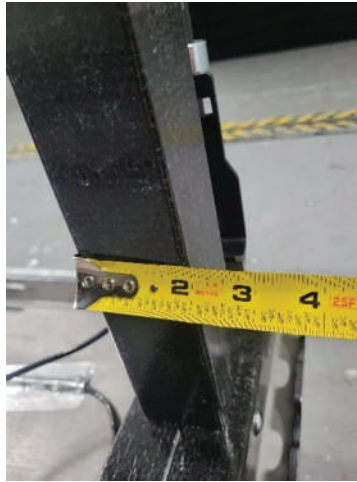
Figure 29: IR Ballast rack leg width 2

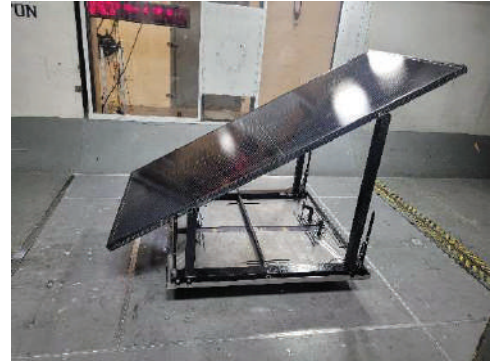
Figure 30: Runs 7 - 8 Test setup

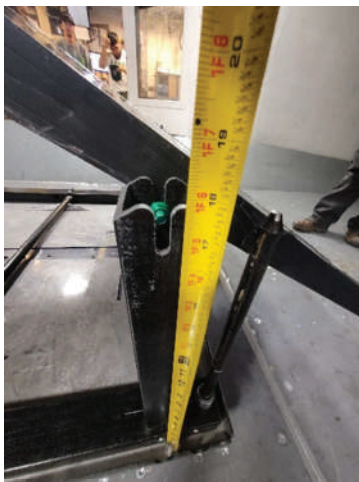
Figure 31: Run 7 trailing edge leg height

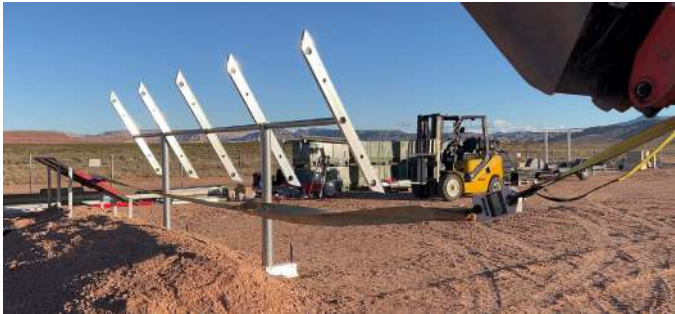
PHOTO 1: Horizontal force test setup

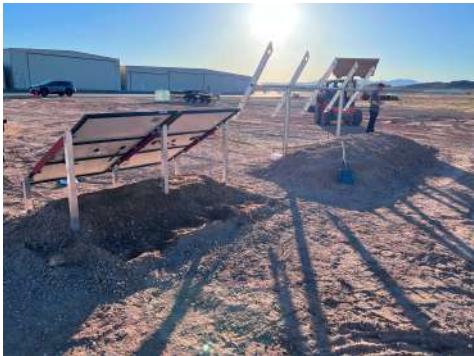
PHOTO 2: Horizontal force test setup

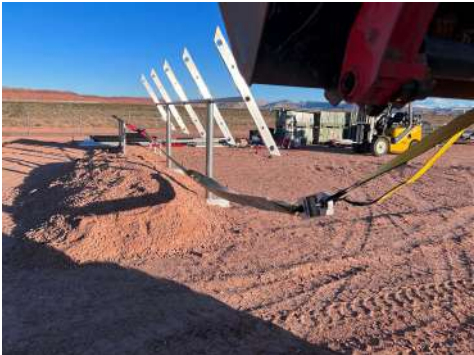
PHOTO 3: Horizontal force test setup

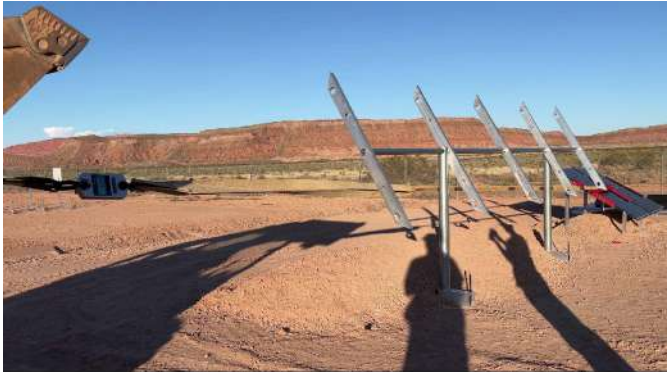
Photo 4: Horizontal force test at max load

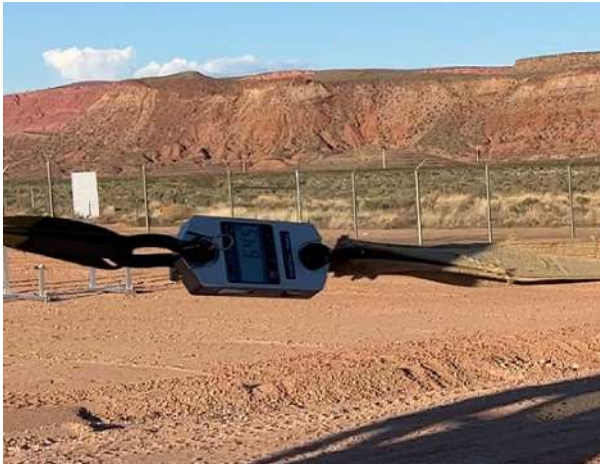
Photo 4: Horizontal force test max load

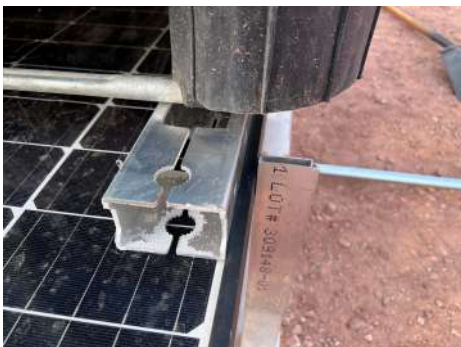
PHOTO 7: Slight deflections noted under load

| SIMULATED SNOW LOAD (COMPRESSIVE LOAD) INSPECTION DETAILS | | | |
|---|---|---|---|
| 2 | Large water tank + (12) five gallon jugs | 2950 | Solar panel held load, ~ 10 -15 minutes under observation. Slight deflections noted under load (See Photos). Minor permanent deformation noted after load removal (See Photos). The alignment tabs in the vertical uprights were no longer flat with the uprights. |

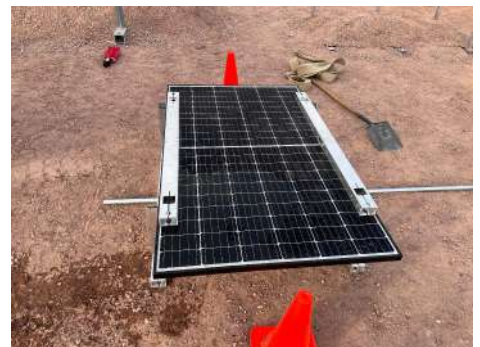
PHOTO 9: IR-30 system after compressive load tests

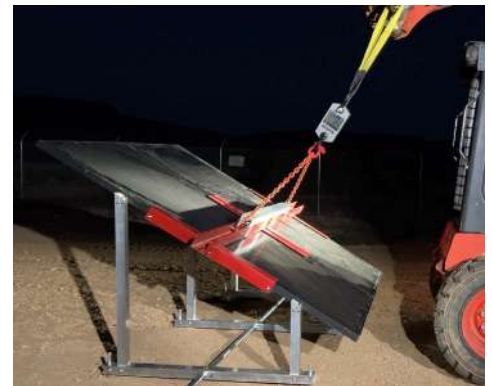
PHOTO 6: Test setup - IR-30 Solar Racking System with AnchorSpikes

The final simulated wind load test was performed on the IR-30 Solar Racking System Ground Frame that had two solar panels installed at a 30 ° angle and utilized the small IR AnchorSpikes and no earth ballast. The load was applied via a crossbar connected to the solar panels which were then connected to the ground frame using the IR-F2 Under Mount Flange Clamp Bracket. The load was applied until failure of a solar panel at 2385 lbf. Visual observations noted that the frame had visibly moved and shifted forward initially at 1500 lbf but continued to hold load as detailed in the table below.

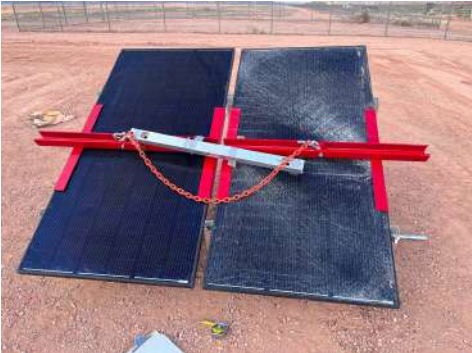
PHOTO 10: Solar panels after testing

| SIMULATED WIND LOAD (TENSILE UPLIFT) FORCE INSPECTION DETAILS | | |
|---|---|---|
| 1 | 2385 | At 1500 lbf the frame visibly shifted and started to roll forward.<br><br>At 2385 lbf one of the solar panels failed and shattered (Photos 7-9). The frame and brackets holding the solar panel kept it in place and were permanently deformed. The aluminum tube upright had bent forward and outward causing the seam of the tube to tear and it allowed the through bolt to come free. Two mounting brackets permanently deformed and there was additional permanent deformation in the base frame (Photos 10-15) |

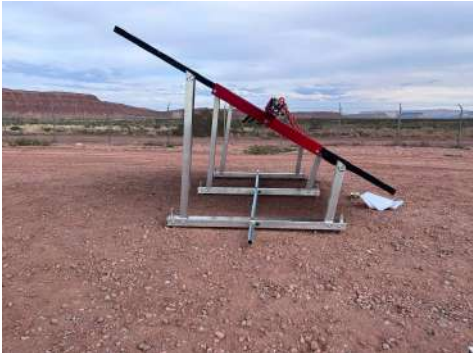
PHOTO 11: Frame after testing

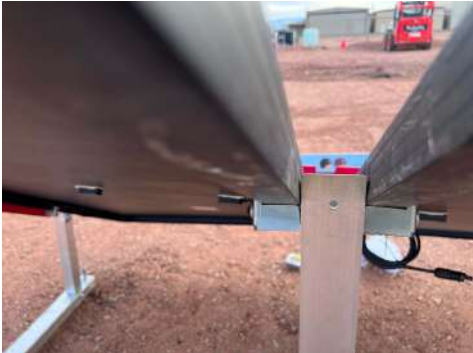
PHOTO 12: Middle brackets after testing

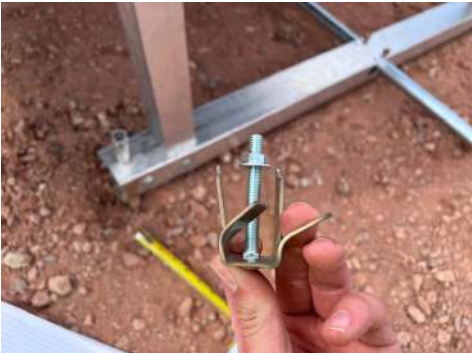
PHOTO 13: Bracket deformation after testing

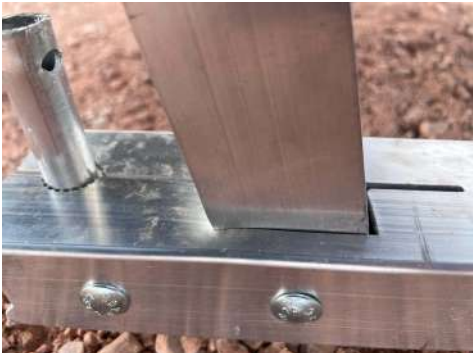
PHOTO 15: Upright deformation after testing
