| IR-45 Solar Racking System | | | | |
| Data Sheet | | | | |

**IR-45 Solar Racking System**

Subject: Witness of Wind Tunnel Testing on IntegraRack Products at the George E Boeing Aeronautics Department (Kirsten Wind Tunnel) at the University of Washington

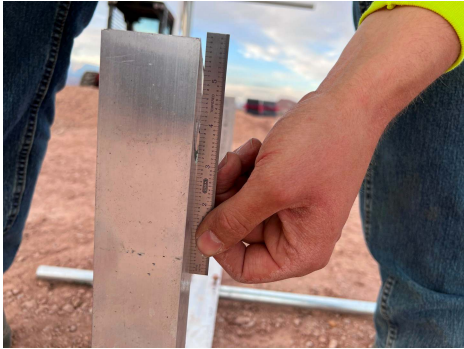
**PHOTO 10:** Slight deformation after load removed

| SIMULATED SNOW LOAD (COMPRESSIVE LOAD) INSPECTION DETAILS | | | |
|---|---|---|---|
| 2 | Large water tank + (12) five gallon jugs | 2950 | Solar panel held load, ~ 10 -15 minutes under observation. Slight deflections noted under load (See Photos). Minor permanent deformation noted after load removal (See Photos). The alignment tabs in the vertical uprights were no longer flat with the uprights. |

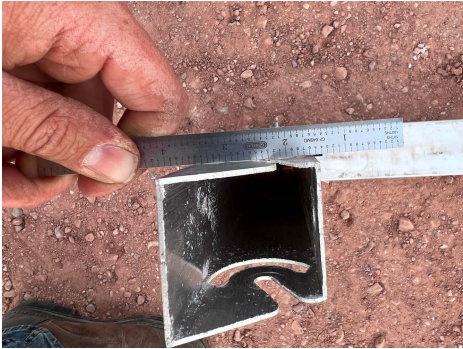
**PHOTO 11:** Slight deformation after load removed

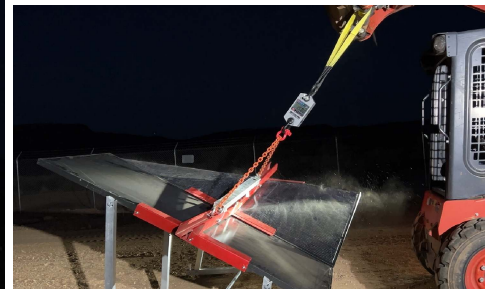
PHOTO 9: IR-30 Solar Racking System right after max load when panel failed

| SIMULATED WIND LOAD (TENSILE UPLIFT) FORCE INSPECTION DETAILS | | |
|---|---|---|
| 1 | 2385 | At 1500 lbf the frame visibly shifted and started to roll forward.<br><br>At 2385 lbf one of the solar panels failed and shattered (Photos 7-9). The frame and brackets holding the solar panel kept it in place and were permanently deformed. The aluminum tube upright had bent forward and outward causing the seam of the tube to tear and it allowed the through bolt to come free. Two mounting brackets permanently deformed and there was additional permanent deformation in the base frame (Photos 10-15) |

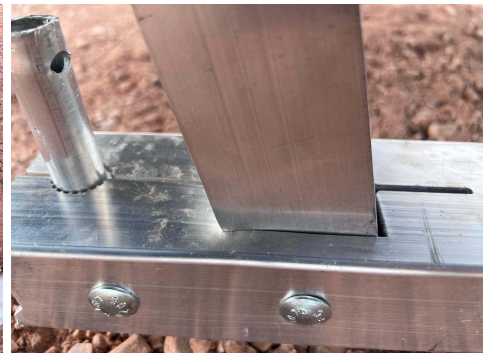
**PHOTO 15:** Upright deformation after testing
