| | | IntegraRack | | | |
| | | IR-45ASA / ASAB Solar Racking System<br>Data Sheet | | | |

Subject: Witness of Wind Tunnel Testing on IntegraRack Products at the George E Boeing Aeronautics Department (Kirsten Wind Tunnel) at the University of Washington

Subject: Simulated Wind Load, Snow Load, and Horizontal Racking Load Testing on IR-30 Solar Racking System.

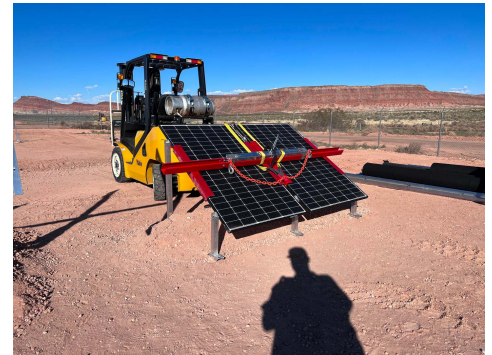
PHOTO 3: Test setup - IR-30 Solar Racking System with red test cross frame

The first simulated wind load test was performed on the IR-30 Solar Racking System Ground Frame that had two solar panels installed at a 30 ° angle and utilized the EarthBallast System. The load was applied via a crossbar connected to the solar panels which were then connected to the ground frame using the IR-F2 Under Mount Flange Clamp Bracket. The test was performed in two parts with the first part used ballast of two loose fill dirt loads from a skid steer, approximately 11 ft<sup>3</sup> total volume, and then the second part used a total of three loads for a total volume of approximately 14 ft<sup>3</sup>. The IR-30 Solar Racking system was monitored for movement as the simulated wind load tensile force was applied. Test loads were measured using a calibrated Dyna-Link 2 Dynamometer (SN 100326, Cal. Date 10/13/2023). Test run details are shown in the table below.

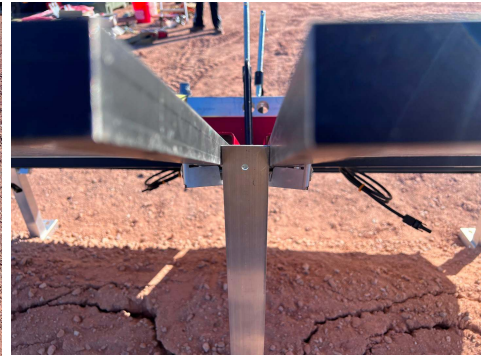
**PHOTO 13:** IR-F2 Clamp bracket after completion of testing

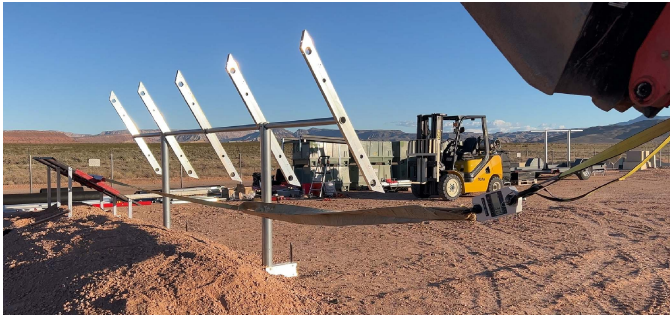
**PHOTO 1:** Horizontal force test setup

The horizontal racking load test was performed on the same IR-30 Solar Racking System Ground Frame that had two solar panels installed at a 30 ° angle and utilized the EarthBallast System and three loads of loose fill dirt ballast. A lifting strap was used to wrap around the panel and run parallel to the frame in order to apply the horizontal racking force. The system was monitored for movement as the simulated load was applied and the maximum load was recorded. The system held the load and no damage or permanent deformation was noted as detailed in the test observations table below.

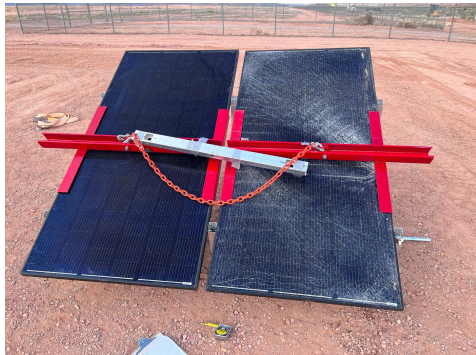
PHOTO 10: Solar panels after testing

| SIMULATED WIND LOAD (TENSILE UPLIFT) FORCE INSPECTION DETAILS | | |
|---|---|---|
| 1 | 2385 | At 1500 lbf the frame visibly shifted and started to roll forward.<br><br>At 2385 lbf one of the solar panels failed and shattered (Photos 7-9). The frame and brackets holding the solar panel kept it in place and were permanently deformed. The aluminum tube upright had bent forward and outward causing the seam of the tube to tear and it allowed the through bolt to come free. Two mounting brackets permanently deformed and there was additional permanent deformation in the base frame (Photos 10-15) |

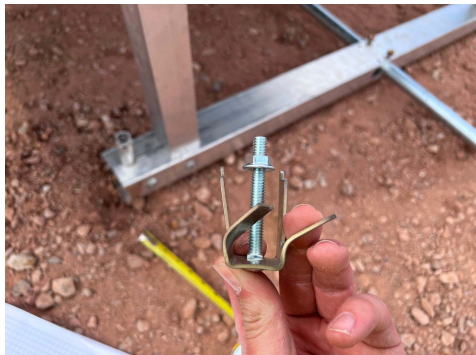
PHOTO 13: Bracket deformation after testing

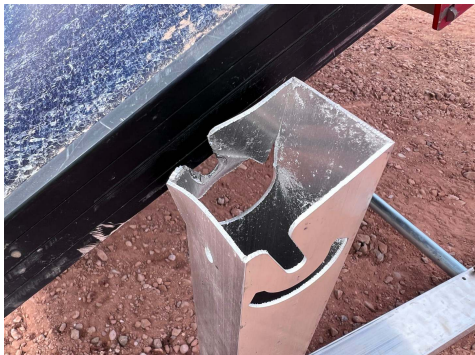
PHOTO 14: Upright mount deformation after testing

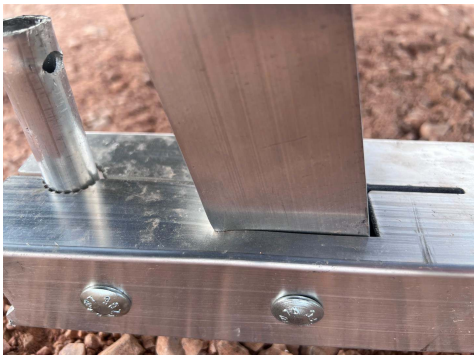
PHOTO 15: Upright deformation after testing

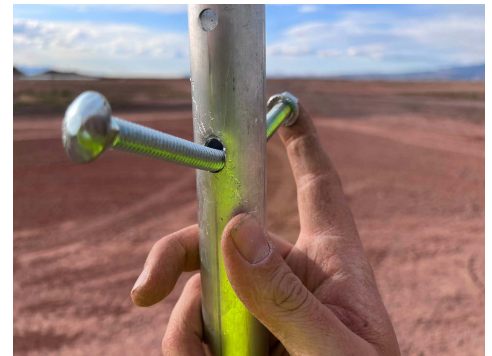
**PHOTO 6:** First anchor pullout with drilled thru hole deformed
