Subject: Pullout Tests on AnchorSpike Epoxy Earth Anchors

# INSPECTION AND TEST REPORT

PNL REF. # 26-240383 S.O. # 001 INDEX 11  
INSPECTION DATE 03/22/2024  
Epoxy Earth Anchor Tensile Pullout (Uplift) Test

Small IR AnchorSpike Tensile Pullout (Uplift) Test

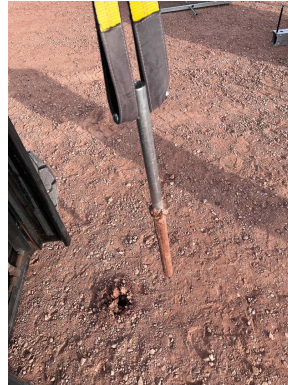
PHOTO 5: First anchor pullout

LARGE EPOXY EARTH ANCHOR TENSILE UPLIFT FORCE INSPECTION DETAILS		
NO.	MAX FORCE REACHED (lbf)	OBSERVATIONS
1	1,950	Anchor pulled out of the ground (See Photos 2, 4-6)
2a	2,990	The bolt installed through the anchor for the purpose of the test bent and the load strap slipped off the anchor (See Photos 3, 7). The drilled thru hole had elongated.
2b	790	The load strap was reattached and test load was applied to the same anchor tested in test 2a. The drilled thru hole failed under load (Photo 8).

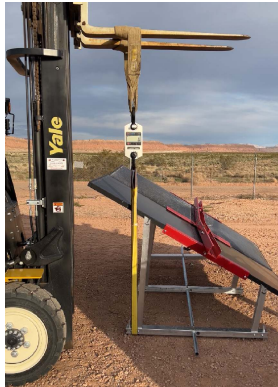
PHOTO 1: Test setup

Tensile pullout (Uplift) tests were performed on the small IR AnchorSpikes installed with the IR Solar Racking System Ground Frame. The load was applied using a loading strap run under the ground frame adjacent to the anchor in order to apply a vertical axial load. The average tensile uplift force at failure was 1066 lbf. The lowest uplift force was 780 lbf. Additional test run details are shown in the table below.

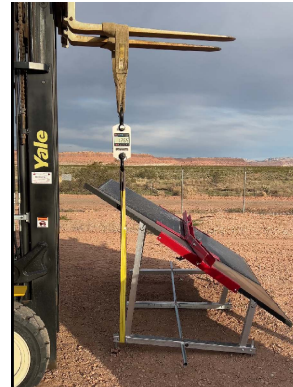
PHOTO 2: Test setup under max load

IR ANCHORSPIKES TENSILE UPLIFT FORCE INSPECTION DETAILS		
NO.	MAX FORCE REACHED (lbf)	OBSERVATIONS
1	915	
2	1,305	Initial minor pullout of anchor noted at 1135 lbf.
3	1,265	Initial minor pullout of anchor noted at 975 lbf.
4	780	
AVG.	1,066
