| | | IR-30 Solar Racking System | | | |
| | | Data Sheet | | | |

Subject: Witness of Wind Tunnel Testing on IntegraRack Products at the George E Boeing Aeronautics Department (Kirsten Wind Tunnel) at the University of Washington

Subject: Simulated Wind Load, Snow Load, and Horizontal Racking Load Testing on IR-30 Solar Racking System.

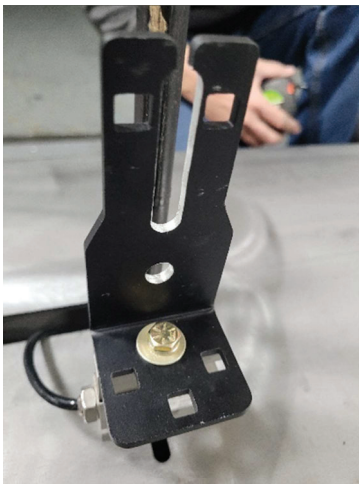
Figure 4: Bracket at back edge LC5-3, LC5-4

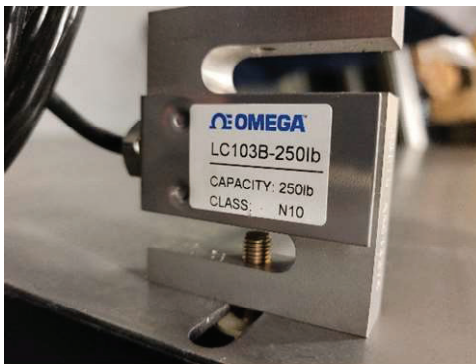
Figure 5: Load Cell Model used for tests

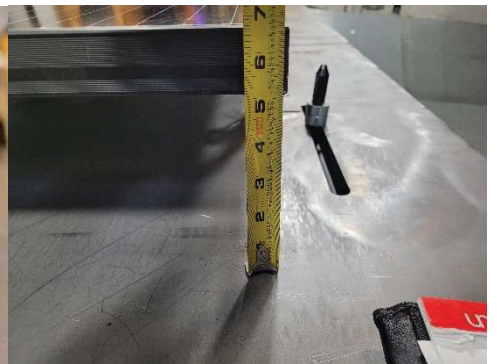
Figure 6: Height from roof to panel, Runs 2 & 3

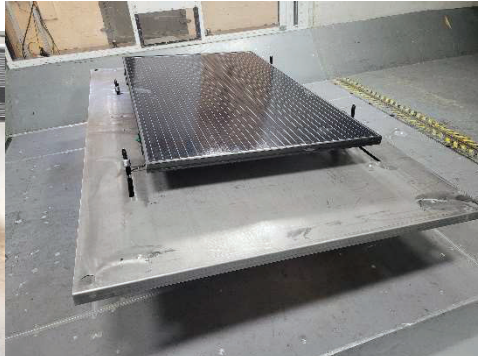
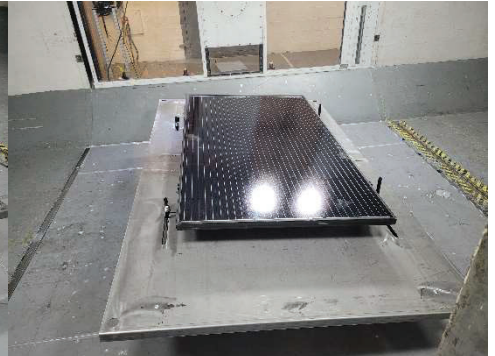
Figure 11: Setup after Run 2, 109 mph winds.  
No damages or loose hardware noted.

to any bracket during or after the test runs and all hardware was found to be secure upon completion of each test (See Figures 11-13).

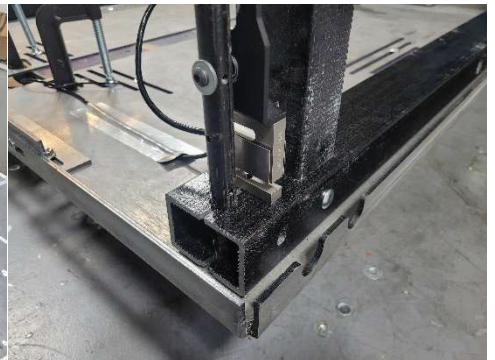
Figure 15: Load cell location at leading edge,  
LC0-1 & LC0-2

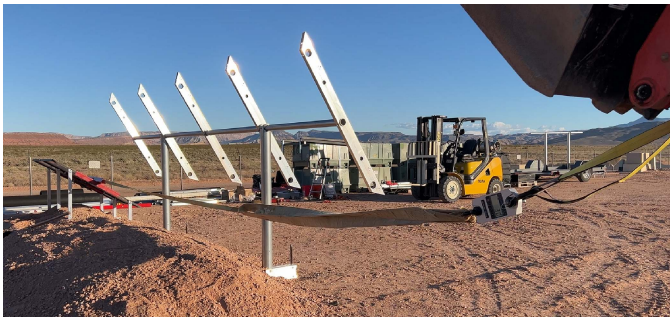
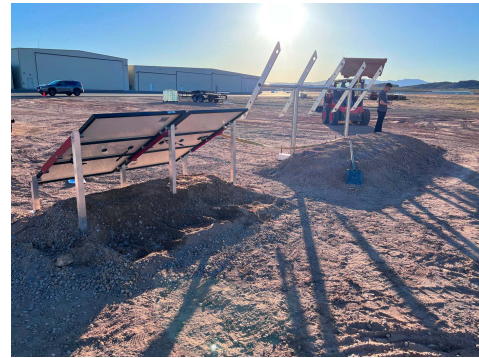
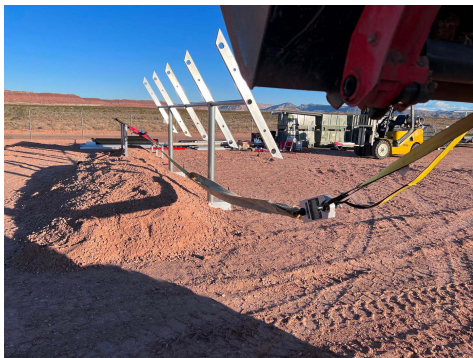
**PHOTO 1:** Horizontal force test setup

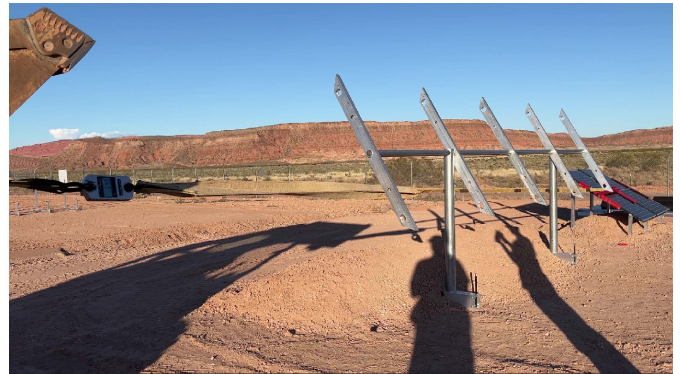
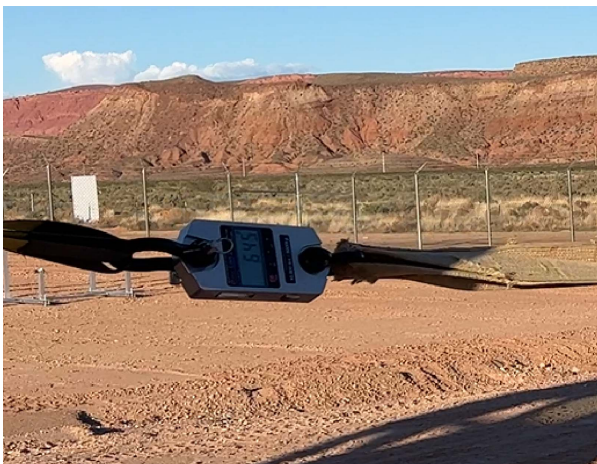
**Photo 4:** Horizontal force test at max load

| SIMULATED HORIZONTAL RACKING FORCE INSPECTION DETAILS | | | | |
|---|---|---|---|---|
| 1 | 90 in. x 42 in. x 14 in.<br>(14 CF) | ~ 1400 lbf<br>(3 skid steer buckets) | 645 | Test was stopped at 645 lbf. No damage or movement was visually noted. |

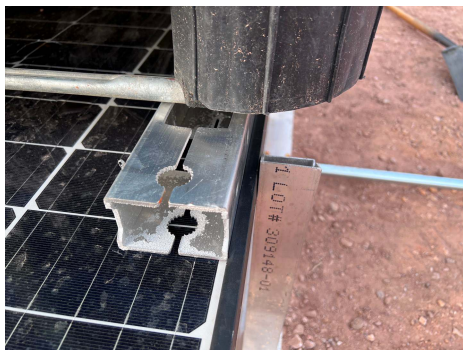
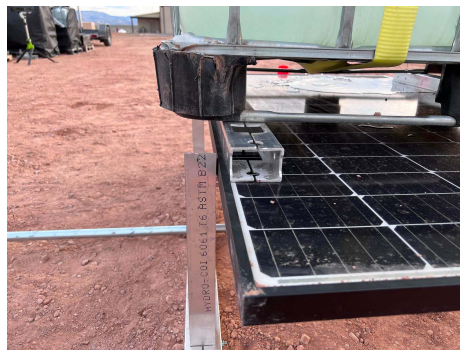
**PHOTO 7:** Slight deflections noted under load

| SIMULATED SNOW LOAD (COMPRESSIVE LOAD) INSPECTION DETAILS | | | |
|---|---|---|---|
| 2 | Large water tank + (12) five gallon jugs | 2950 | Solar panel held load, ~ 10 -15 minutes under observation. Slight deflections noted under load (See Photos). Minor permanent deformation noted after load removal (See Photos). The alignment tabs in the vertical uprights were no longer flat with the uprights. |

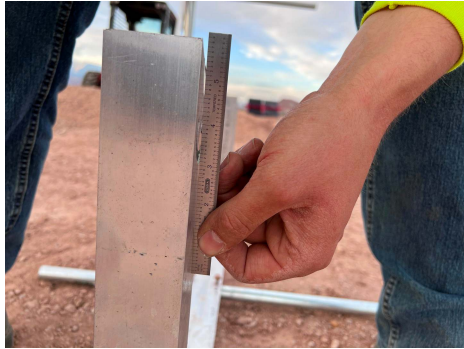
**PHOTO 10:** Slight deformation after load removed

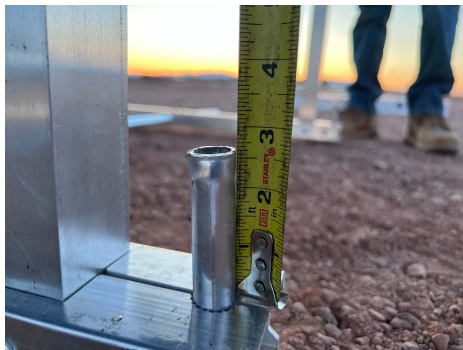
PHOTO 4: 'Stickout' measurement example at Spike #3

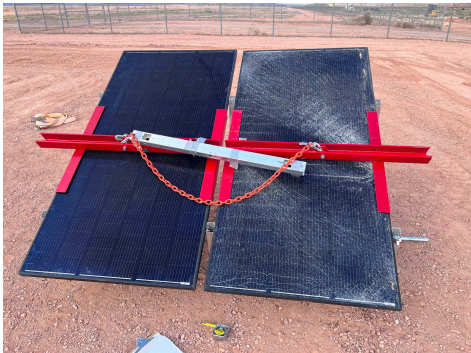
**PHOTO 10:** Solar panels after testing

| SIMULATED WIND LOAD (TENSILE UPLIFT) FORCE INSPECTION DETAILS | | |
|---|---|---|
| 1 | 2385 | At 1500 lbf the frame visibly shifted and started to roll forward.<br><br>At 2385 lbf one of the solar panels failed and shattered (Photos 7-9). The frame and brackets holding the solar panel kept it in place and were permanently deformed. The aluminum tube upright had bent forward and outward causing the seam of the tube to tear and it allowed the through bolt to come free. Two mounting brackets permanently deformed and there was additional permanent deformation in the base frame (Photos 10-15) |

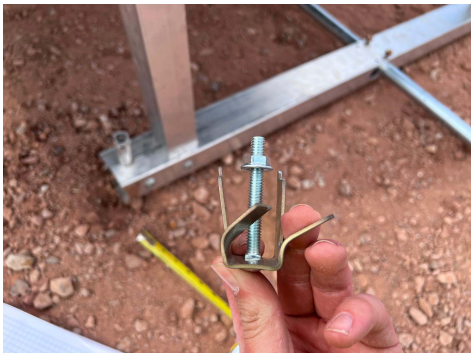
**PHOTO 13:** Bracket deformation after testing

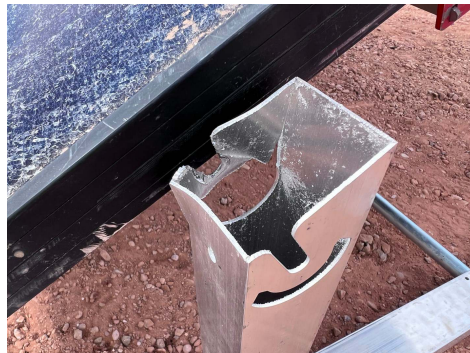
**PHOTO 14:** Upright mount deformation after testing

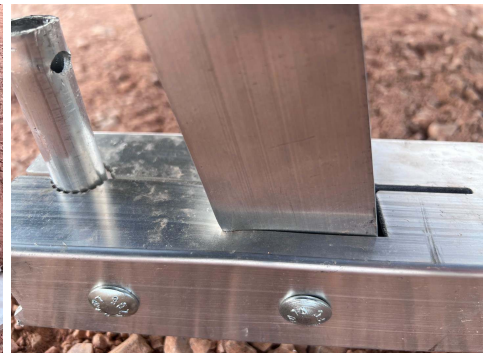
**PHOTO 15:** Upright deformation after testing
