PROJECT							
	IntegraRack							
TITLE								
IR-40FSAA / FSAB / FSAC Solar Racking System								
Data Sheet								
Black Zinc Plated High Strength Steel / High Strength Steel and Composite								
APPROVED	Paul Budge	2/21/2025	SIZE	CODE				
CHECKED	Paul Budge	2/21/2025	B	DWG NO				
DRAWN	Jeff Glauser	2/21/2025	REV					
		SCALE 1:20	WEIGHT 15lbs / 22lbs / 16lbs	SHEET 1/4

Subject: Witness of Wind Tunnel Testing on IntegraRack Products at the George E Boeing Aeronautics Department (Kirsten Wind Tunnel) at the University of Washington

Subject: Simulated Wind Load, Snow Load, and Horizontal Racking Load Testing on IR-30 Solar Racking System.

INSPECTION AND TEST REPORT

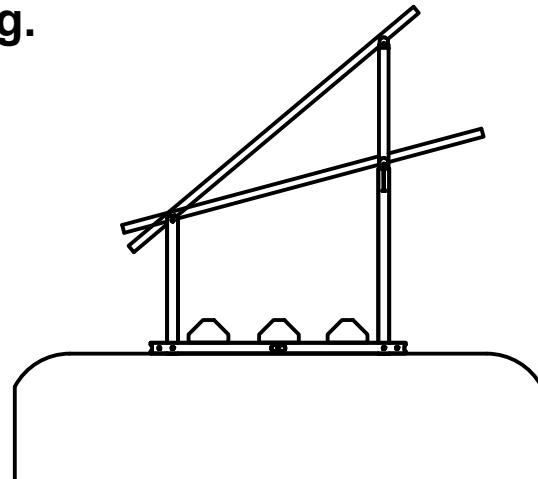
Base Frame Ballasted:

Three 175lb curb stop ballasts per solar module.
525lbs minimum per solar module for
60-70 mph windspeed at 40 degree angle.
(No stakes required)

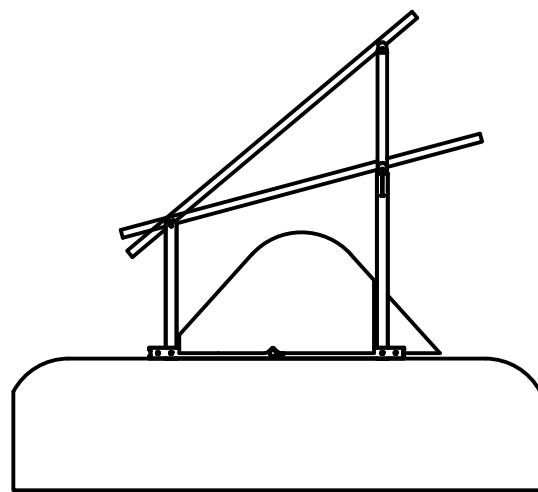
IR EarthBallast™ System:

22in fill to top of mound. 1000lbs
minimum per solar module.
Center of mound 6" offset toward rear leg.
(3/4" Steel concrete forming stakes required at
each end of base tube member)

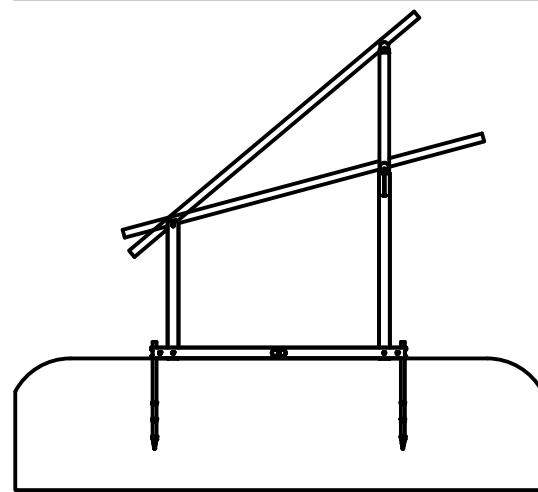
IR AnchorSpike™ / EarthScrew™:

Two AnchorSpikes / EarthScrews per frame section.
Medium/high density compacted soil required.
(1000lb minimum uplift test per AnchorSpike / EarthScrew.
Not compatible in regions with frost depths over 20 inches)

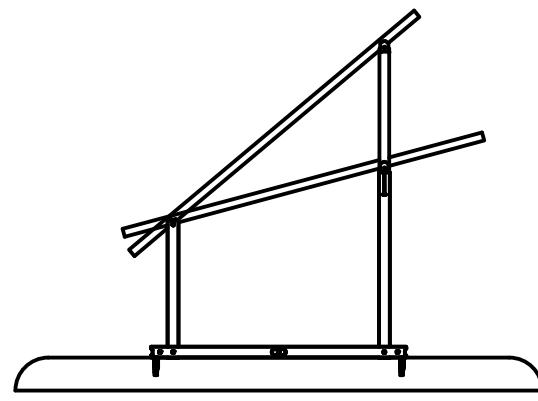
Base Frame Bolted:

Bolted to concrete footing,
concrete ballast pad, or steel beam.
(1000lbs minimum hold down per frame section)

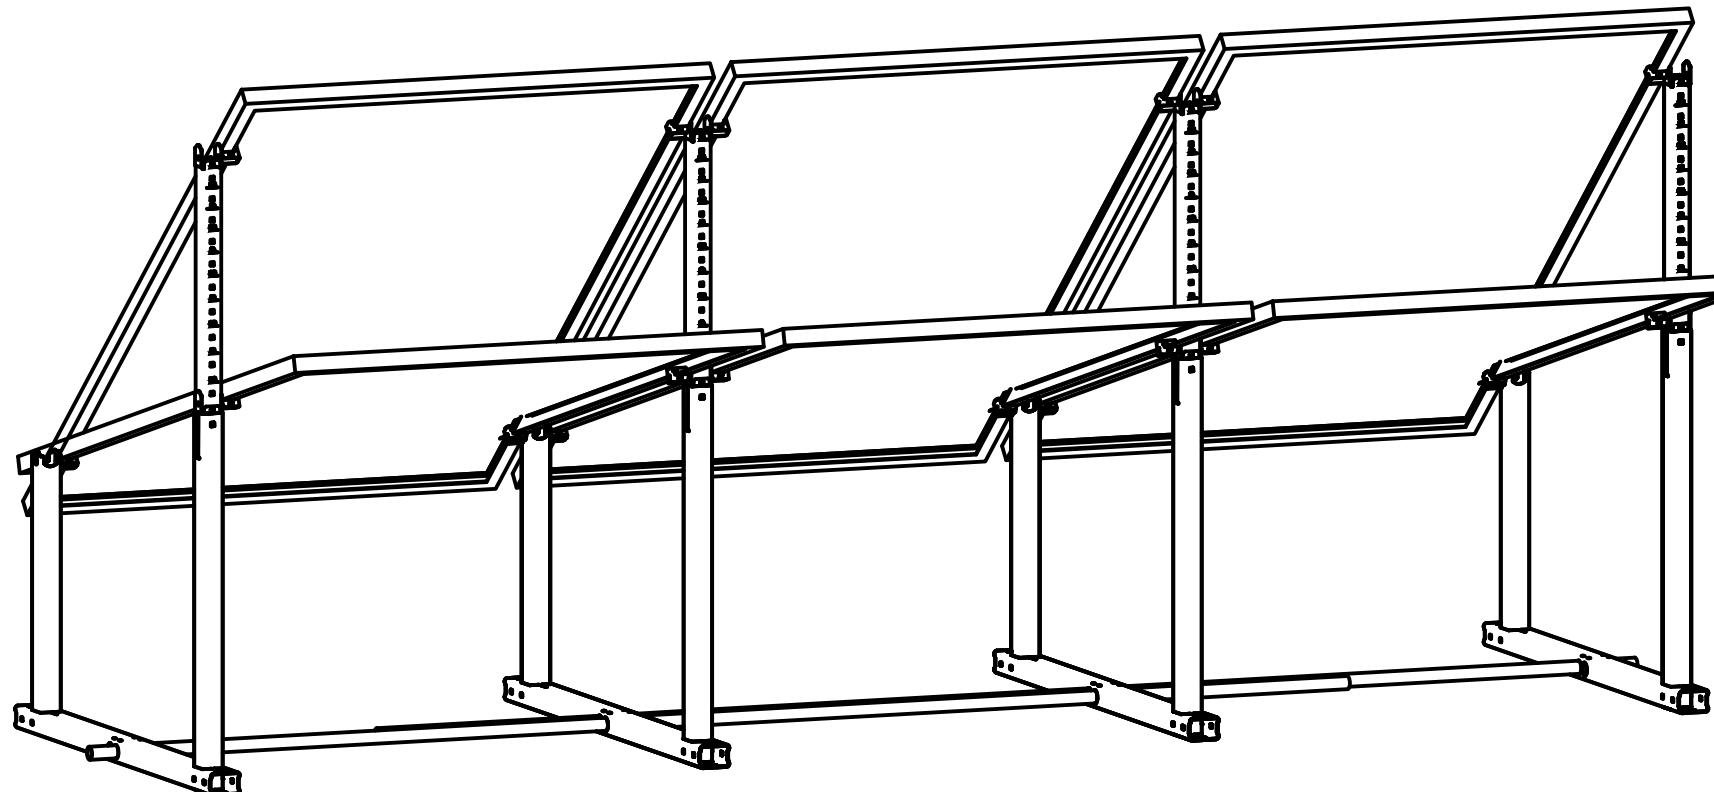
AnchorSpike hole-to-hole dimension: 44.8 inches

*Images shown at 15 and 40 degrees positions

Height off the ground and space between frames will vary based on module size and adjustment angle.
(Solar module size represented is 44.7" x 67.8")

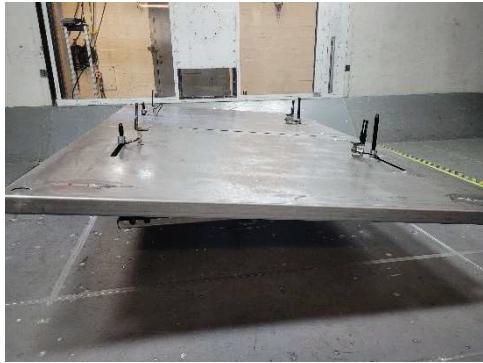
Figure 1: Run 1 through 3 simulated roof setup

A total of 8 runs were performed on IntegraRack products. Test Runs 1 through 3 were performed with the IR-D1 bracket (See Figures 1-4) with an installed 18 SF solar panel on a simulated roof incline. Run 1 was performed to tare KWT's system through the full 0 to 110 degree rotation of the test platform with the simulated roof and panel installed. The roof surface had been installed at an approximate 5 – 6 degree incline (See Figure 1). The solar panel was mounted at 0 degrees relative to the roof surface with a general height of 5 in from the roof surface. at all four corners of the panel. Test Runs 4 and 5 were performed on the same panel and bracket with the panel height adjusted and installed at an angle with the front corners set to 3-1/2 in. and the back corners set to a height of 6 in. from the roof surface.

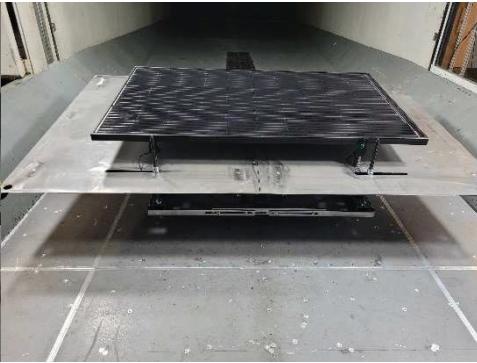
Figure 2: Run 1 through 3 setup with panel

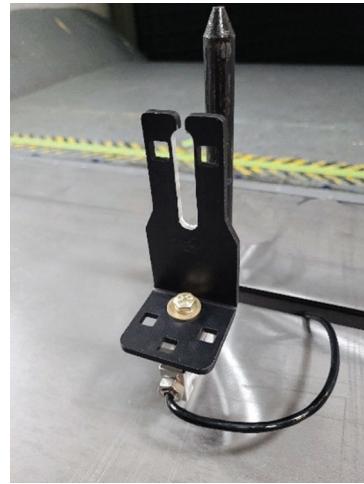
Figure 3: Bracket at leading edge LC0-1, LC0-2

Test Runs 2 through 5 included rotating the test setup from 0 to 110 degrees while KWT instrumentation recorded test data. Wind speed was increased until limitations of KWT instrumentation prevented it from being increased further. Four load cells, Omega model LC103B-250 lb Class N10, were installed between the IntegraRack bracket and the roof surface to monitor and record loads applied to the brackets throughout testing (See Figures 5-10). The load cells were labeled LC0-1, LC0-2, LC5-3, and LC5-4 with LC0 being installed at the leading edge and LC5 being installed at the back edge.

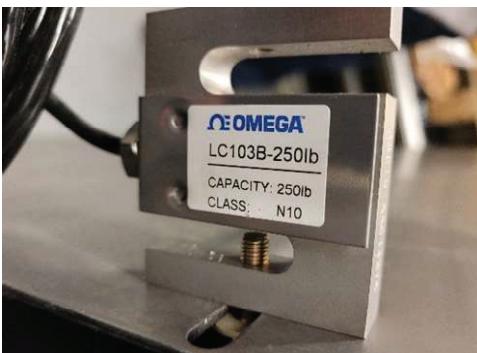
Figure 5: Load Cell Model used for tests

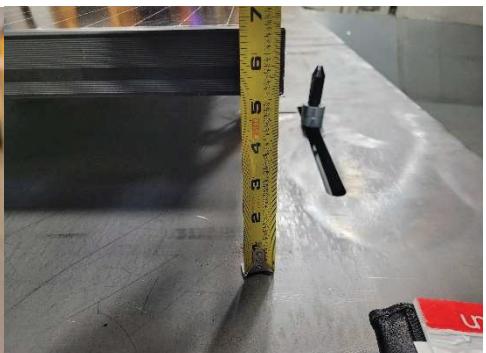
Figure 6: Height from roof to panel, Runs 2 & 3

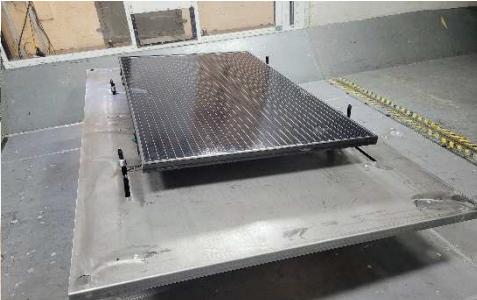
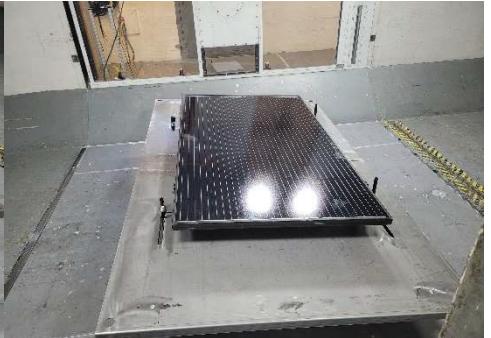
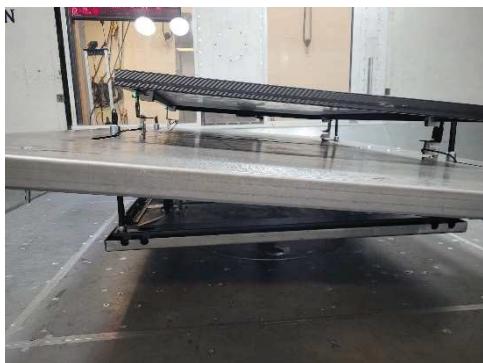
Figure 11: Setup after Run 2, 109 mph winds.
No damages or loose hardware noted.

Figure 12: Setup after Run 2, 109 mph winds.
No damages or loose hardware noted

Figure 13: Setup after Run 2, 109 mph winds.
No damages or loose hardware noted

The maximum load at a bracket recorded during Test Runs 2 and 3 was 75.015 lbf at a wind speed of 157.67 MPH when the panel was at a rotation point of 60 degrees. No damage or deformation was noted

to any bracket during or after the test runs and all hardware was found to be secure upon completion of each test (See Figures 11-13).

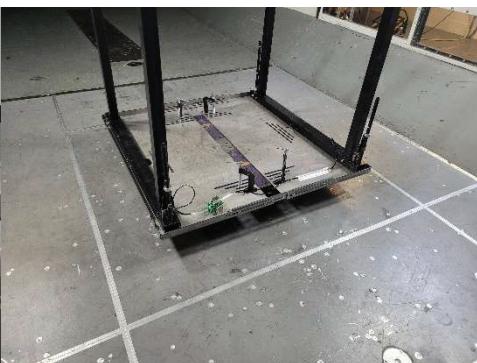
Figure 14: Setup for Run 6 with IR Ballast Frame

Test Runs 6 through 8 were performed on the IR Ballast Racks (See Figures 14-32). The simulated roof structure was removed and the frames and panel were mounted directly to the KWT test platform. These runs were performed at a set angle with no platform rotation during the test run. Two load cells were used for the test setups and were mounted at the brackets at the leading edge of the test platform at the wind intake side.

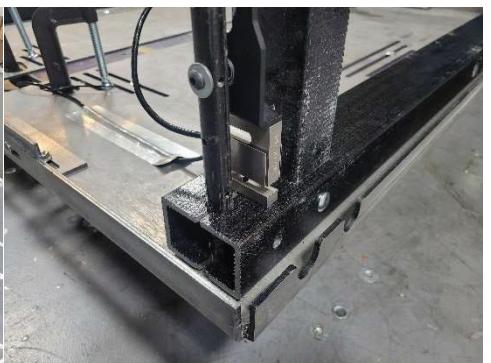
Figure 15: Load cell location at leading edge,
LC0-1 & LC0-2

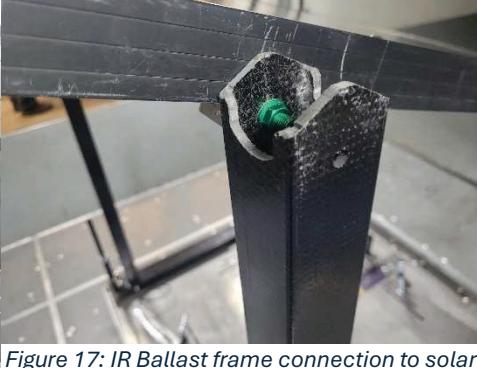
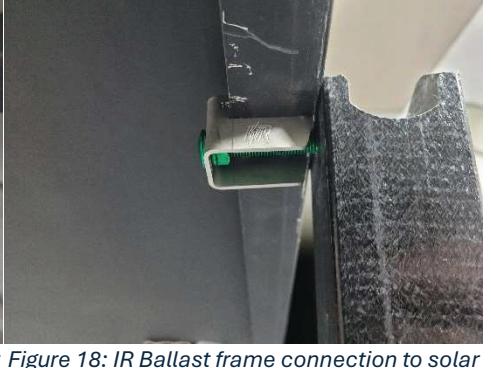
Figure 17: IR Ballast frame connection to solar panel

Figure 18: IR Ballast frame connection to solar panel

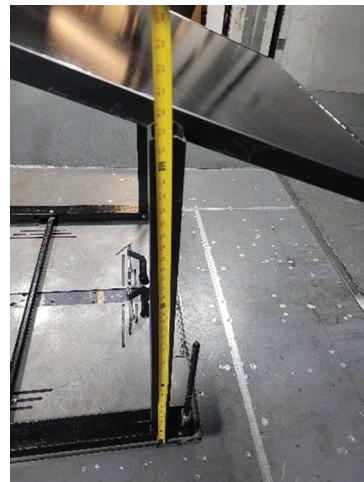
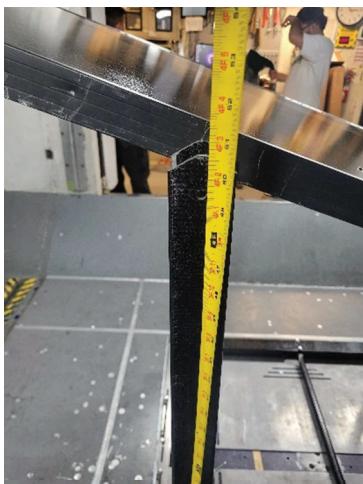
Figure 24: Run 6 trailing edge leg height

Figure 25: Run 6 leading edge leg height

Run 6 was performed on the IR18C with the solar panel at an approximate 18 degree angle (Figures 24-25). The maximum load at a bracket recorded during Test Run 6 was 168.59 lbf at a wind speed of 101.59 MPH. Runs 7 and 8 were performed on the IR30C with the solar panel at a 30 degree angle (Figures 30-32) with Run 7 having the solar panel mounted and aligned with the wind direction to produce maximum forces on the frame and Run 8 being run in an orientation 90 degrees offset from Run 7. The maximum load at a bracket was during Test Run 7 and was 183.38 lbf at a wind speed of 81.138 MPH. Run 7 was stopped when the drag limit of the KWT test apparatus was reached. The solar frame experienced shaking under wind load but no damage was found to any part and all bolts were found to still be tight and in place after the test run. Run 8 was pitch limited by the KWT test apparatus. Similar to Run 7 the frame and solar panel had experienced shaking under load but no damage to the frame or panel was noted and all bolts and connections remained tight.

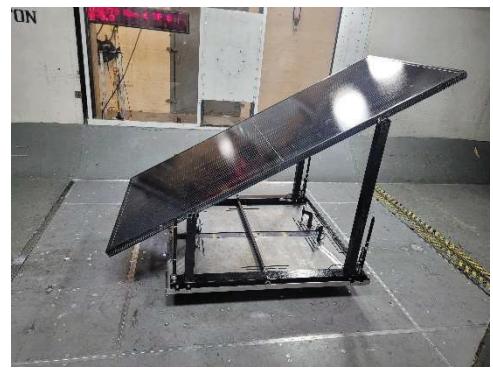
Figure 30: Runs 7 - 8 Test setup

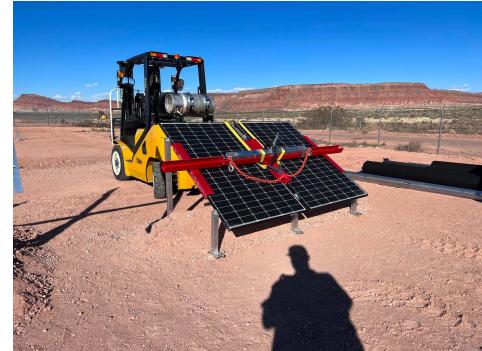
PHOTO 3: Test setup - IR-30 Solar Racking System with red test cross frame

The solar panels were set at an approximate 30° angle. The tensile force was applied upwards and away, at a perpendicular angle from the solar panels using the skid steer (Photo 4). Load was monitored with the digital dynamometer. Load was recorded when an initial shift of the solar panel frame was noted and when the shift was large enough to cause visual changes to the frame and in the ballast surface (Photos 5-13).

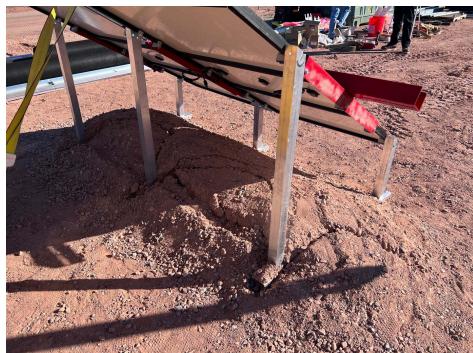
PHOTO 14: Ballast and frame after completion of testing

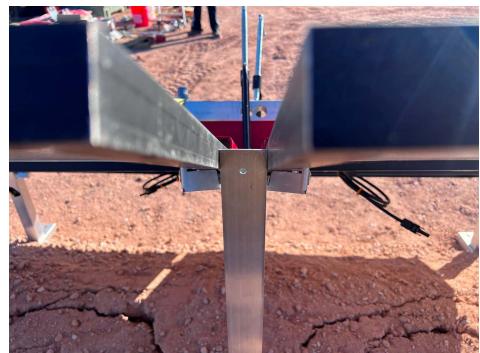
PHOTO 15: IR-F2 Clamp bracket after completion of testing

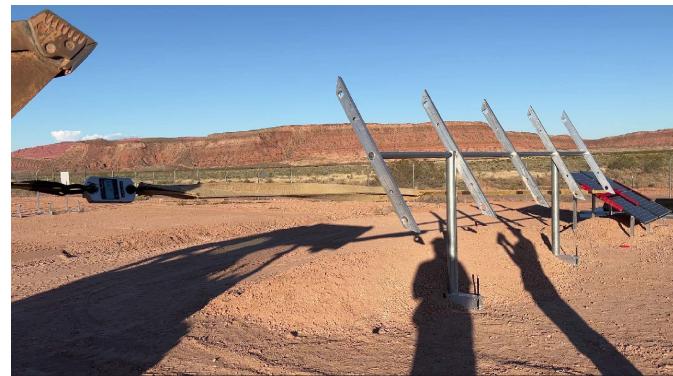
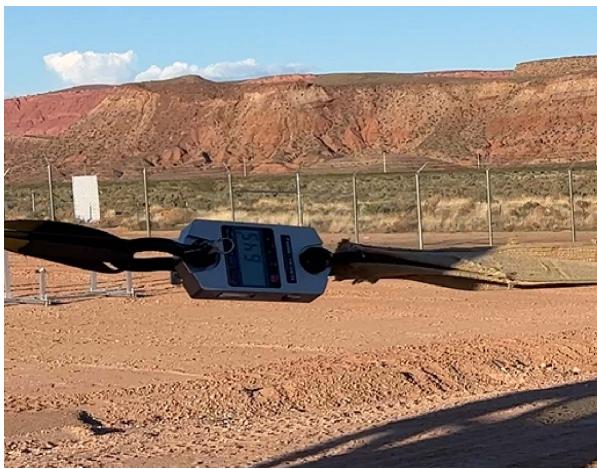
Photo 4: Horizontal force test at max load

Photo 4: Horizontal force test max load

The IR-30 Solar Racking System Ground Frame was installed with the IR EarthBallast System and two solar panels. The EarthBallast system utilizes a mesh that is epoxied to the frame which is then loaded with loose dirt fill (ballast) that supports and holds down the frame. The horizontal load test was performed after the vertical uplift tensile load test. The system was tested with 3 loads of dirt from a Kubota SSV75 skid steer. The skid steer dirt loads were estimated at ~ 500 lbf each using an estimate of 100 lbf/ft³ for the density of soil. A lifting strap was wrapped around the panel lengthwise and run parallel to the frame in order to apply a horizontal force to the system (Photos). Force was applied using the skid steer and load was monitored with the digital dynamometer. The test was stopped at a load of 645 lbf. No movement or damage was visually noted during or after the test.

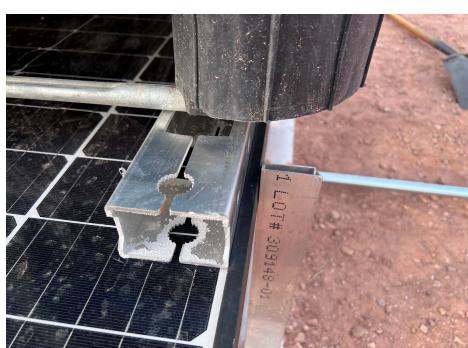
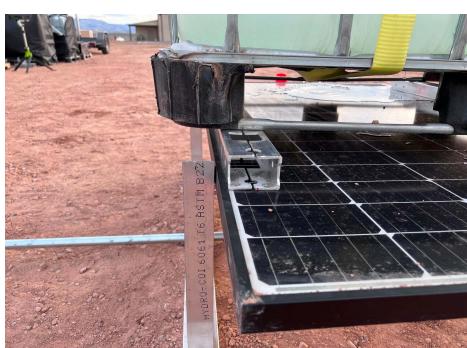
PHOTO 7: Slight deflections noted under load

PHOTO 8: Slight deflection noted under load

COMPRESSIVE FORCE		OBSERVATIONS
	DESCRIPTION	WEIGHT (lbf)	
1	Large water tank	2410	Solar panel held load overnight (> 10 h).
2	Large water tank + (12) five gallon jugs	2950	Solar panel held load, ~ 10 -15 minutes under observation. Slight deflections noted under load (See Photos). Minor permanent deformation noted after load removal (See Photos). The alignment tabs in the vertical uprights were no longer flat with the uprights.

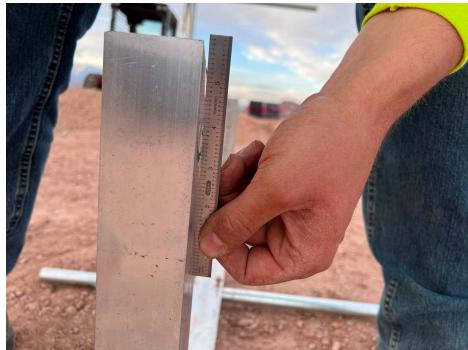
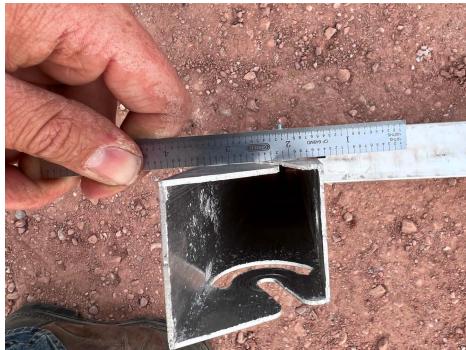
PHOTO 10: Slight deformation after load removed

PHOTO 11: Slight deformation after load removed

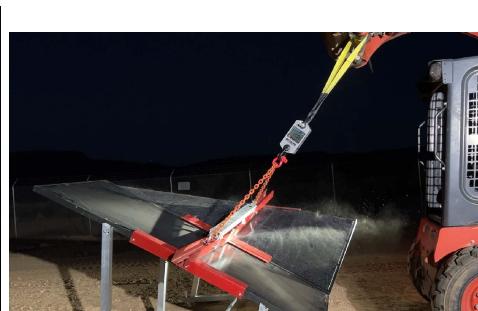
PHOTO 9: IR-30 Solar Racking System right after max load when panel failed

SIMULATED WIND LOAD (TENSILE UPLIFT) FORCE INSPECTION DETAILS		
TEST NO.	MAX. FORCE (lbf)	OBSERVATIONS
1	2385	At 1500 lbf the frame visibly shifted and started to roll forward. At 2385 lbf one of the solar panels failed and shattered (Photos 7-9). The frame and brackets holding the solar panel kept it in place and were permanently deformed. The aluminum tube upright had bent forward and outward causing the seam of the tube to tear and it allowed the through bolt to come free. Two mounting brackets permanently deformed and there was additional permanent deformation in the base frame (Photos 10-15)

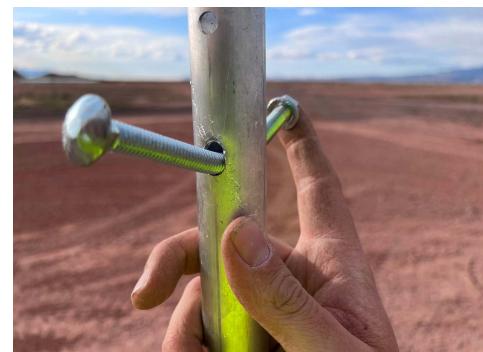
PHOTO 6: First anchor pullout with drilled thru hole deformed

LARGE EPOXY EARTH ANCHOR TENSILE UPLIFT FORCE INSPECTION DETAILS		
NO.	MAX FORCE REACHED (lbf)	OBSERVATIONS
1	1,950	Anchor pulled out of the ground (See Photos 2, 4-6)
2a	2,990	The bolt installed through the anchor for the purpose of the test bent and the load strap slipped off the anchor (See Photos 3, 7). The drilled thru hole had elongated.
2b	790	The load strap was reattached and test load was applied to the same anchor tested in test 2a. The drilled thru hole failed under load (Photo 8).

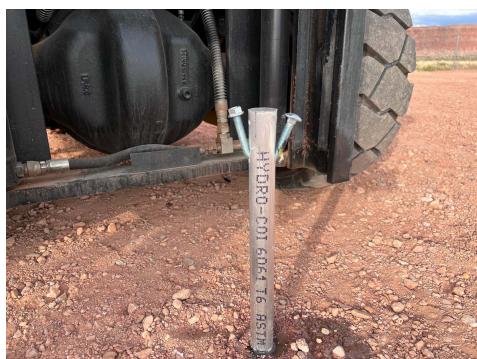
PHOTO 7: Second anchor - first pull where the thru bolt bent and load strap slipped off

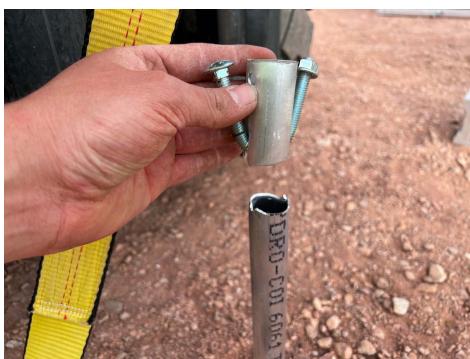
PHOTO 8: Second anchor - second test where anchor failed at drilled thru hole
