| | IntegraRack | | | |
| | IR-W5MBCB MultiBallast | | | |
| | Data Sheet | | | |

Subject: Witness of Wind Tunnel Testing on IntegraRack Products at the George E Boeing Aeronautics Department (Kirsten Wind Tunnel) at the University of Washington

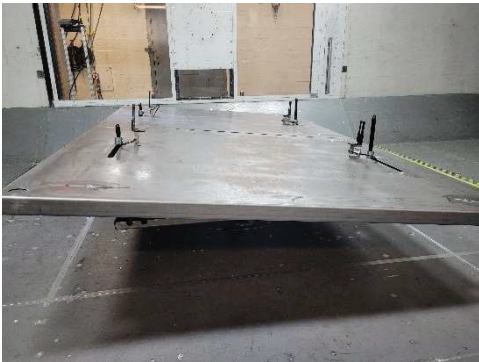
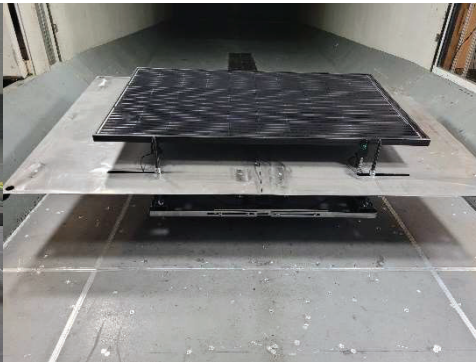
Figure 1: Run 1 through 3 simulated roof setup

Figure 2: Run 1 through 3 setup with panel

A total of 8 runs were performed on IntegraRack products. Test Runs 1 through 3 were performed with the IR-D1 bracket (See Figures 1-4) with an installed 18 SF solar panel on a simulated roof incline. Run 1 was performed to tare KWT's system through the full 0 to 110 degree rotation of the test platform with the simulated roof and panel installed. The roof surface had been installed at an approximate 5 – 6 degree incline (See Figure 1). The solar panel was mounted at 0 degrees relative to the roof surface with a general height of 5 in from the roof surface. at all four corners of the panel. Test Runs 4 and 5 were performed on the same panel and bracket with the panel height adjusted and installed at an angle with the front corners set to 3-1/2 in. and the back corners set to a height of 6 in. from the roof surface.

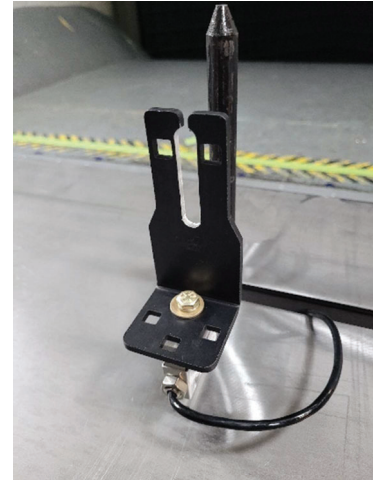
Figure 3: Bracket at leading edge LC0-1, LC0-2

Test Runs 2 through 5 included rotating the test setup from 0 to 110 degrees while KWT instrumentation recorded test data. Wind speed was increased until limitations of KWT instrumentation prevented it from being increased further. Four load cells, Omega model LC103B-250 lb Class N10, were installed between the IntegraRack bracket and the roof surface to monitor and record loads applied to the brackets throughout testing (See Figures 5-10). The load cells were labeled LC0-1, LC0-2, LC5-3, and LC5-4 with LC0 being installed at the leading edge and LC5 being installed at the back edge.

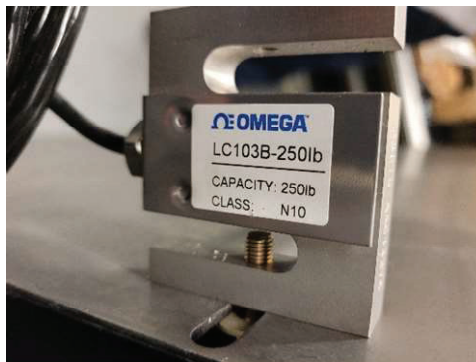
Figure 5: Load Cell Model used for tests

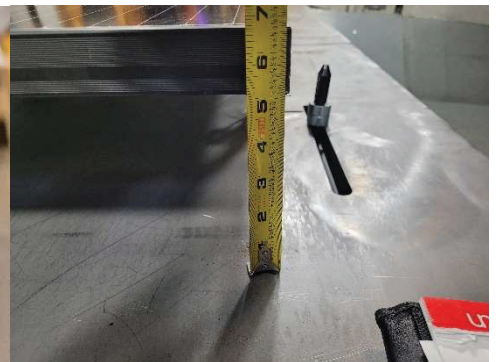
Figure 6: Height from roof to panel, Runs 2 & 3

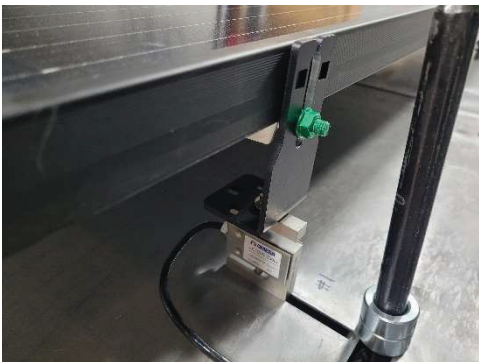
Figure 7: LC0-1 Location

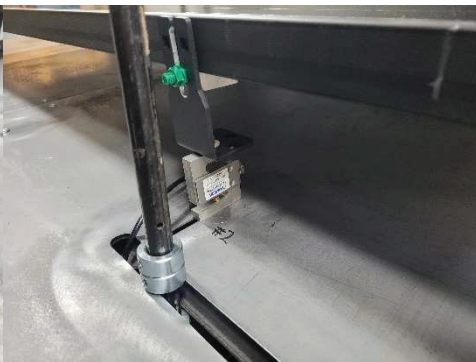
Figure 8: LC0-2 Location

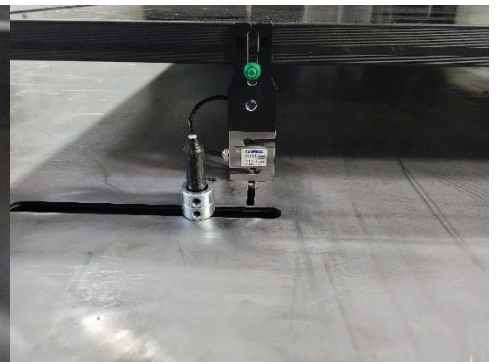
Figure 9: LC5-3 Location

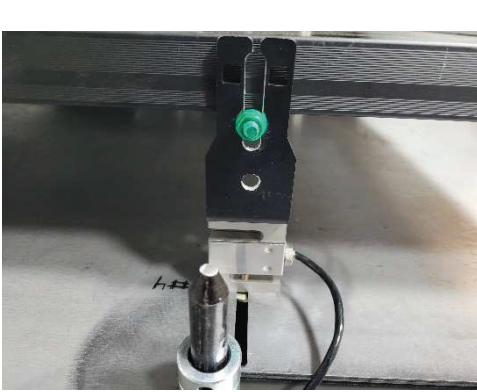
Figure 10: LC5-4 Location

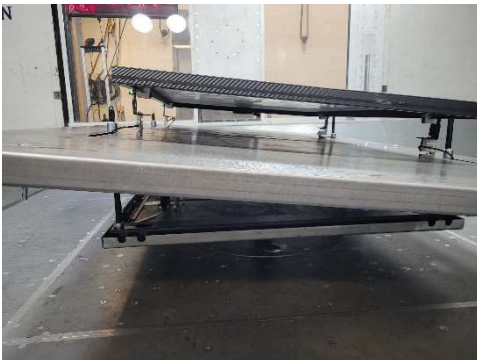
Figure 11: Setup after Run 2, 109 mph winds.  
No damages or loose hardware noted.

Figure 12: Setup after Run 2, 109 mph winds.  
No damages or loose hardware noted

Figure 13: Setup after Run 2, 109 mph winds.  
No damages or loose hardware noted

The maximum load at a bracket recorded during Test Runs 2 and 3 was 75.015 lbf at a wind speed of 157.67 MPH when the panel was at a rotation point of 60 degrees. No damage or deformation was noted

to any bracket during or after the test runs and all hardware was found to be secure upon completion of each test (See Figures 11-13).

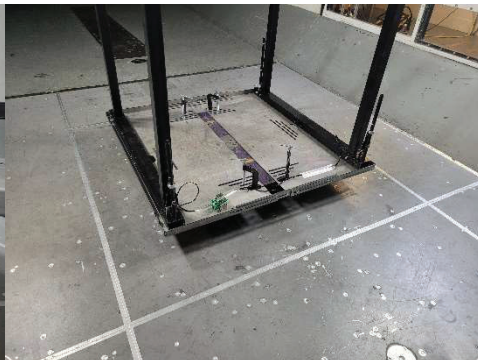
Figure 14: Setup for Run 6 with IR Ballast  
Frame

Test Runs 6 through 8 were performed on the IR Ballast Racks (See Figures 14-32). The simulated roof structure was removed and the frames and panel were mounted directly to the KWT test platform. These runs were performed at a set angle with no platform rotation during the test run. Two load cells were used for the test setups and were mounted at the brackets at the leading edge of the test platform at the wind intake side.

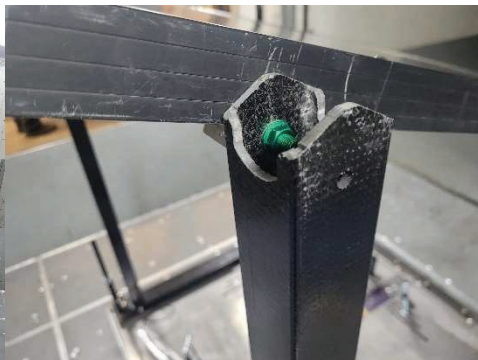
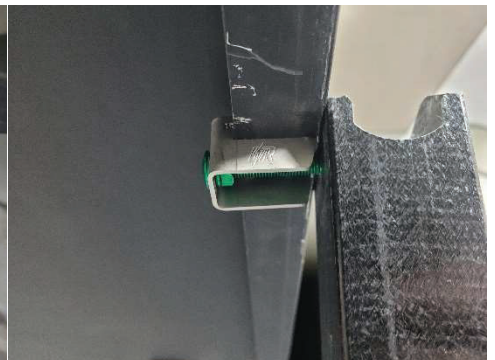
Figure 17: IR Ballast frame connection to solar  
panel

Figure 18: IR Ballast frame connection to solar  
panel

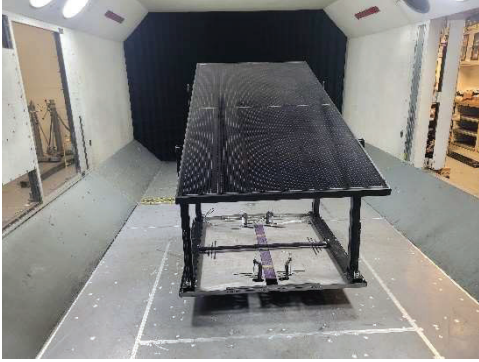
Figure 19: Test setup for Run 6

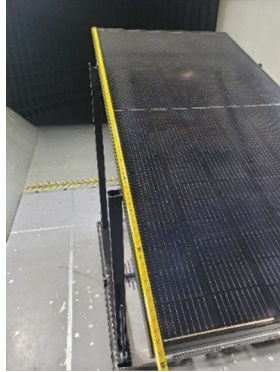
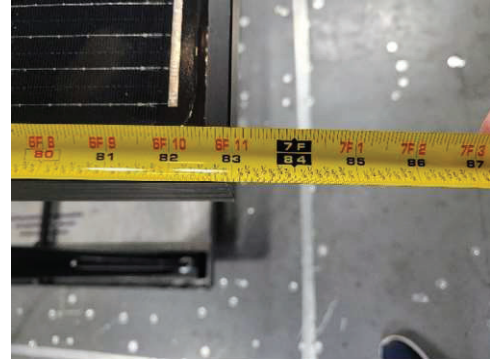
Figure 20: Solar panels total length, Run 6 through 8

Figure 21: Solar panels total length 83 in.

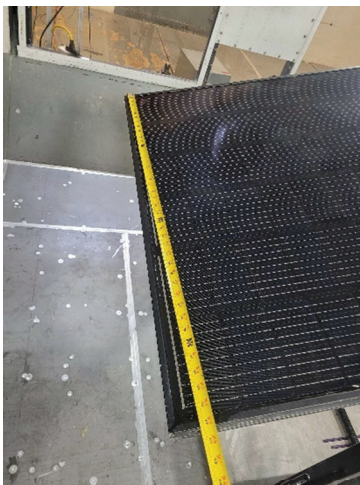
Figure 22: Solar panels width, Run 6 through 8

Figure 23: Total width 41-1/4 in.

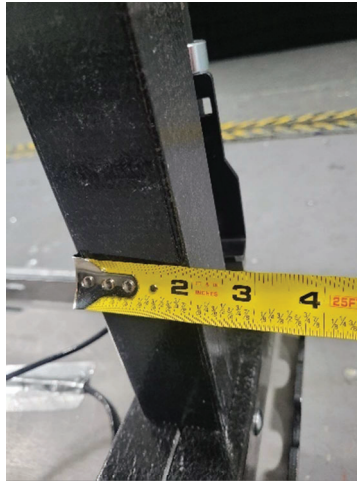
Figure 28: IR Ballast rack leg width 1

Figure 29: IR Ballast rack leg width 2

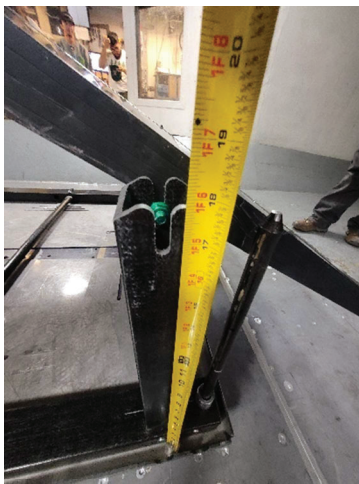
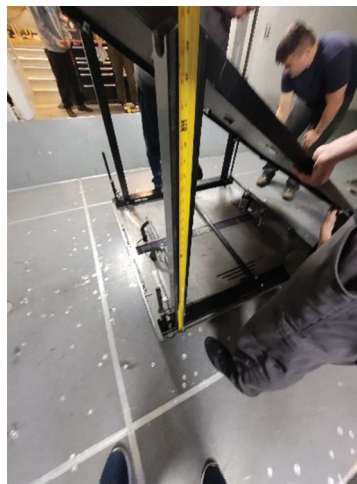
Figure 30: Runs 7 - 8 Test setup

Figure 31: Run 7 trailing edge leg height

Figure 32: Run 7 Leading edge leg height

Run 6 was performed on the IR18C with the solar panel at an approximate 18 degree angle (Figures 24-25). The maximum load at a bracket recorded during Test Run 6 was 168.59 lbf at a wind speed of 101.59 MPH. Runs 7 and 8 were performed on the IR30C with the solar panel at a 30 degree angle (Figures 30-32) with Run 7 having the solar panel mounted and aligned with the wind direction to produce maximum forces on the frame and Run 8 being run in an orientation 90 degrees offset from Run 7. The maximum load at a bracket was during Test Run 7 and was 183.38 lbf at a wind speed of 81.138 MPH. Run 7 was stopped when the drag limit of the KWT test apparatus was reached. The solar frame experienced shaking under wind load but no damage was found to any part and all bolts were found to still be tight and in place after the test run. Run 8 was pitch limited by the KWT test apparatus. Similar to Run 7 the frame and solar panel had experienced shaking under load but no damage to the frame or panel was noted and all bolts and connections remained tight.

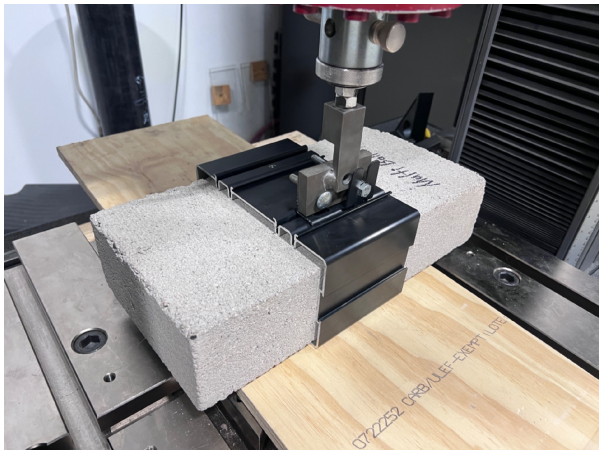
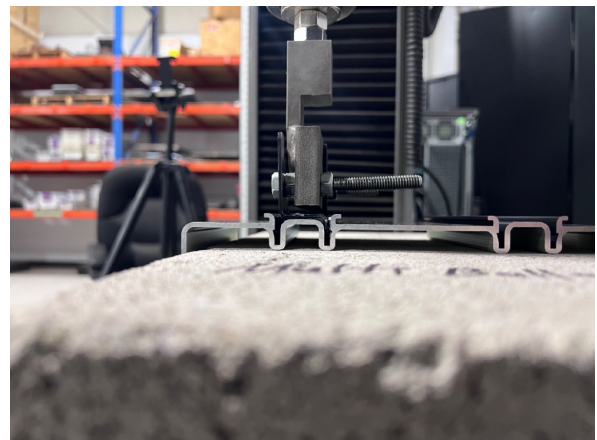
Photo 5: Compression test, setup #2

Photo 6: Compression test, setup #2

**Photo 7:** Compression test #2 post test

| CLIENT | | PROJECT/TEST DESCRIPTION | | CLIENT ORDER NO. |
|---|---|---|---|---|
| 2 | Multiballast to concrete block with H-module bracket (Photo 5) | 0.185 | 2,750 | Test manually stopped @ 2000 lbf, minor deformation noted in H-module bracket. |

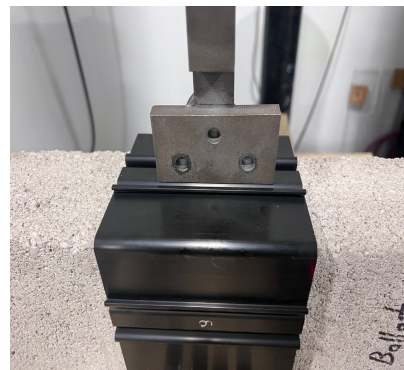
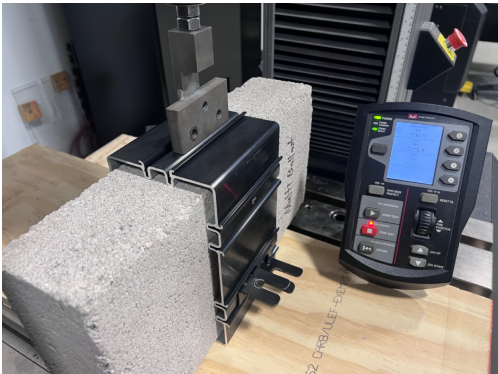
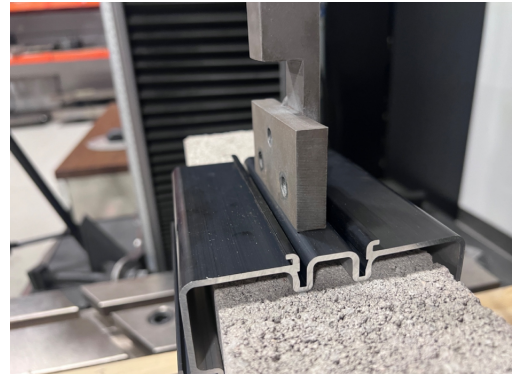
**Photo 8:** Compression test, setup #3

**Photo 9:** Compression test, setup #3

**Photo 10:** Compression test #3 post test

| CLIENT | | PROJECT/TEST DESCRIPTION | | CLIENT ORDER NO. |
|---|---|---|---|---|
| <p>The Multiballast was installed on the concrete block by sliding the mounting bracket over the block. On the wide side of the block, there was a H-module bracket installed on one of the slide rails, and a 8°, 13°, 20° riser mount with a H-module bracket installed on top of that on the other rail. Test specimen was provided to us assembled by the client (photo 1). The test assembly was then clamped to the table of our universal test machine (UTM) plywood to give adequate clamping force without prematurely damaging the assembly (photo 2).</p> <p>The UTM was then bolted to the H-module bracket which was installed the riser mount installed on the Multiballast base mount using the designed slide rails for installation. Using only 1 of the 2 mounting holes on the H-module the UTM was bolted to the H-module bracket (photo 3) and applied a compressive force pushing straight down on the bracket at a speed of 2 in/min. Compressive testing was done using the same method on the other H-module bracket without the riser mount (photo 5), and a 3rd test was done on the side of the assembly using a steel block about the same width as the H-module bracket to apply load directly through the Multiballast and block (photo 9).</p> | | | | |
| 3 | Multiballast to concrete block (Photo 9) | 0.099 | 2,371 | Test manually stopped @ 2000 lbf, no deformation was noted. |
