**To:** Rex Vaughn, Chair  
Cedar Lake Improvement Board

**From:** Mark Kieser, Senior Scientist  
Marwan Al Hinaai, Project Scientist  
Kieser & Associates, LLC

**RE:** **Shallow Groundwater Investigation Results for Areas Adjacent to Jones Ditch on Cedar Lake Conducted on November 24, 2025**

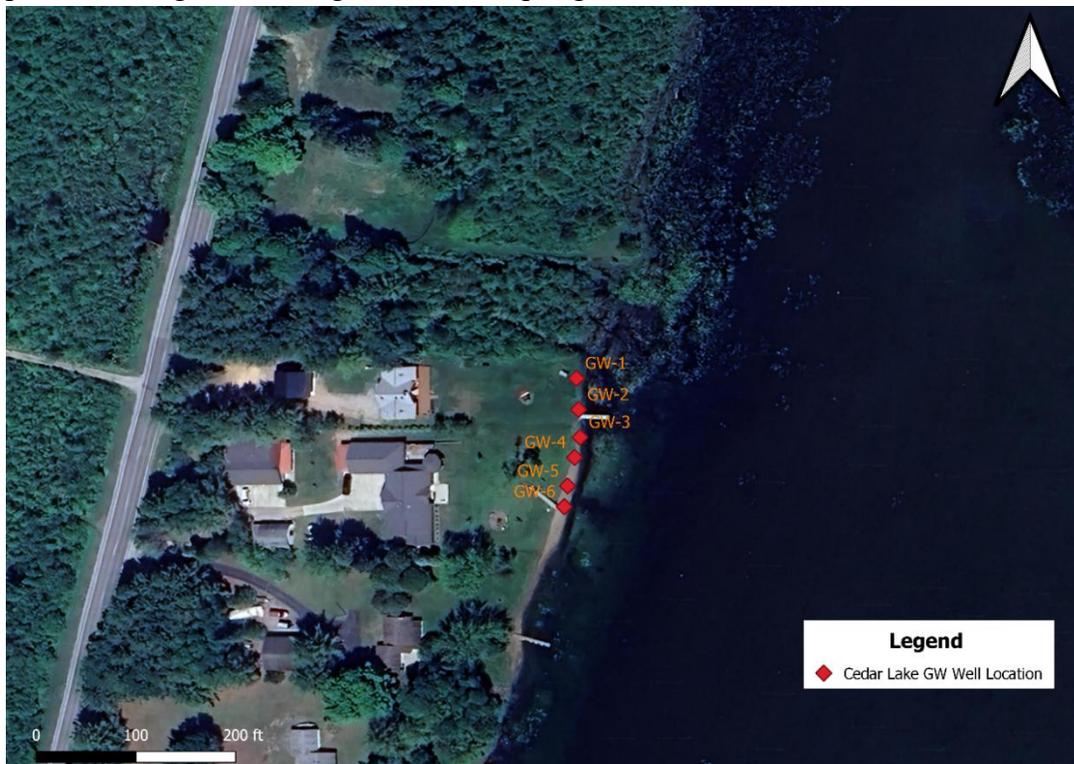
On November 24, 2025, K&A installed six temporary shallow groundwater wells along approximately 150 feet of shoreline on Cedar Lake, just south of Jones Ditch (Figure 1). The wells were placed along the residential shoreline beginning near the wetland transition at the northern end of this area extending south across two properties. The northern property included two wells, while four wells were installed on the adjacent southern property. The southern-most well was located approximately 35 feet from the southern property boundary. This boundary was identified by the landowner who was present during K&A siting of initial sampling locations.

*Figure 1. Six temporary shallow groundwater wells installed and sampled on November 24, 2025 in the vicinity of Jones Ditch.*

One-inch diameter stainless steel well screens (one foot in length) with stainless steel riser pipe were spaced roughly 25 feet apart and manually driven to depths of approximately 1.5-2.0 feet below ground surface. All well materials were power-washed before installation. Subsequent decontamination included a 10% bleach solution rinse, followed by a deionized water rinse. Groundwater was encountered at depths comparable to the adjacent lake water elevation. All wells were positioned approximately 5-10 feet inland from the shoreline.

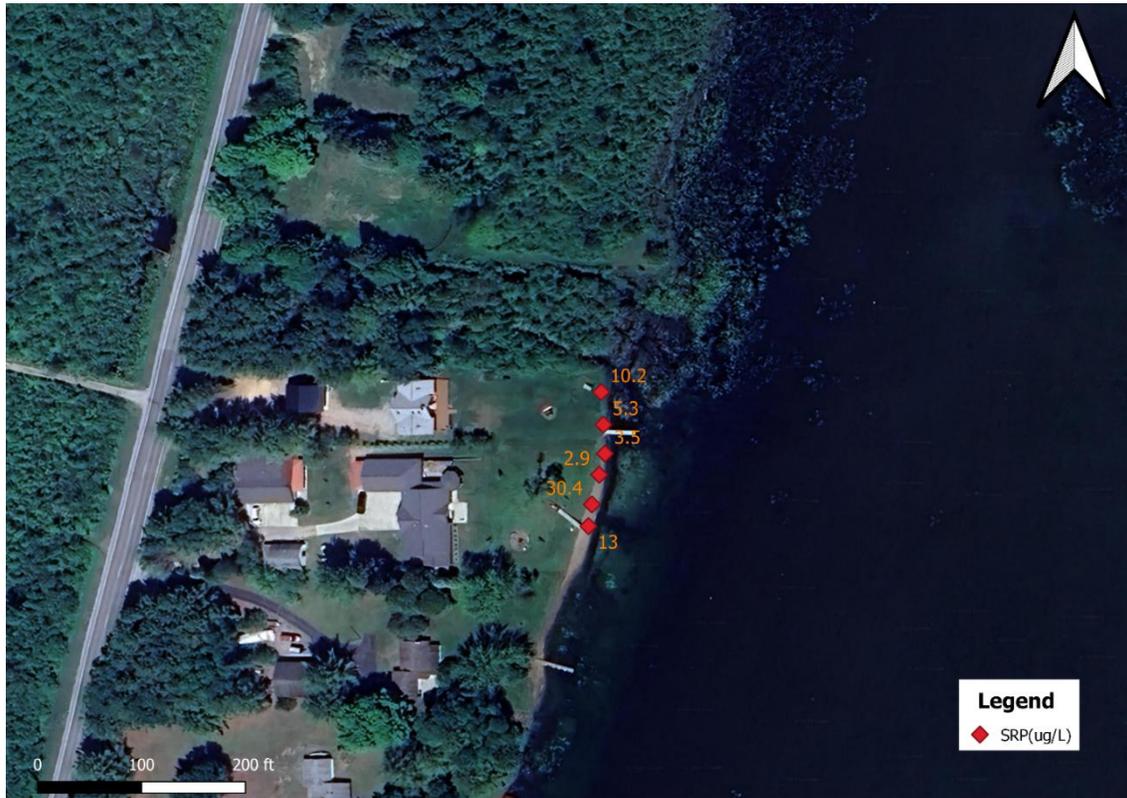
Table 1 summarizes SRP and bacteria testing results for groundwater sampling on November 24, 2025. (Attachment A contains copies of lab reports.) Figure 2 shows SRP results mapped for all six groundwater wells. SRP concentrations ranged from 2.9 µg/L to 30.4 µg/L. Based on recent and extensive groundwater sampling along shorelines of Black Lake (Cheboygan County), background SRP concentrations along undeveloped or unimpacted shorelines are about 2 µg/L. Thus, measured SRP levels generally above 2 µg/L may suggest a local septic system drain field source.

was removed by the new owner, but not the gravel bed. The highest shoreline concentrations of SRP (30.4 and 13  $\mu\text{g/L}$ ) were observed downgradient of the historic gravel bed described by the current owner.

Figure 2. SRP levels ( $\mu\text{g/L}$ ) at the six temporary shallow groundwater wells at Jones Ditch based on November 11, 2025 sampling.

- Shallow groundwater appears to be impacted by SRP in at least 5 of the 6 Cedar Lake shoreline locations sampled. The concentration of 30.4 µg/L in front of a former septic system gravel bed is sufficient to stimulate luxuriant *Chara* growth observed in the summer of 2025 at this shoreline location. The highest nearshore/in-lake surface water concentration at this location was 3.3 µg/L from K&A's August 27, 2025 monitoring. This abandoned gravel field may continue to leach soluble phosphorus into the near future.

1. Complete PCR analyses to evaluate human contributions to microbial loading from select November 11, 2025 samples.
2. Consider additional analysis of existing PCR samples for mammalian and/or avian DNA sources.
3. Conduct follow-up sampling during periods of measurable Jones Ditch flow in the spring of 2026 for SRP, bacteria and PCR analyses.
4. Evaluate septic system proximity and potential hydrologic connectivity to surface waters along Jones Ditch.
5. Consider additional groundwater sample collection on the CLIB property in relation to the former septic system.
6. Consider PCR analysis of additional shoreline surface water samples collected in the summer of 2026.
7. Consider nearshore/in-lake groundwater testing along this shoreline in 2026.
