A Summary of Findings from LakeScan™
Guided Surveys and Analysis of:

Cedar Lake South

2024 DATA AND ANALYSIS SUMMARY REPORT WITH MANAGEMENT RECOMMENDATIONS

Kieser & Associates, LLC

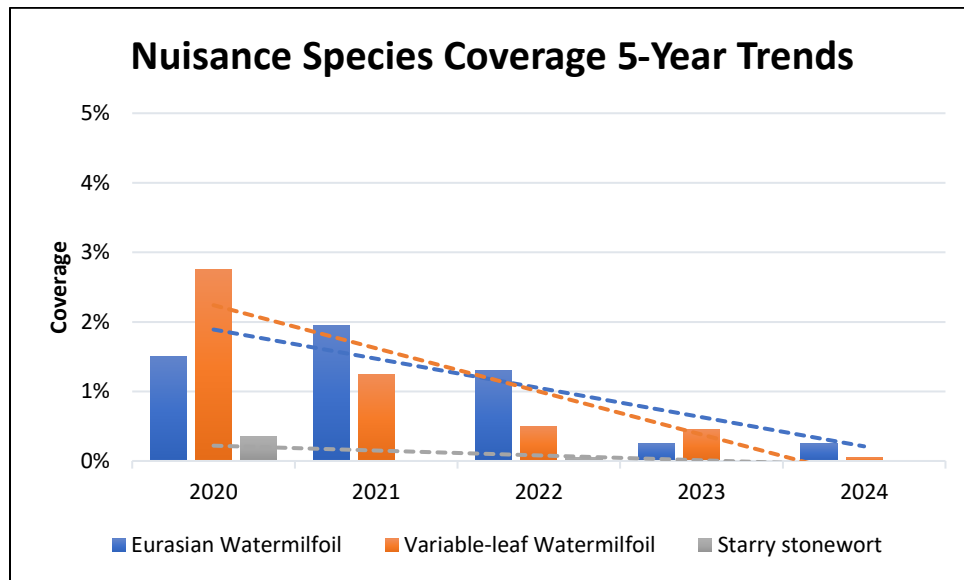
Figure ES-1 – Nuisance species coverage 5-year trends.

Over the last five years, variable-leaf watermilfoil (*Myriophyllum heterophyllum*), Eurasian watermilfoil, and starry stonewort (*Nitellopsis obtusa*) in Cedar Lake South have exhibited declining trends (Figure ES-1). Coverage of the variable-leaf watermilfoil has decreased by 2% since 2020 and has remained consistently under 3% throughout the last five years (Figure ES-1). Eurasian watermilfoil has remained consistently under 2% coverage over the past five years, but did have the same coverage as last year (0.25%), indicating that the species might have reached a stable population level or is exhibiting resistance to the current management regimen preventing lower coverages from being observed. Starry stonewort which was last found in 2022, was again not found during either survey in 2024, demonstrating the continued success of mitigating the rebound and spread of the species.

- **Continued management of Eurasian watermilfoil.**
 - Watermilfoil coverages have trended downward over the last five years with average coverage in 2022-2024 at less than 1%. Thus, current management interventions appear to be effective at suppressing growth and reducing the cumulative coverage of nuisance watermilfoil presence. Despite downward five-year trends, Eurasian watermilfoil populations might be stabilizing around 0.25%. While eradication of the species may be unlikely, a harsher management regimen might be explored. Therefore, it is recommended that the Cedar Lake Improvement Board continues exploring management options for effectively treating nuisance watermilfoil conditions in Cedar Lake South.

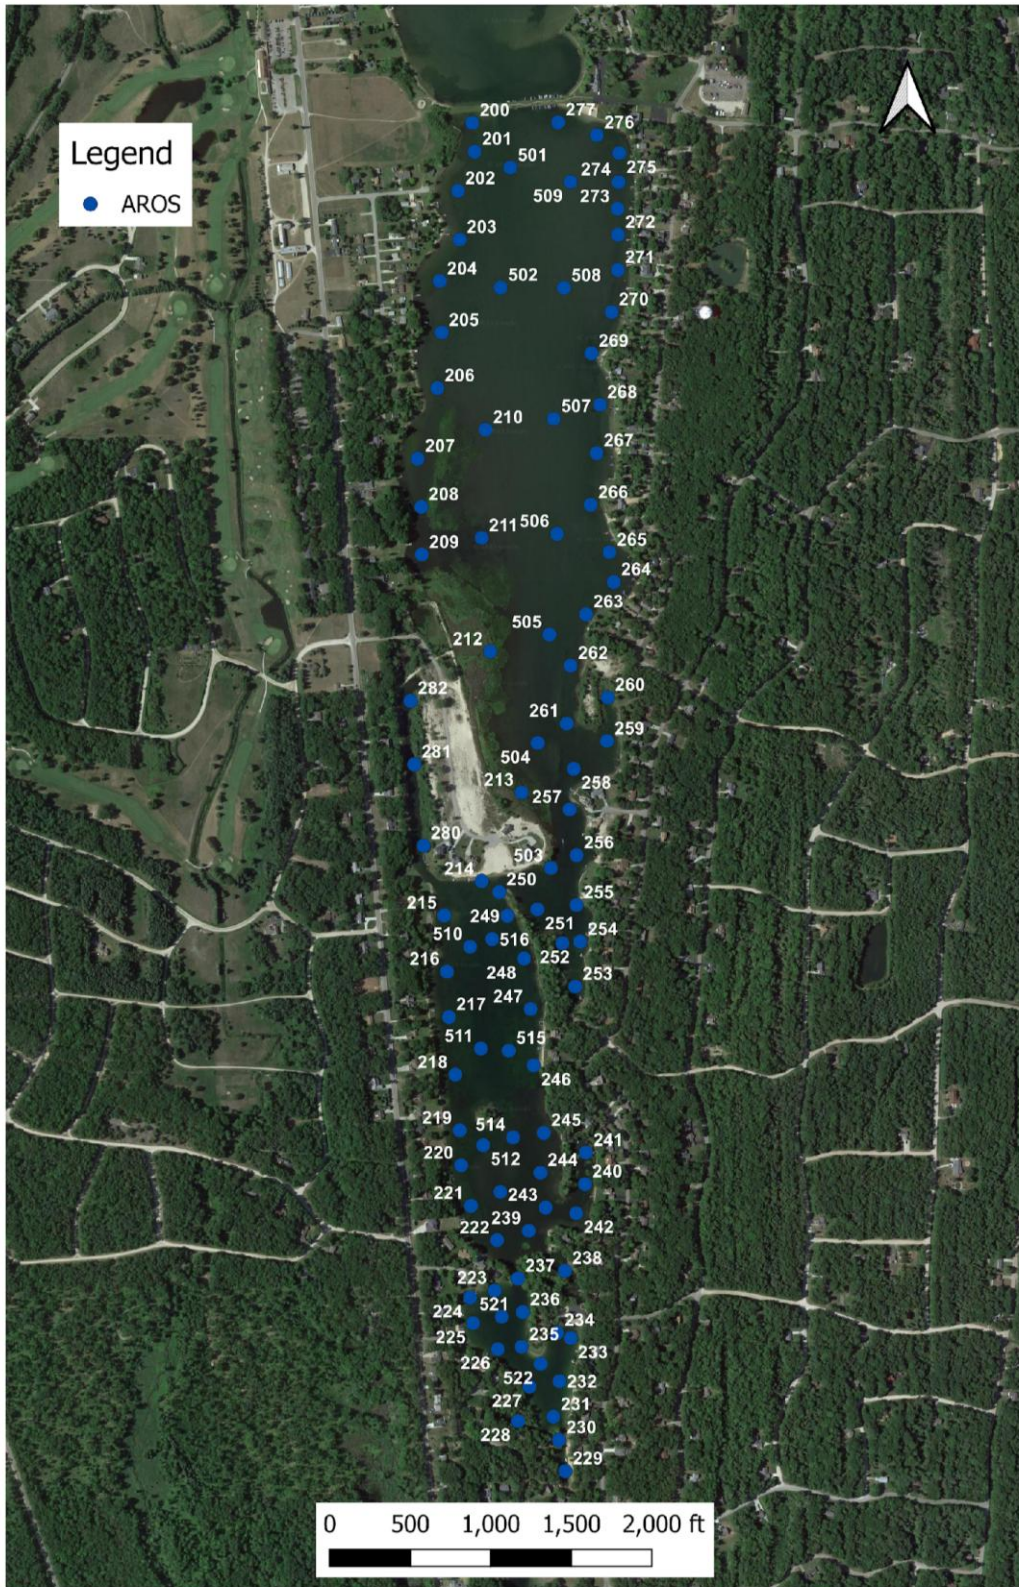
Figure 1 - Map of Aquatic Resource Observation Sites (AROS).

The LakeScan™ analysis involves collecting data over two vegetation surveys during the critical summer recreational season. These surveys are based on a system where the lake is first divided into biological tiers (Table 1) and then further subdivided into Aquatic Resource Observation Sites (AROS; Figure 1). For each survey, field personnel record the density, distribution, and position in the water column of each aquatic plant species in each AROS, as well as noting any nuisance conditions. Dissolved oxygen profiles, temperature profiles, and Secchi depth are additionally recorded. Other water quality sampling can be included with surveys when requested.

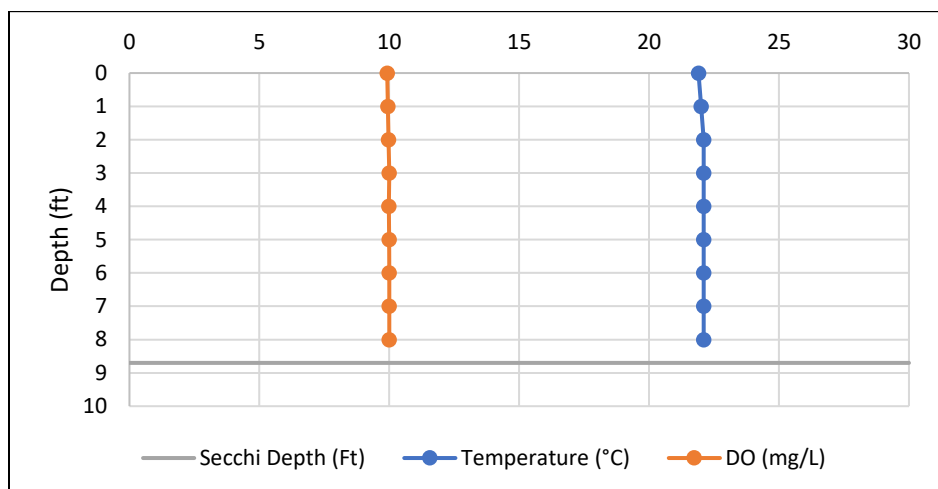
Figure 2 – Early-season survey (7/1/2024) dissolved oxygen and temperature profiles with Secchi depth, taken near AROS 214.

Secchi disk clarity on Cedar Lake South was clear to bottom at around 8ft during both surveys, illustrating stability in water clarity throughout the summer of 2024 (Figures 2 and 3). The DO and temperature profiles remained consistent across the two surveys with no notable stratification, which is expected on Cedar Lake due to its shallow depths. Temperatures did increase by roughly 4 °C and DO decreased by nearly 2 mg/L between the early and late-season surveys, reflecting the warmer summer temperatures leading up to the late-season survey.

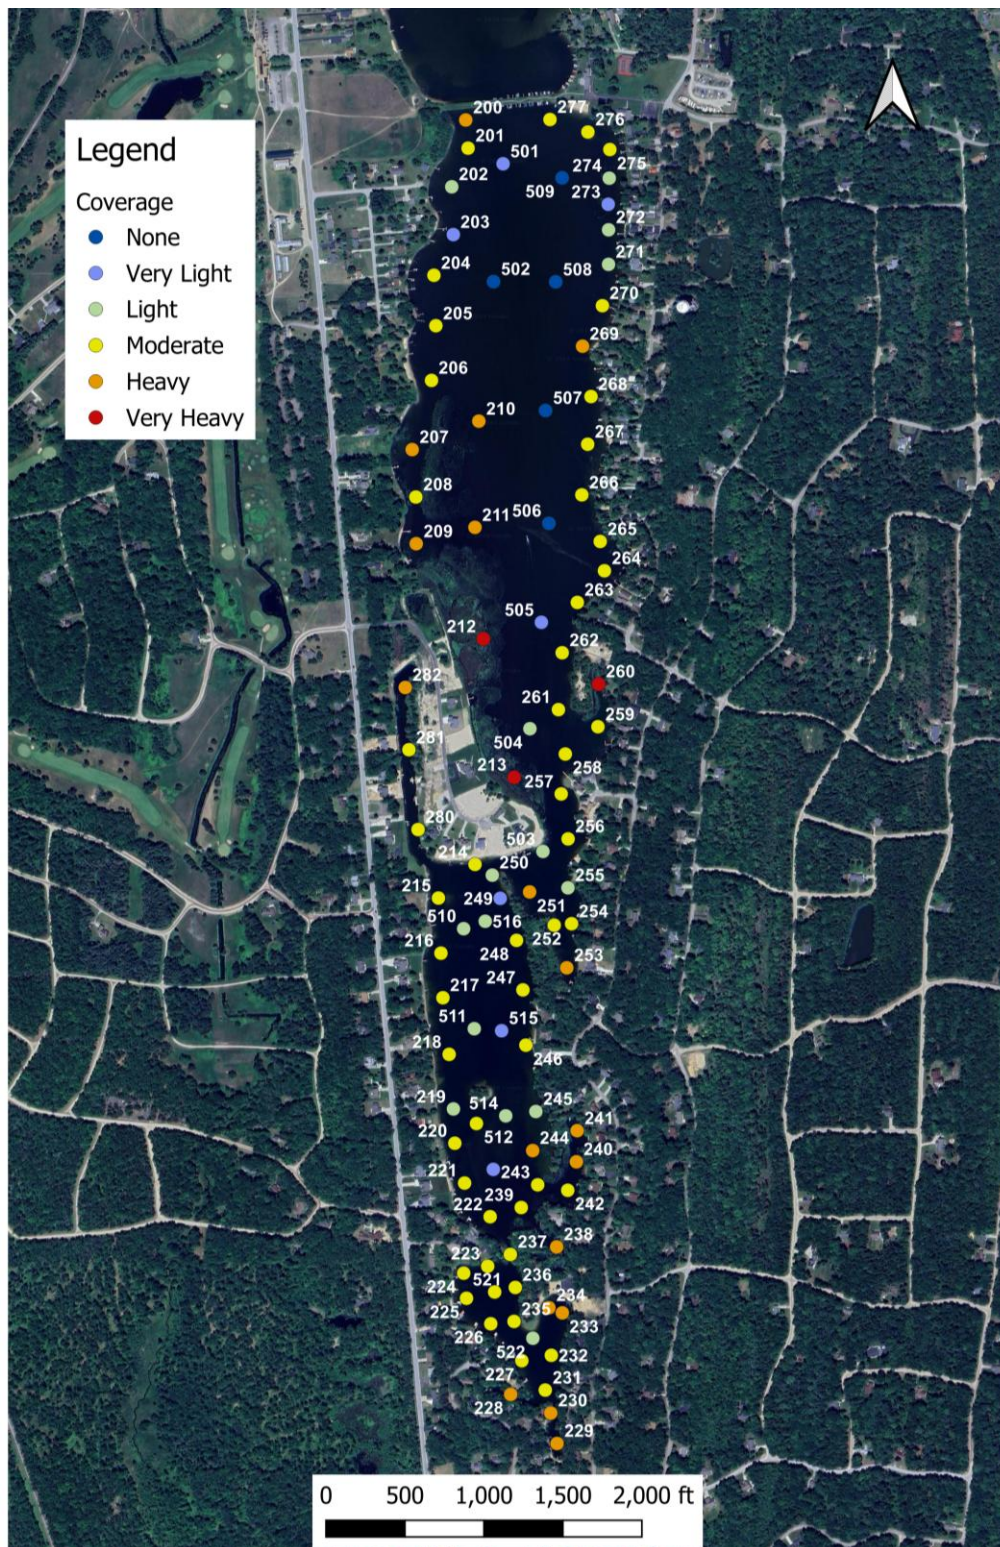
Figure 4 – Early-season survey (7/1/2024 & 7/2/2024) vegetation 3D Density (a function of observed vegetation coverage, and height of all vegetation species).

A visual depiction of the data on all combined species observed in Cedar Lake South during the early-season survey is displayed using three-dimensional density, which reflects a combination of vegetation density, distribution and height observations for all species observed during the survey (Figure 4). Color-coding is provided for each AROS to spatially depict observed vegetation data. The colors range in a gradient from dark blue which depicts no vegetation observed, to yellow depicting medium density and distribution of plant species, to red which depicts high density and distribution of vegetation within the AROS.

The most common native species observed during the early-season survey on Cedar Lake South were *Chara*, broadleaf pondweed, white waterlily, rushes, and Richardson's pondweed. *Chara* was the most commonly observed species, and was found at moderate to high densities throughout a majority of observation areas. Broadleaf pondweeds were observed at moderate densities around the lake, flowering in many locations, but typically not causing any nuisance concerns, except in AROS 256, 257, 268, 269, 276 which had tall broadleaf pondweed growing to the surface which could cause some minor recreational nuisance conditions.

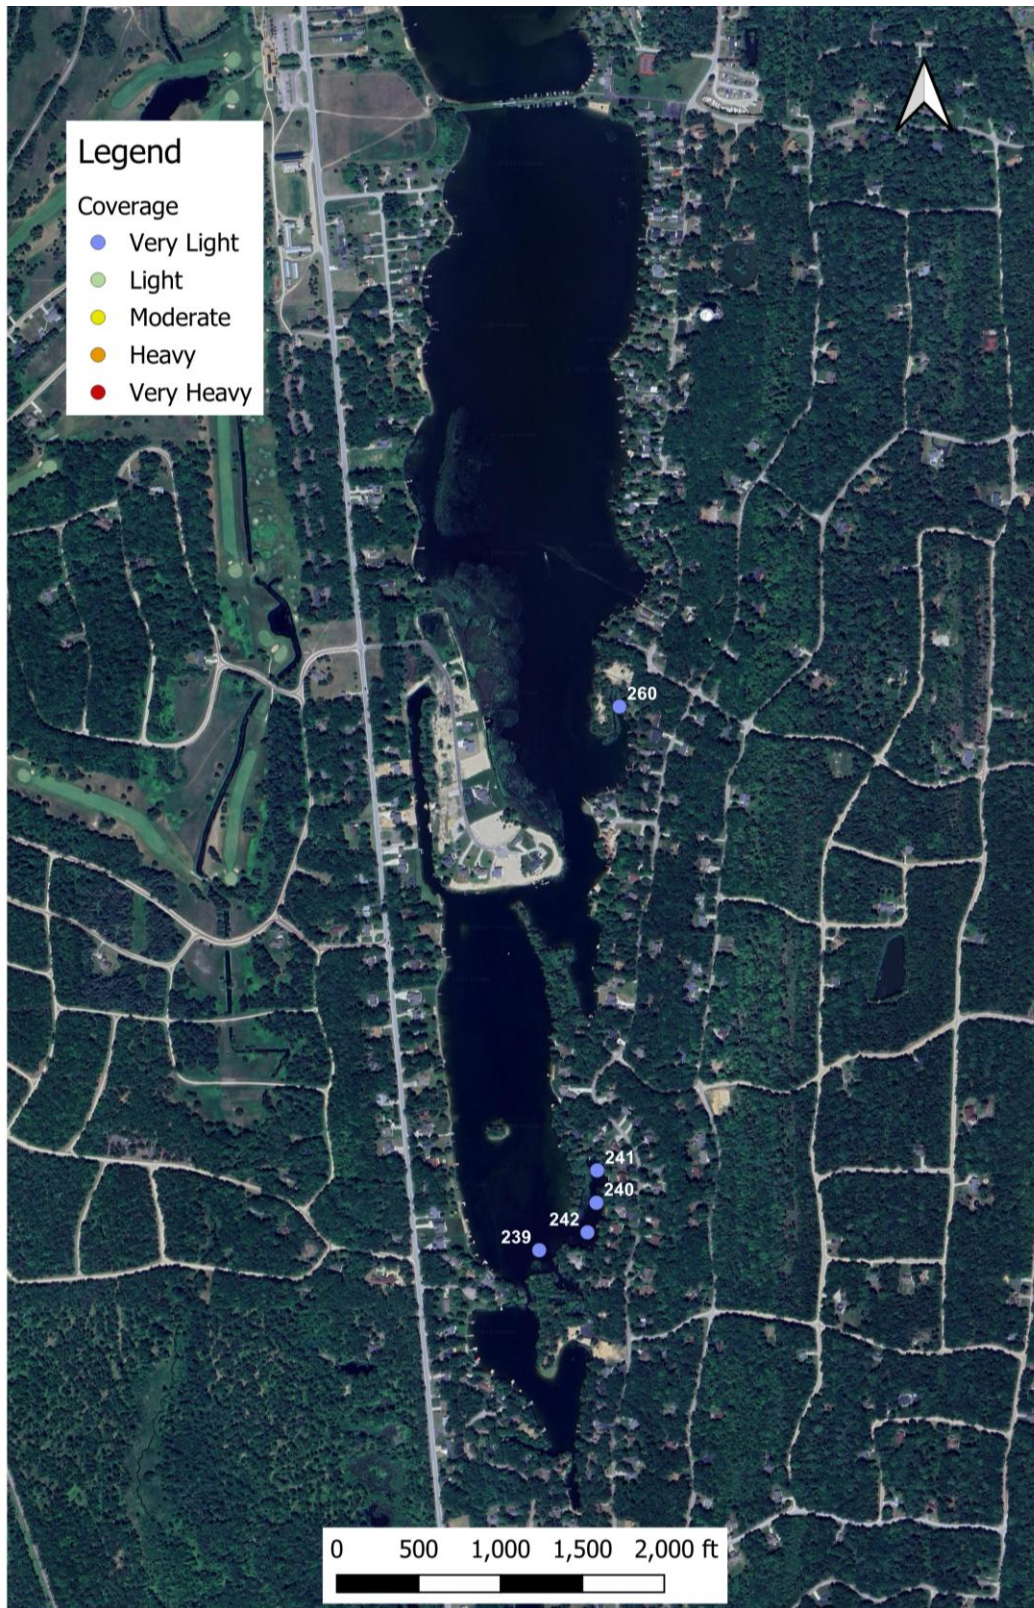
Figure 5 – Early-season (7/1/2024 & 7/2/2024) Eurasian watermilfoil coverage (a combination of the LakeScan™ density and distribution observations).

The only submerged aquatic invasive species observed in Cedar Lake South during the 2024 early-season survey was hybrid Eurasian watermilfoil. Eurasian watermilfoil was found in light clusters in AROS 239-242 and 260 (Figure 5). Additionally, the emergent invasive species purple loosestrife was found at two

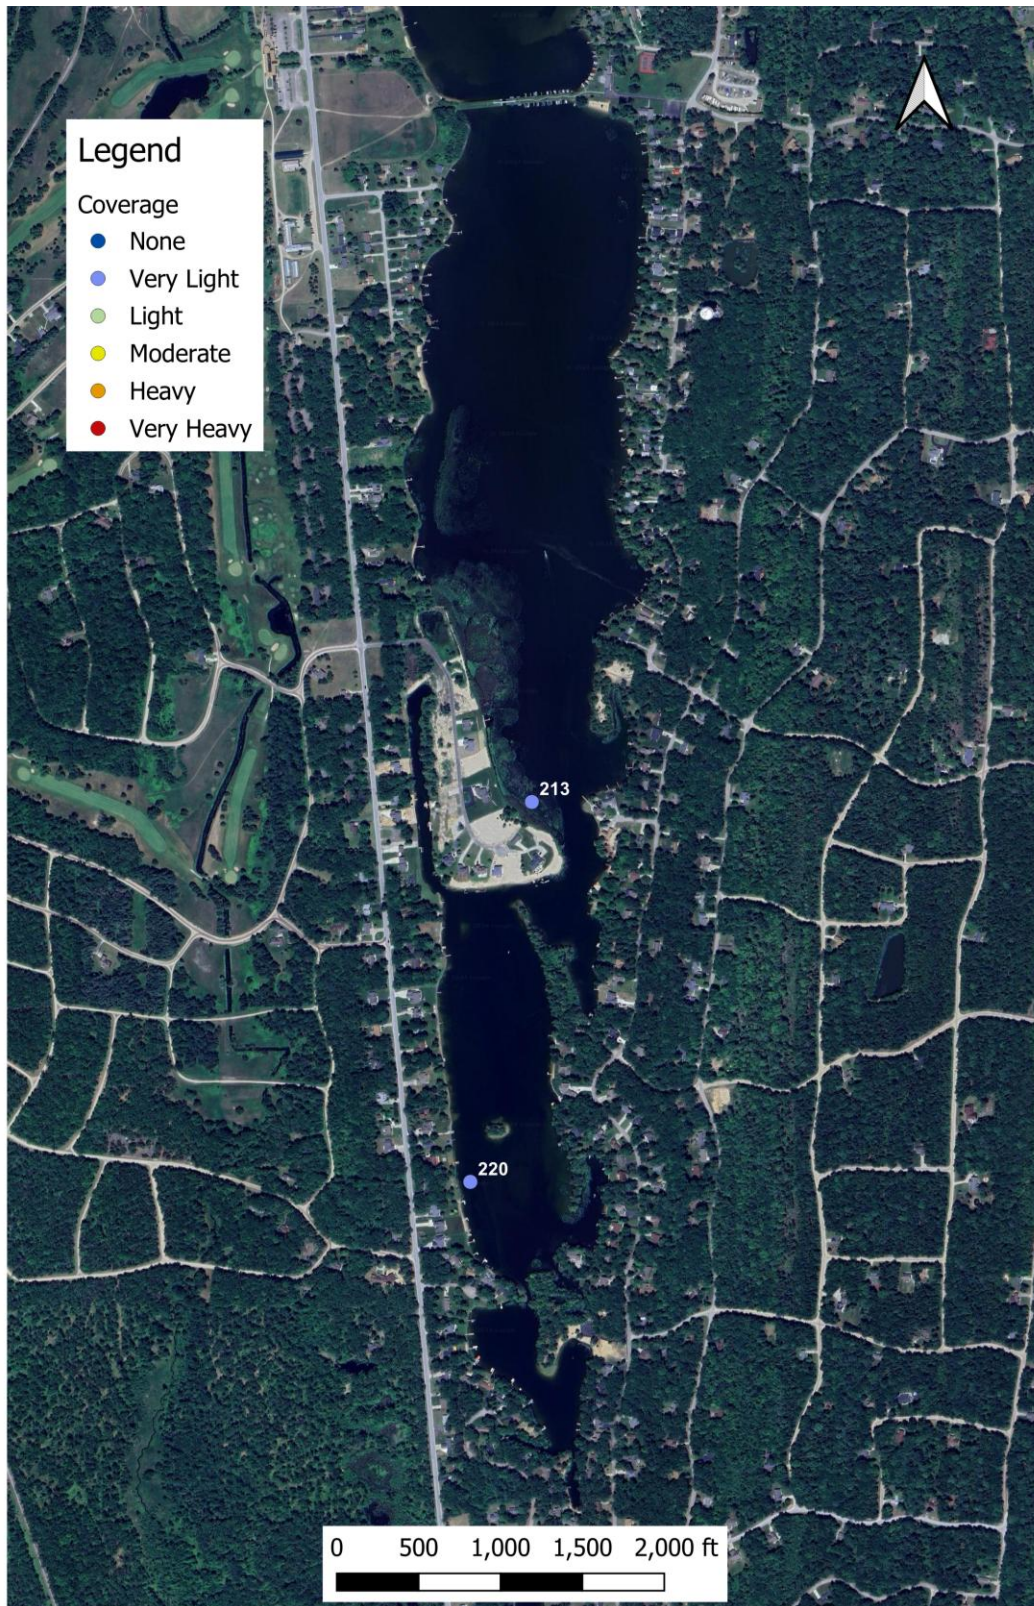
Figure 6 – Early-season (7/1/2024 & 7/2/2024) purple loosestrife coverage.

locations along the shoreline (AROS 213 and 220), not causing any management concerns at the time of the survey (Figure 6).

Given the scattered shoreline distribution of purple loosestrife noted in Cedar Lake South with stand-alone clusters of this emergent wetland invasive species, consideration of voluntary riparian owner removal should be recommended as part of the updated Cedar Lake Watershed Management Plan. Whereas increasing stands noted in Cedar Lake North recommended for potential treatment with biocontrols, observations suggest that proper manual removal efforts along shorelines in Cedar Lake South could be sufficient to limit the growth and spread of this species.

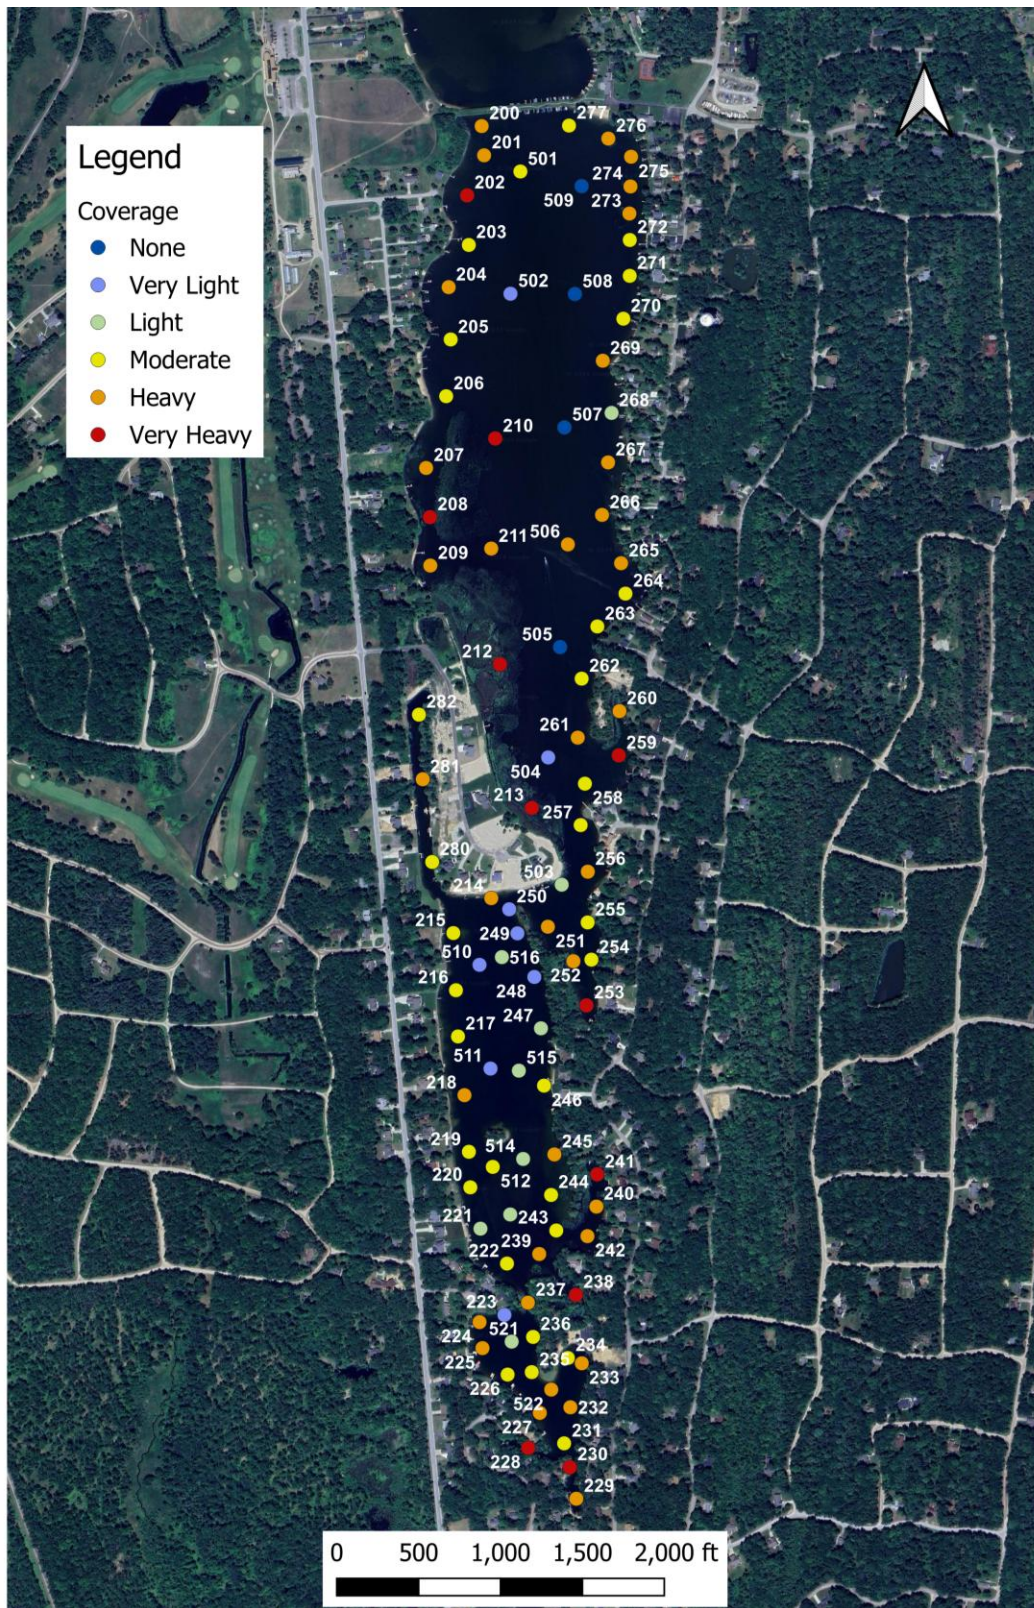
Figure 7 – Late-season survey (8/7/2024 & 8/8/2024) vegetation 3D Density (a function of observed vegetation coverage, and height of all vegetation species).

A visual depiction of the data on all combined species observed in Cedar Lake South during the late-season survey is displayed using three-dimensional density in Figure 7. The most common native species observed during the survey were *Chara*, broadleaf pondweed, white waterlily, naiad, rushes, and Richardson's pondweed. *Chara* was the most commonly observed species, and was found at moderate to high densities throughout a majority of observation areas. Native pondweeds were observed at moderate densities around the lake, flowering in many locations, but typically not causing any nuisance concerns, except in AROS 200-202, 268-270, 275-277, 222, 237, 231, and 239 which had tall pondweeds growing to the surface. Variable-leaf watermilfoil was only found in AROS 226 at the time of the survey (Figure 8).

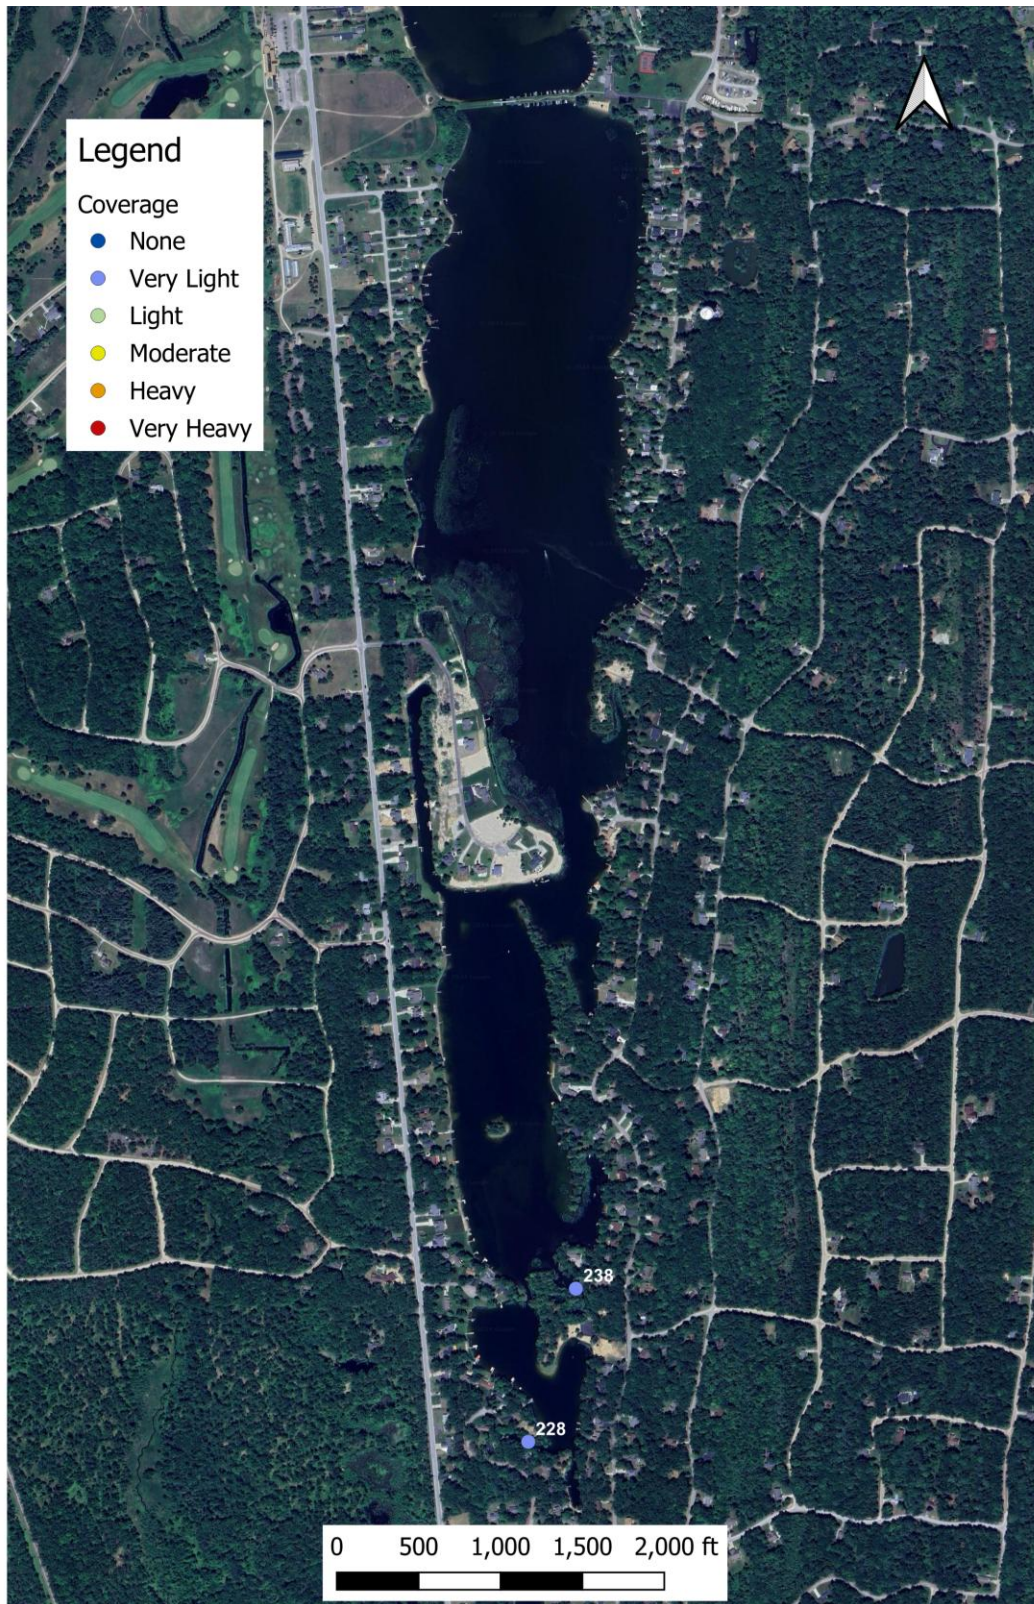
Figure 9 – Late-season (8/7/2024 & 8/8/2024) Eurasian watermilfoil coverage.

The only submerged aquatic invasive species observed in Cedar Lake South during the 2024 late-season survey was hybrid Eurasian watermilfoil. Eurasian watermilfoil was found in light clusters in AROS 228 & 238 (Figure 9). The emergent invasive species purple loosestrife was flowering and more conspicuous at the time of the survey, and was found at many shoreline locations, but was typically only seen in light stand-alone clusters, not warranting any CLIB-led management recommendations (Figure 10).

Watermilfoil coverages have trended downward over the last five years with average coverage in 2022-2024 at less than 1%. Thus, current management interventions appear to be effective at suppressing growth and reducing the cumulative coverage of nuisance watermilfoil presence. Despite downward five-year trends, Eurasian watermilfoil populations might be stabilizing around 0.25%. While eradication of the species may be unlikely, a harsher management regimen might be explored. Therefore, it is recommended that the Cedar Lake Improvement Board continues exploring management options for effectively treating nuisance watermilfoil conditions in Cedar Lake South.

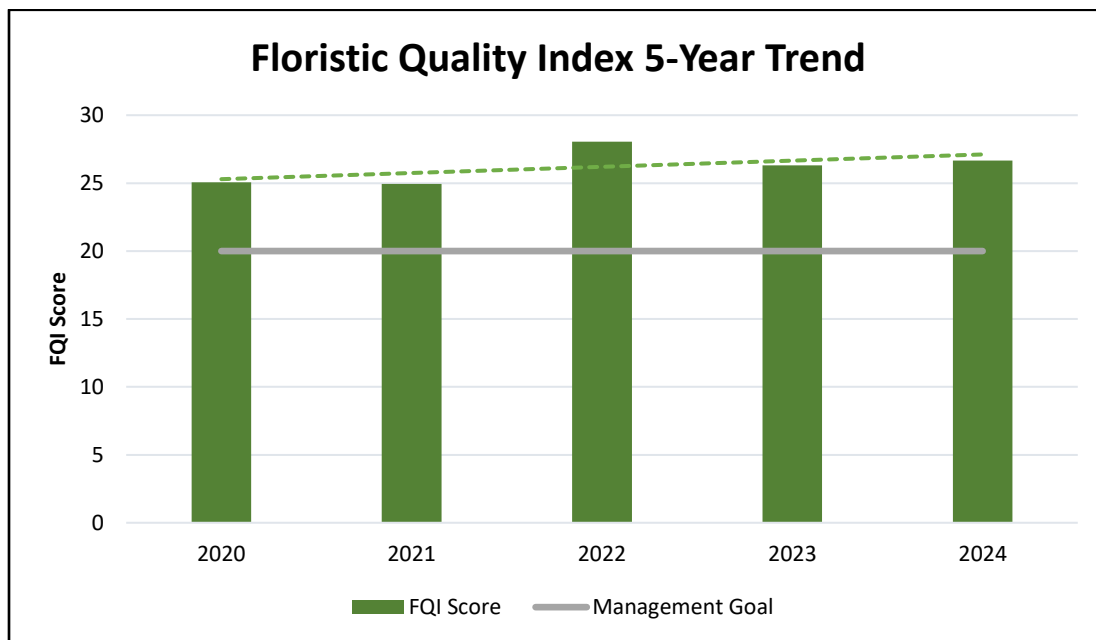
Figure 11 – Floristic Quality Index 5-Year Trend.

Over the past five years, the Floristic Quality Index on Cedar Lake North has exhibited a positive trend, indicating an increase in desirable, native plants and a decrease in undesirable, invasive aquatic species such as starry stonewort and Eurasian watermilfoil (Figure 11). Cedar Lake South has met the FQI management score of 20 each year for the past the last five years, indicating that a high level of floristic quality in the lake is being maintained by the current management regimen.

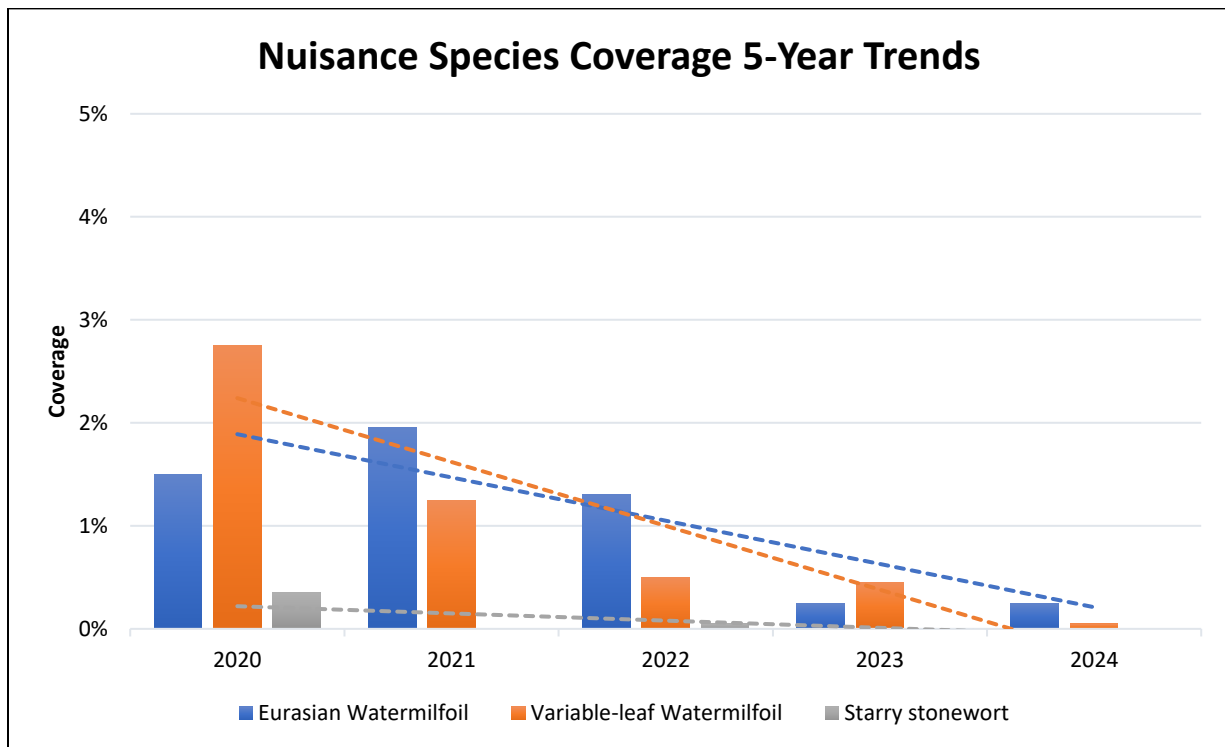
Figure 12 – Nuisance species coverage 5-year trends.

Over the last five years, variable-leaf watermilfoil, Eurasian watermilfoil, and starry stonewort in Cedar Lake South have exhibited declining trends (Figure 12). Coverage of variable-leaf watermilfoil has decreased by 2% since 2020 and has remained consistently under 3% throughout the last five years. Eurasian watermilfoil has remained consistently under 2% coverage over the past five years, but did have the same coverage as in 2023 (0.25%), indicating that the species might have reached a stable population level. While eradication of the species may be unlikely, a harsher management regimen might be explored to address this observed stabilization. Starry stonewort, which was last found in 2022, was again not found during either survey in 2024, demonstrating the continued success of mitigating the rebound and spread of the species. The overall coverage of all nuisance species in Cedar Lake South remains minor, indicating that management activities are successfully controlling nuisance species populations on a multi-year basis.

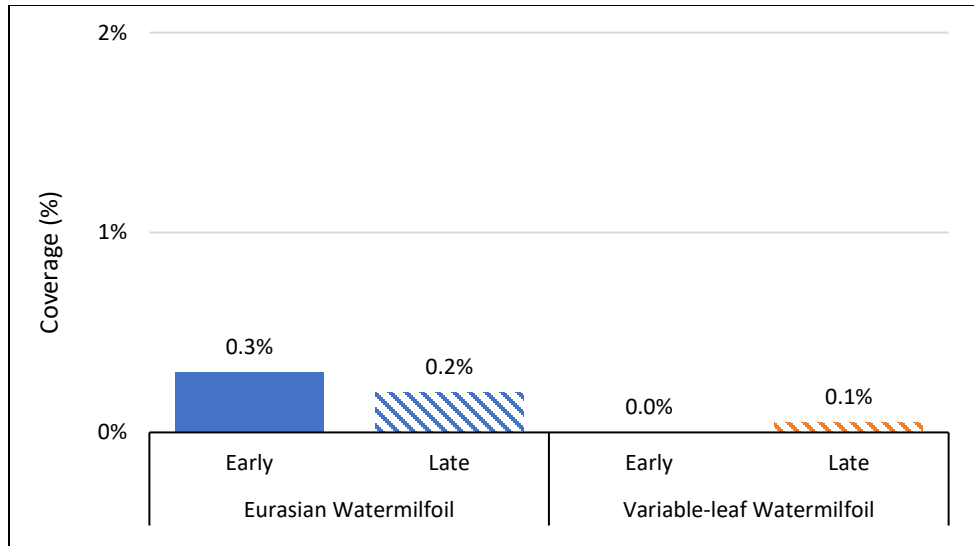
Figure 13 – Changes in coverage across both surveys for targeted species.

During the early-season survey, which occurred 13 and 14 days after the first herbicide treatment, Eurasian watermilfoil was found at 0.3% coverage and decreased slightly to 0.2% by the late-season. The average coverage of Eurasian watermilfoil was the same in 2024 compared to 2023 and the species has maintained low and manageable levels of coverage at less than 1% from 2022-2024, indicating multi-year success of current herbicide treatments on managing the spread of the hybrid Eurasian watermilfoil and repressing nuisance conditions (Figure 13).

Variable-leaf watermilfoil had lower coverages than Eurasian watermilfoil with 0% coverage in the early-season and 0.1% coverage in the late season. The relatively low coverages of less than 1% across both surveys, further demonstrates the effectiveness and long-term success of the current treatment regimen on managing nuisance variable-leaf watermilfoil conditions.

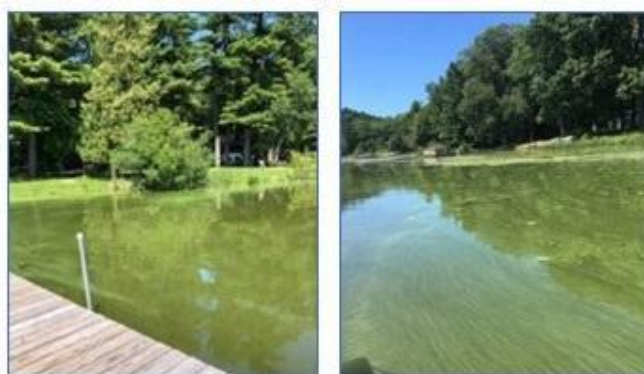
Figure A1 - Example blue green algae images from the 2019 LakeScan™ field crew.

Blue green algae blooms are becoming increasingly common in Michigan. Blooms can appear as though green latex paint has been spilled on the water, or resemble an oil slick in enclosed bays or along leeward shores. Blue green algae blooms are usually temporal events and may disappear as rapidly as they appear. Blue green algae blooms are becoming more common for a variety of reasons; however, the spread and impact of zebra mussels has been closely associated with blooms of blue green algae.

Blue green algae are really a form of bacteria known as cyanobacteria. They are becoming an important issue for lake managers, riparian property owners and lake users because studies have revealed that substances made and released into the water by some of these nuisance algae can be toxic or carcinogenic. They are known to have negative impacts on aquatic ecosystems and can potentially poison and sicken pets, livestock, and wildlife. Blue green algae can have both direct and indirect negative impacts on fisheries. Persons can be exposed to the phytotoxins by ingestion or dermal absorption (through the skin). They can also be exposed to toxins by inhalation of aerosols created by overhead irrigation, strong winds, and boating activity.

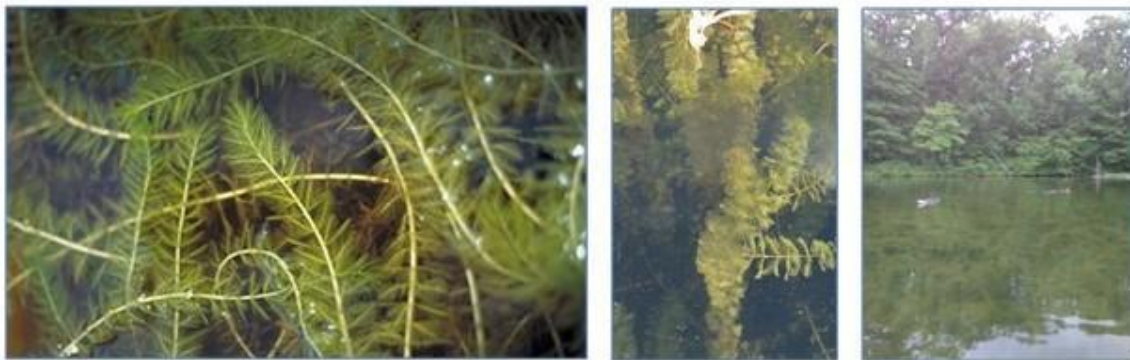
Figure A2 - Example Eurasian Watermilfoil and Hybrids images from the 2019 LakeScan™ field crew.

the dominance of distinct milfoil genotypes. Some of these genotypes may be more herbicide resistant than others and treatment strategies must be adjusted to remain effective in different parts of the lake.

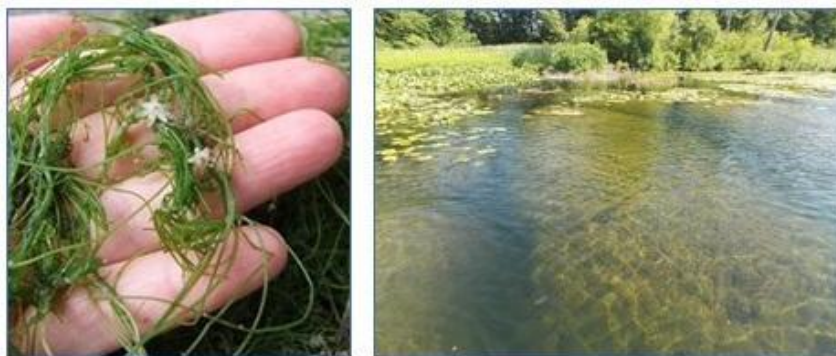
Figure A3 - Example starry stonewort images from the 2019 LakeScan™ field crew.

Starry stonewort chemical treatments using copper-, diquat-, flumioxazin, and endothall-based algaecides have produced mixed results and long-term management has yet to be achieved using chemical biocides alone.¹¹ While starry stonewort is susceptible to most selective algaecides, the dense mats of vegetation are very difficult to penetrate and provide reasonable biocide exposure. Consequently, multiple algaecide applications may be required to “whittle down” dense starry stonewort growth if the mats reach sufficient height.

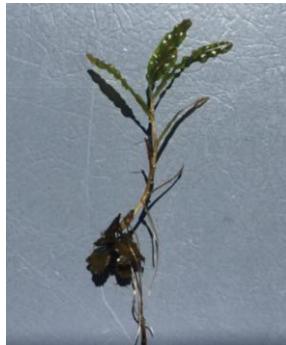
Figure A4 - Example curly leaf pondweed image from the 2021 LakeScan™ field crew.

Management: Like other invasive species, curly-leaf pondweed is difficult to control once established and is considered widespread in Michigan. Therefore, prevention of new populations in uninfected waters is the most economical management approach. Several herbicides have been shown to be effective at long-term control of curly-leaf pondweed, but eradication is difficult after establishment. Bottom barriers have shown effectiveness at combating curly-leaf pondweed in small areas, and mechanical harvesting of curly-leaf pondweed can be effective if timed and managed correctly.¹⁴

The most viable ways to control curly-leaf pondweed is through chemical and physical means after developing an integrated pest management plan. Early infestations may best be controlled by manual removal, diver-assisted suction harvesting (DASH), or benthic barrier use during spring before turions are produced. Aquatic herbicides including endothall, diquat, and flumioxazin are the most effective for general applications. Aquatic herbicides including flumioxazin and imazamox are effective for specific types of application and in specific environments. Chemical treatments are a part of a long-term integrated management plan as the turions are viable for at least 5 years and only diquat, fluridone, and some hormone treatments have shown a reduction of turion development in the laboratory.¹⁵

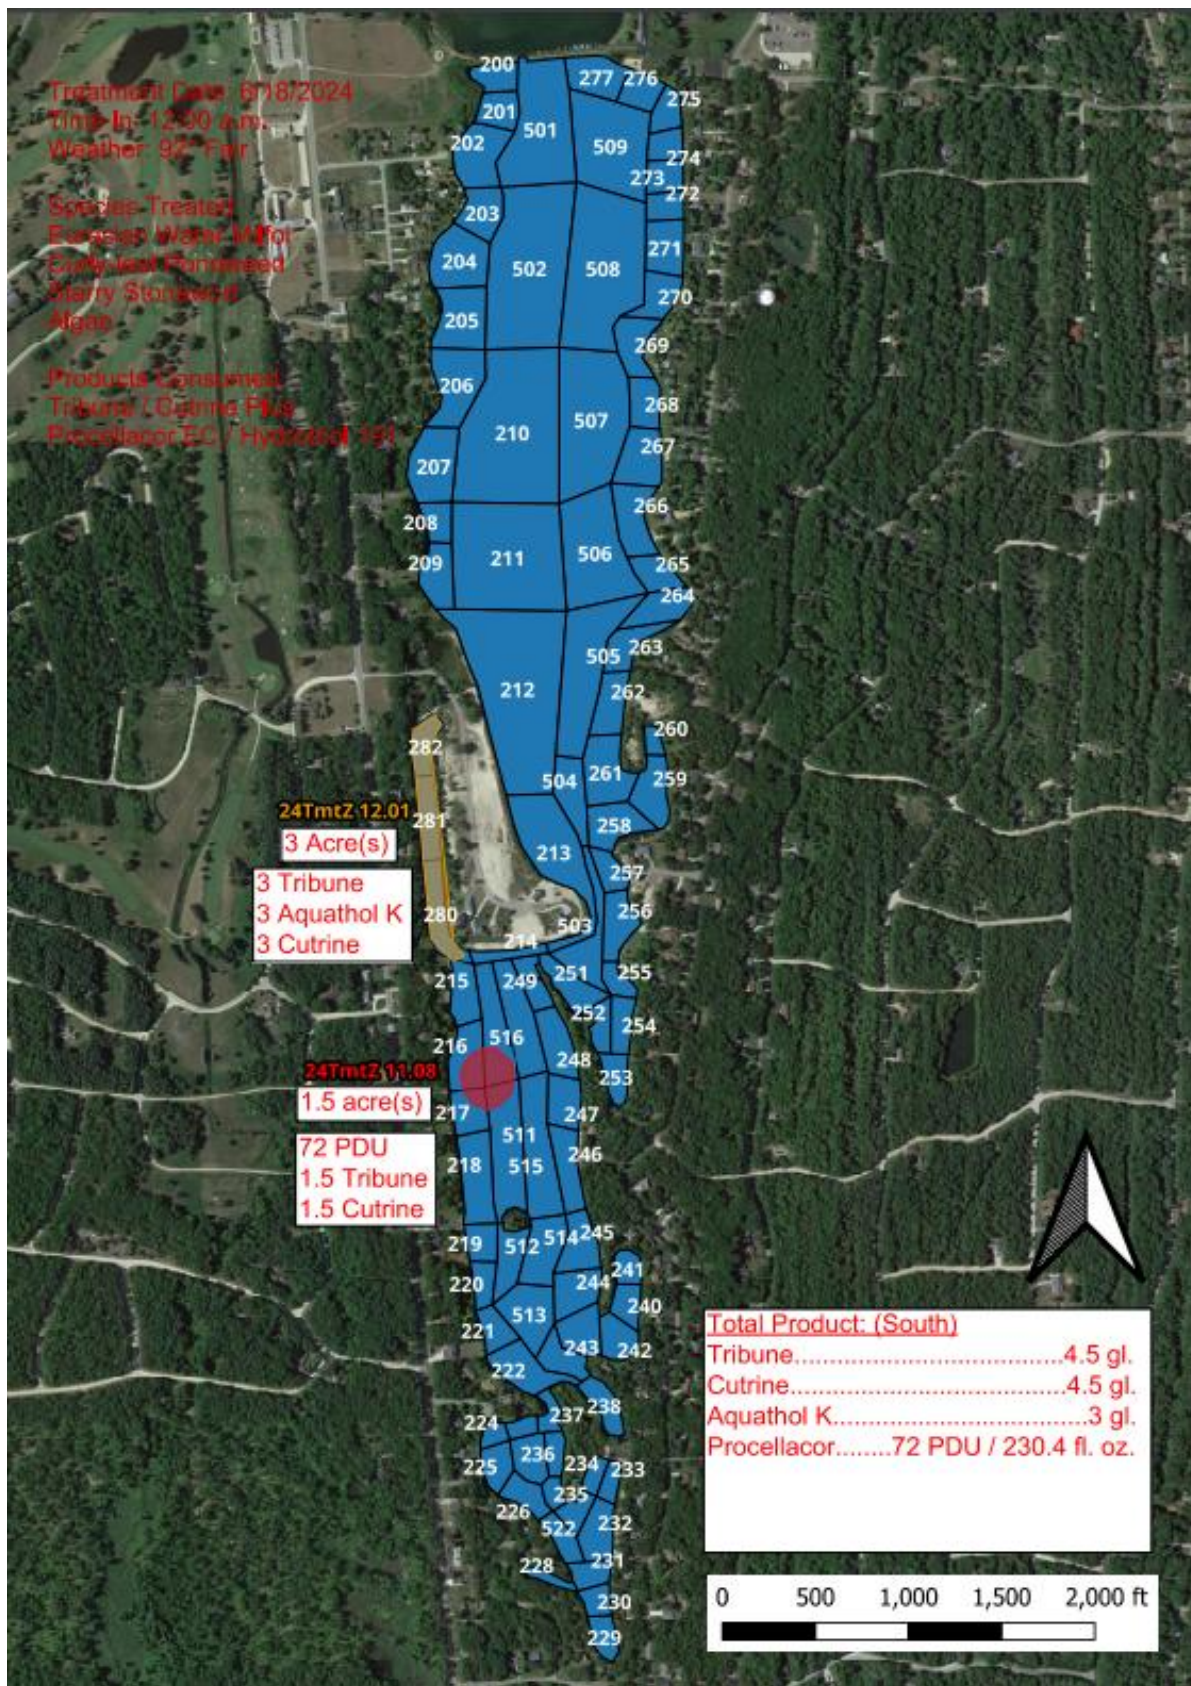
Figure B3 – Solitude Lake Management treatment map for Cedar Lake South, Iosco County, on June 18, 2024.

A total of two chemical herbicide treatments were conducted by Solitude Lake Management on the Cedar Lake South in 2024. The first chemical herbicide treatment took place on Tuesday, June 18, 2024, 13 and 14 days prior to the early-season survey. Solitude reported that the treatment targeted roughly 4.5 acres with treatment applications that target Eurasian watermilfoil, curly-leaf pondweed, starry stonewort, and algae using Tribune, Cutrine, Aquathol K, and ProcellaCOR. Aquathol K was only used in the shallow channel (AROS 280-282) to alleviate nuisance conditions. The second and final chemical herbicide treatment occurred on September 18, 2024. The treatment targeted roughly 0.25 acres of Eurasian watermilfoil using Tribune and Cutrine Plus in the southernmost channel of the lake.

It is important to note that the "species targeted" descriptors provided by Solitude and included in Appendix B Figure B3 include curly-leaf pondweed and starry stonewort as treated species for the June 18th treatment despite neither of the species being noted during surveys in the previous two years. Future species treated references provided by the applicator should be made consistent with pre-season survey findings and mutually-agreed upon target species, for accuracy in reporting. Where new invasive species are suspected by the applicator, immediate notification to K&A should otherwise be made and treatments recommendations discussed.

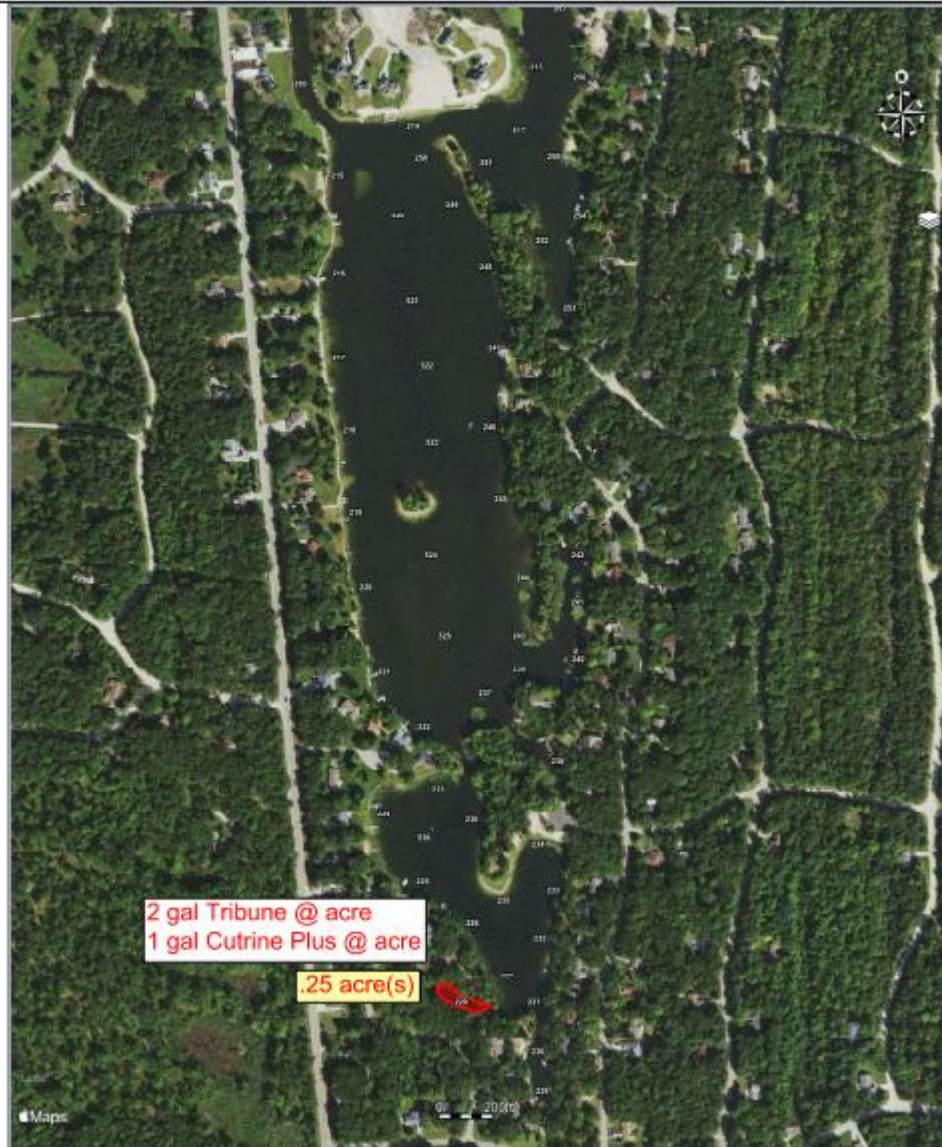
Figure B4 – Solitude Lake Management treatment map for Cedar Lake South, Iosco County, on September 18, 2024.

Treatment Date: 9/18/2024
Time In: 12:00 P.M.
Weather: 78° Fair

Species Treated:
Eurasian Water Milfoil

Products Consumed:
Tribune
Cutrine Plus
