A Summary of Findings from LakeScan™
Guided Surveys and Analysis of:

Cedar Lake South

2025 DATA AND ANALYSIS SUMMARY REPORT WITH MANAGEMENT RECOMMENDATIONS

Kieser & Associates, LLC

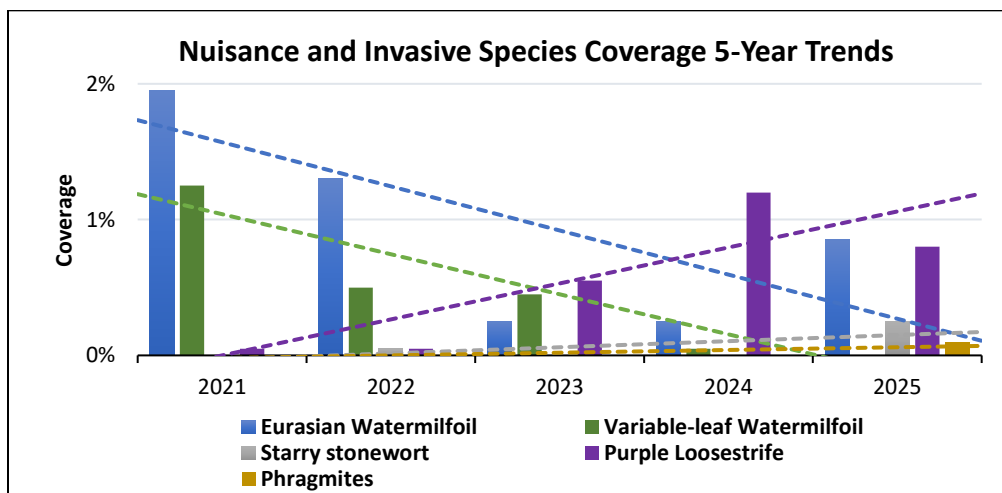
Over the past five years, coverage of Eurasian watermilfoil and variable leaf watermilfoil (*Myriophyllum heterophyllum*) a native species known to cause nuisance concerns on the lake, have exhibited declining trends while coverage of purple loosestrife, starry stonewort, and *Phragmites* have displayed recent increasing trends (Figure ES-1). Coverage of variable-leaf watermilfoil decreased from 1.2% coverage in 2021 to 0% coverage in 2025. Invasive Eurasian watermilfoil coverage has remained consistently under 2% over the past five years, but the species increased in coverage by 0.6% in the last year. It is important to note that the early-season survey occurred before the first herbicide treatment, which may have influenced the reported increase in Eurasian watermilfoil coverage in 2025. Despite increasing trendlines, purple loosestrife declined in coverage by 0.4% in the last year and *Phragmites* coverage between the two surveys was an almost negligible 0.1%. Starry stonewort was observed on the lake for the first time since 2022, which could warrant further management intervention in 2026. Despite increasing coverages for some species, the overall coverage of nuisance and invasive species in Cedar Lake South has consistently remained under 2% in the past five years. All recorded invasive species observed in 2025 were under 1% coverage.

Figure ES-1 –Nuisance and invasive species average yearly coverage 5-year trends.

- **Continued management of Eurasian watermilfoil.**
 - Eurasian watermilfoil coverage has trended downward over the last five years with average coverage in 2021-2025 at less than 1%. Thus, current management interventions appear to be effective at suppressing growth and reducing the cumulative coverage of nuisance watermilfoil presence. Despite less than 1% coverage in 2025, Eurasian watermilfoil displayed a slight increase in coverage over the past year, and the species coverage additionally increased between the early and late-season surveys indicating the possibility of species rebound. Therefore, it is recommended that the Cedar Lake Improvement Board consider deviating from the actions taken in 2025 and instead continue exploring management options similar to those conducted in previous years where reduction of the species across the two surveys was observed.

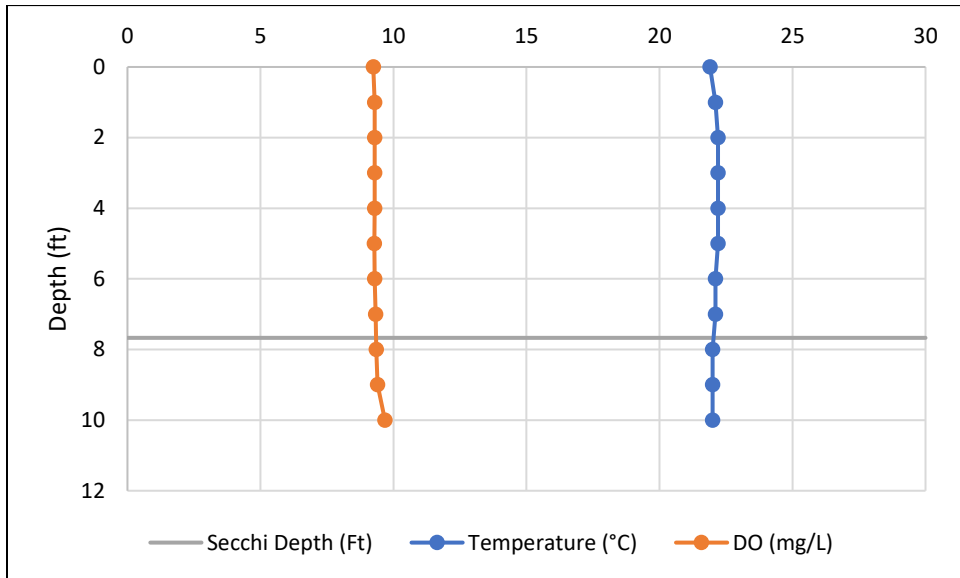
Secchi disk clarity on Cedar Lake South increased from 5.5 ft to 7.67 feet between the early and late-season surveys, respectively. This increase in water clarity could possibly be attributed to a slight decrease in lake productivity or a decrease in turbidity caused by sediment disturbance from swimming, boating, and other activities declining at the end of the recreational season. The DO and temperature profiles remained consistent across the two surveys with no notable stratification; this is to be expected due to the shallow depths of Cedar Lake (Figures 2 and 3). The only other notable difference between the two profiles was the 5 °C lower temperatures observed in the late-season.

Figure 3 – Late-season survey (8/26/25) dissolved oxygen and temperature profiles with Secchi depth.

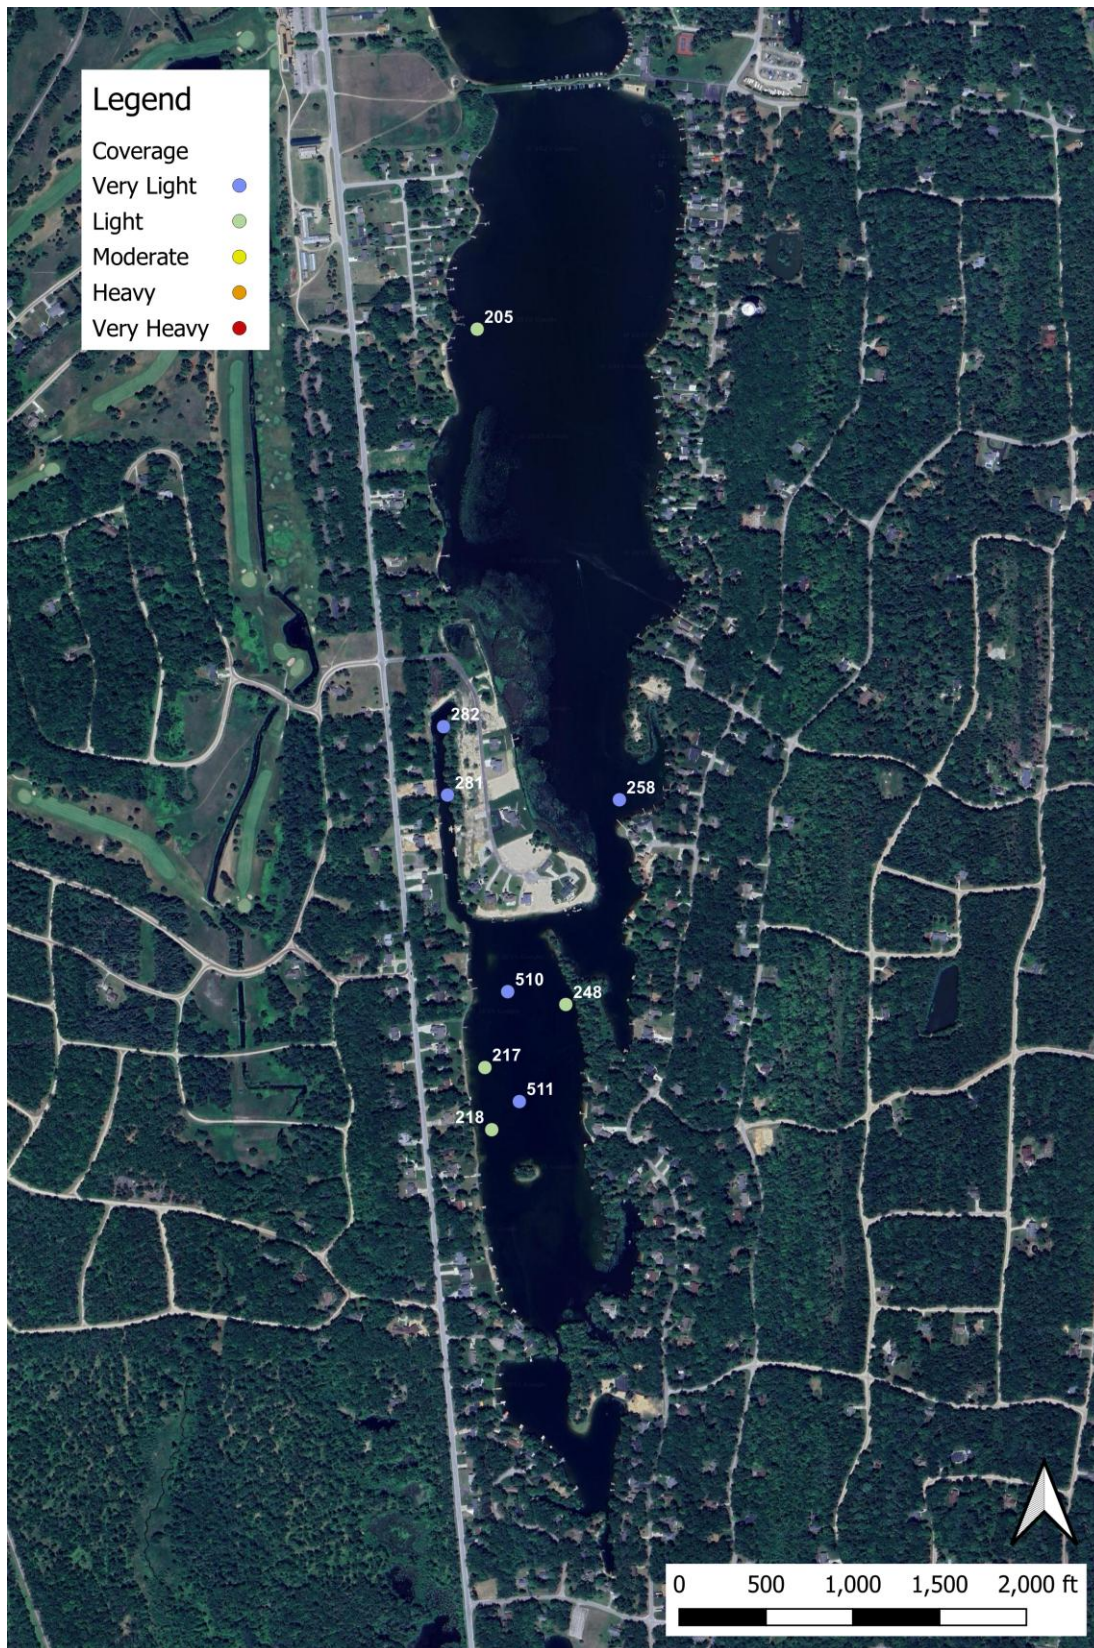
The submerged aquatic invasive species observed in Cedar Lake South during the 2025 early-season survey were hybrid Eurasian watermilfoil and starry stonewort. Hybrid Eurasian watermilfoil was found in nine AROS, including as light clusters in AROS 205, 281, 282, 248, 258 and as a denser cluster in AROS 217, 216, 510, and 511 (Figure 5). The areas where Eurasian watermilfoil was the most dense and continuous such as AROS 281, 282, and the intersection of AROS 217, 216, 510 and 511 were noted as candidates for potential treatment. Starry stonewort was found only in the northeast portion of AROS 503 and was not causing any recreational nuisance concerns at the time of the survey (Figure 6).

Figure 5 – Early-season (7/1/25) hybrid Eurasian watermilfoil coverage (a combination of the LakeScan™ density and distribution observations).

Eurasian watermilfoil coverage has trended downward over the last five years with average coverage in 2021-2025 at less than 1%. Thus, current management interventions appear to be effective at suppressing growth and reducing the cumulative coverage of nuisance watermilfoil presence. Despite less than 1% coverage in 2025, Eurasian watermilfoil displayed a slight increase in coverage over the past year, and the species coverage additionally increased between the early and late-season surveys indicating the possibility of species rebound. Therefore, it is recommended that the Cedar Lake Improvement Board considers deviating from the actions taken in 2025 and instead continues exploring management options similar to those conducted in previous years where reduction of the species across the two surveys was observed.

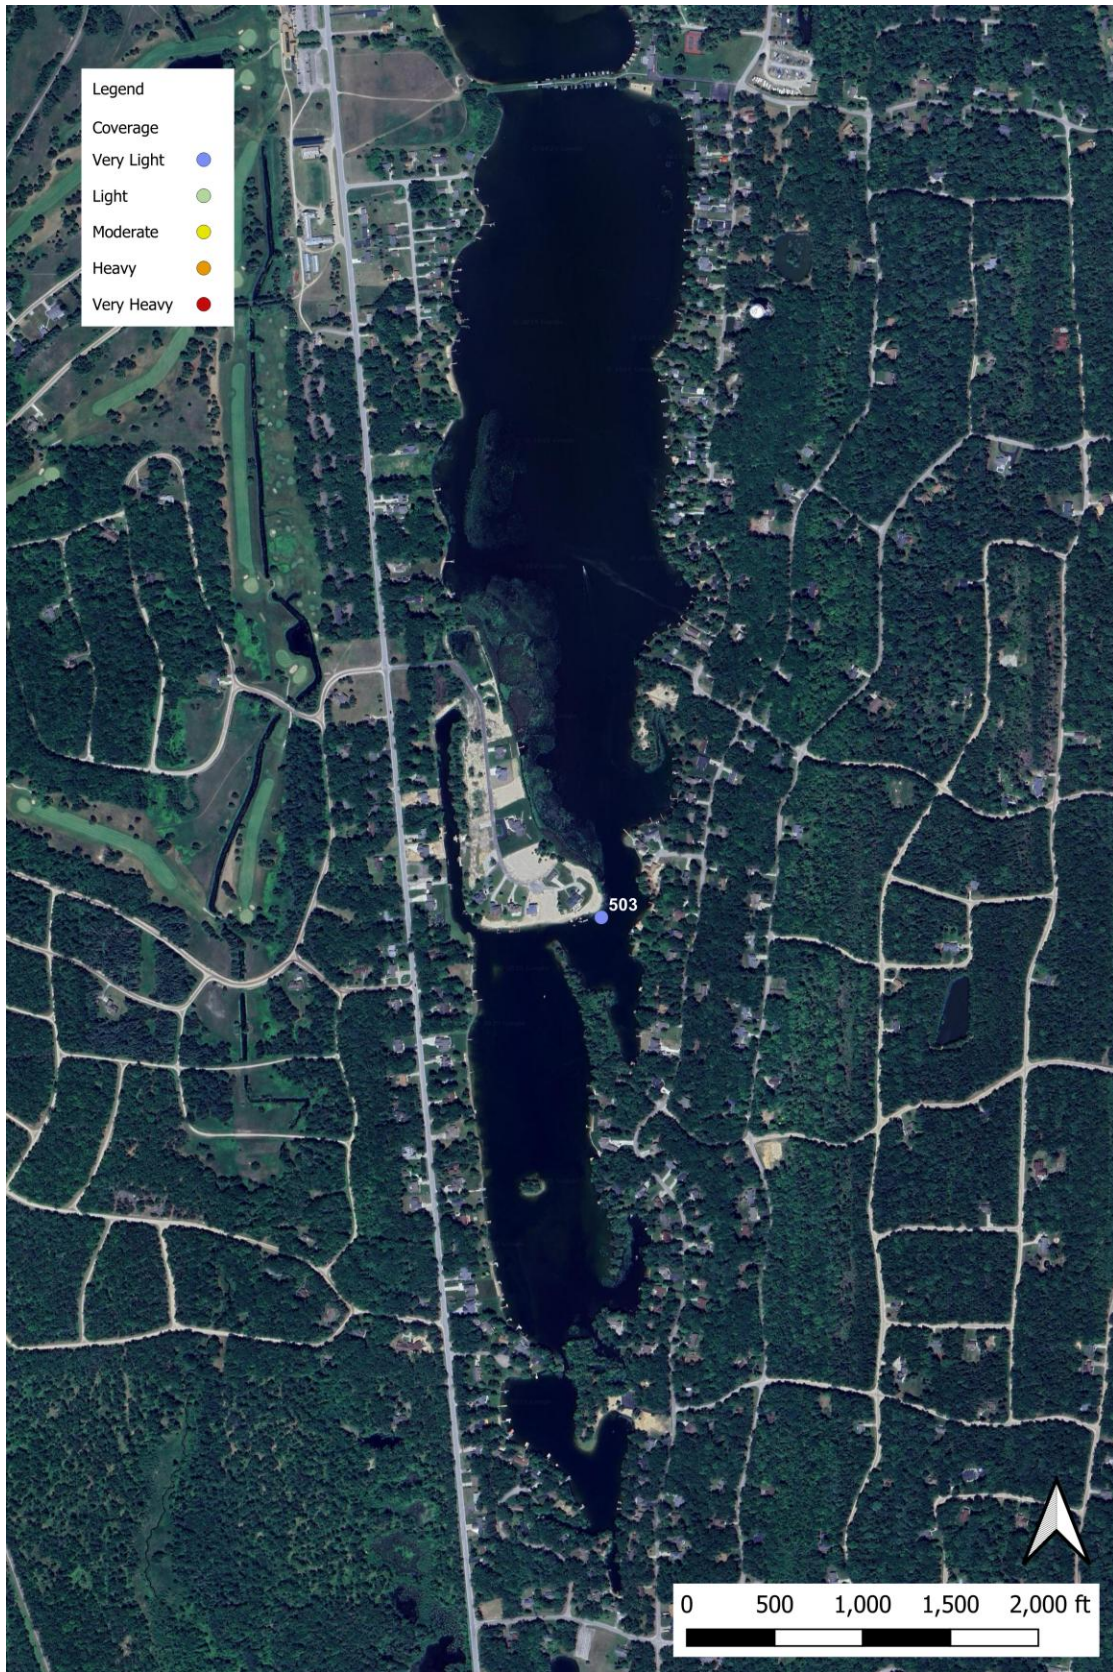
Figure 6 – Early-season (7/1/25) starry stonewort coverage.

A pocket of starry-stonewort continues to persist in the middle bay of the lake. The 2025 survey observations mark the first year that the species was noted since 2022, indicating a rebound of species coverage and the persistence of reproductive structures in the sediments after previous management actions were performed. LakeScan™ surveys in 2026 will reveal if the treatment conducted on September 18, 2025 was effective at reducing the spread of the species.

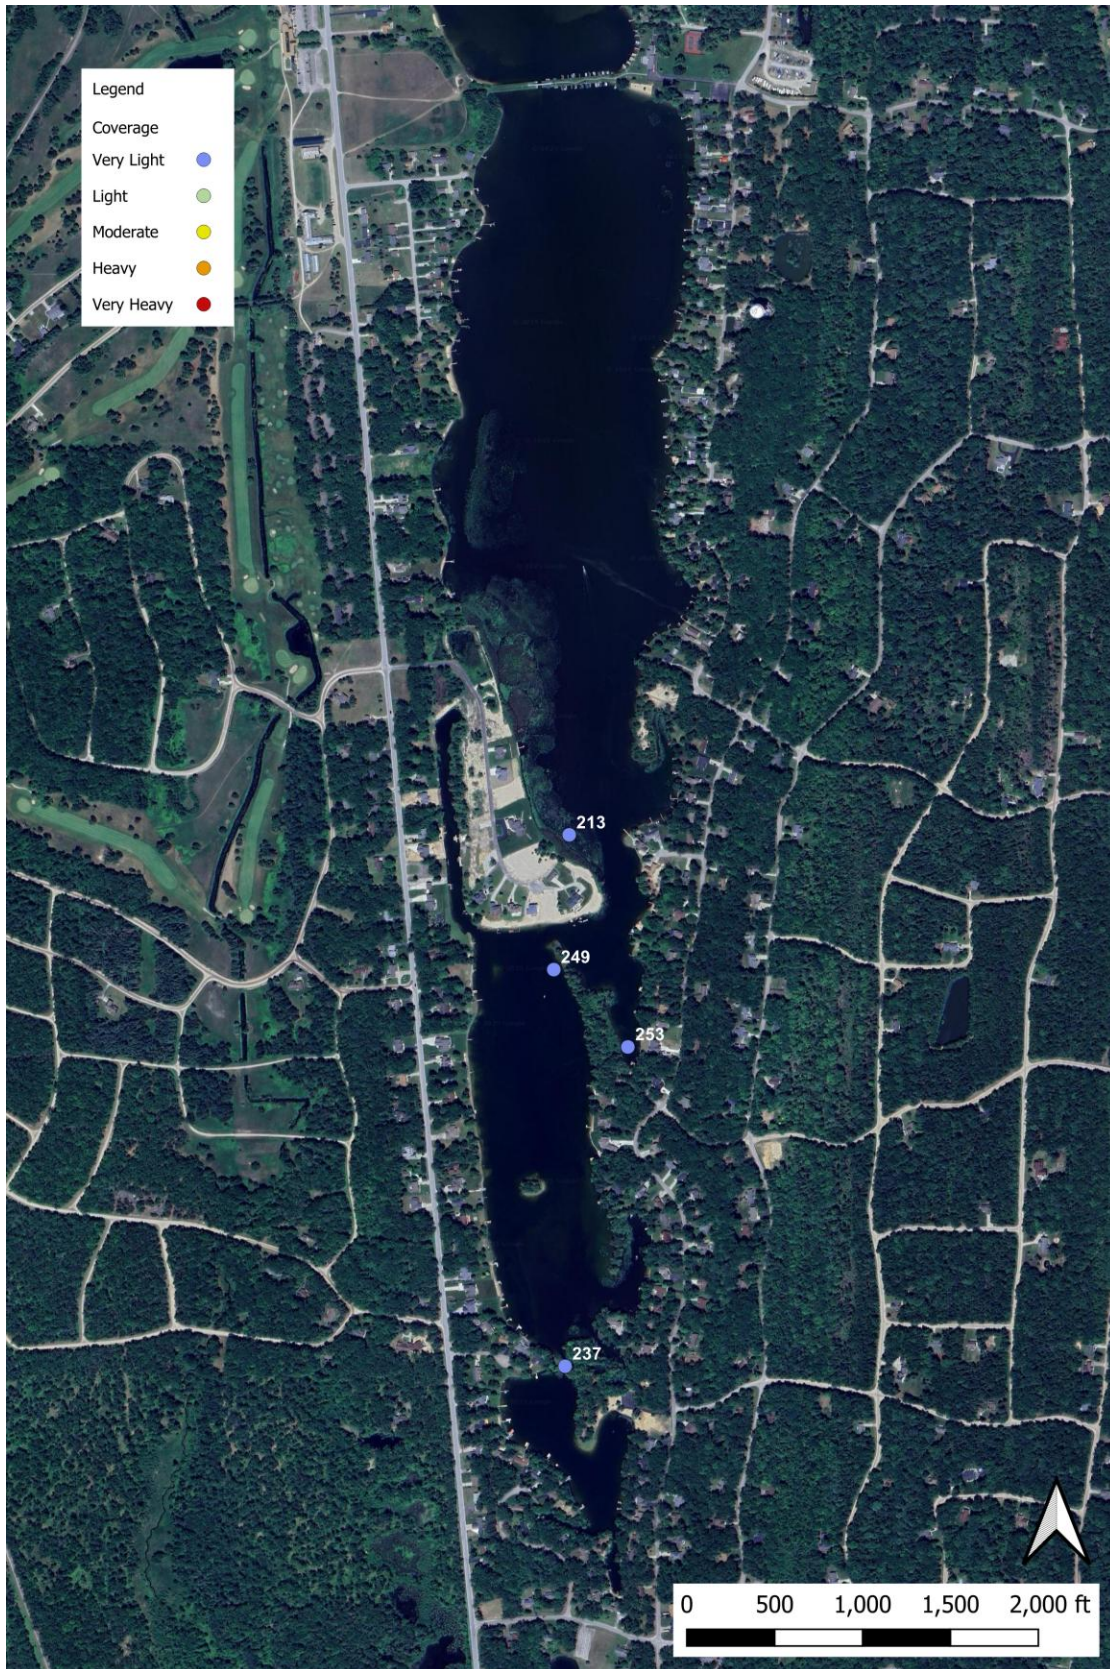
Additionally, the emergent aquatic invasive species purple loosestrife was found at four locations along the shoreline (AROS 213, 237, 249 and 253), not causing any management concerns during the time of the survey (Figure 7). A suspected cluster of *Phragmites* was noted in AROS 213, but could not be reasonably identified from the boat survey.

Figure 6 – Early-season (7/1/25) purple loosestrife coverage.

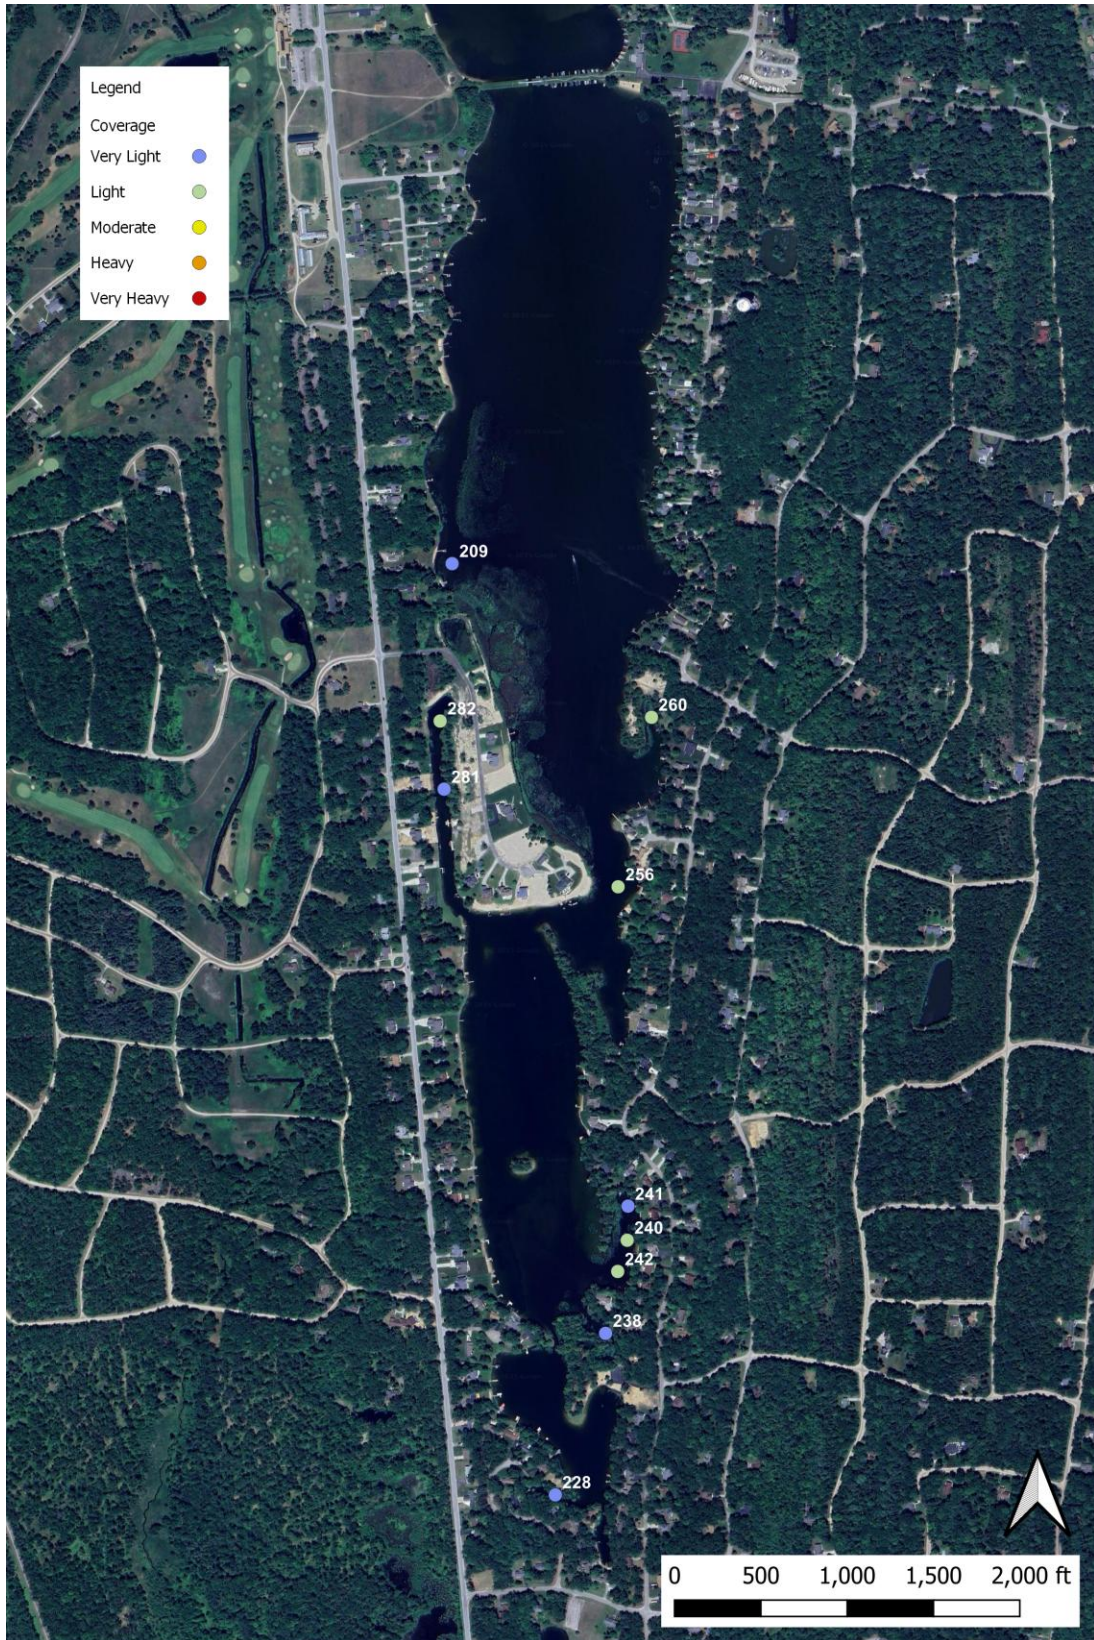
The submerged aquatic invasive species observed in Cedar Lake South during the 2025 late-season survey were hybrid Eurasian watermilfoil and starry stonewort. Eurasian watermilfoil was not overly dense or causing nuisance conditions at any location in the lake, but was the most continuous through the canals at AROS 281-282 and 241-242. Eurasian watermilfoil was found as scattered patches in AROS 260 and 256 and only as single stalks/clusters in AROS 238, 228, and 209 (Figure 8). No Eurasian watermilfoil was noted in the early-season treatment area between AROS 217, 216, 510 and 511. Starry stonewort was found in expanding coverage from what was observed during the early-season survey, and was observed at AROS 256, 257, and 251 with the densest distribution at AROS 251 (Figure 9).

Figure 8 – Late-season (8/26/25) hybrid Eurasian watermilfoil coverage (a combination of the LakeScan™ density and distribution observations).

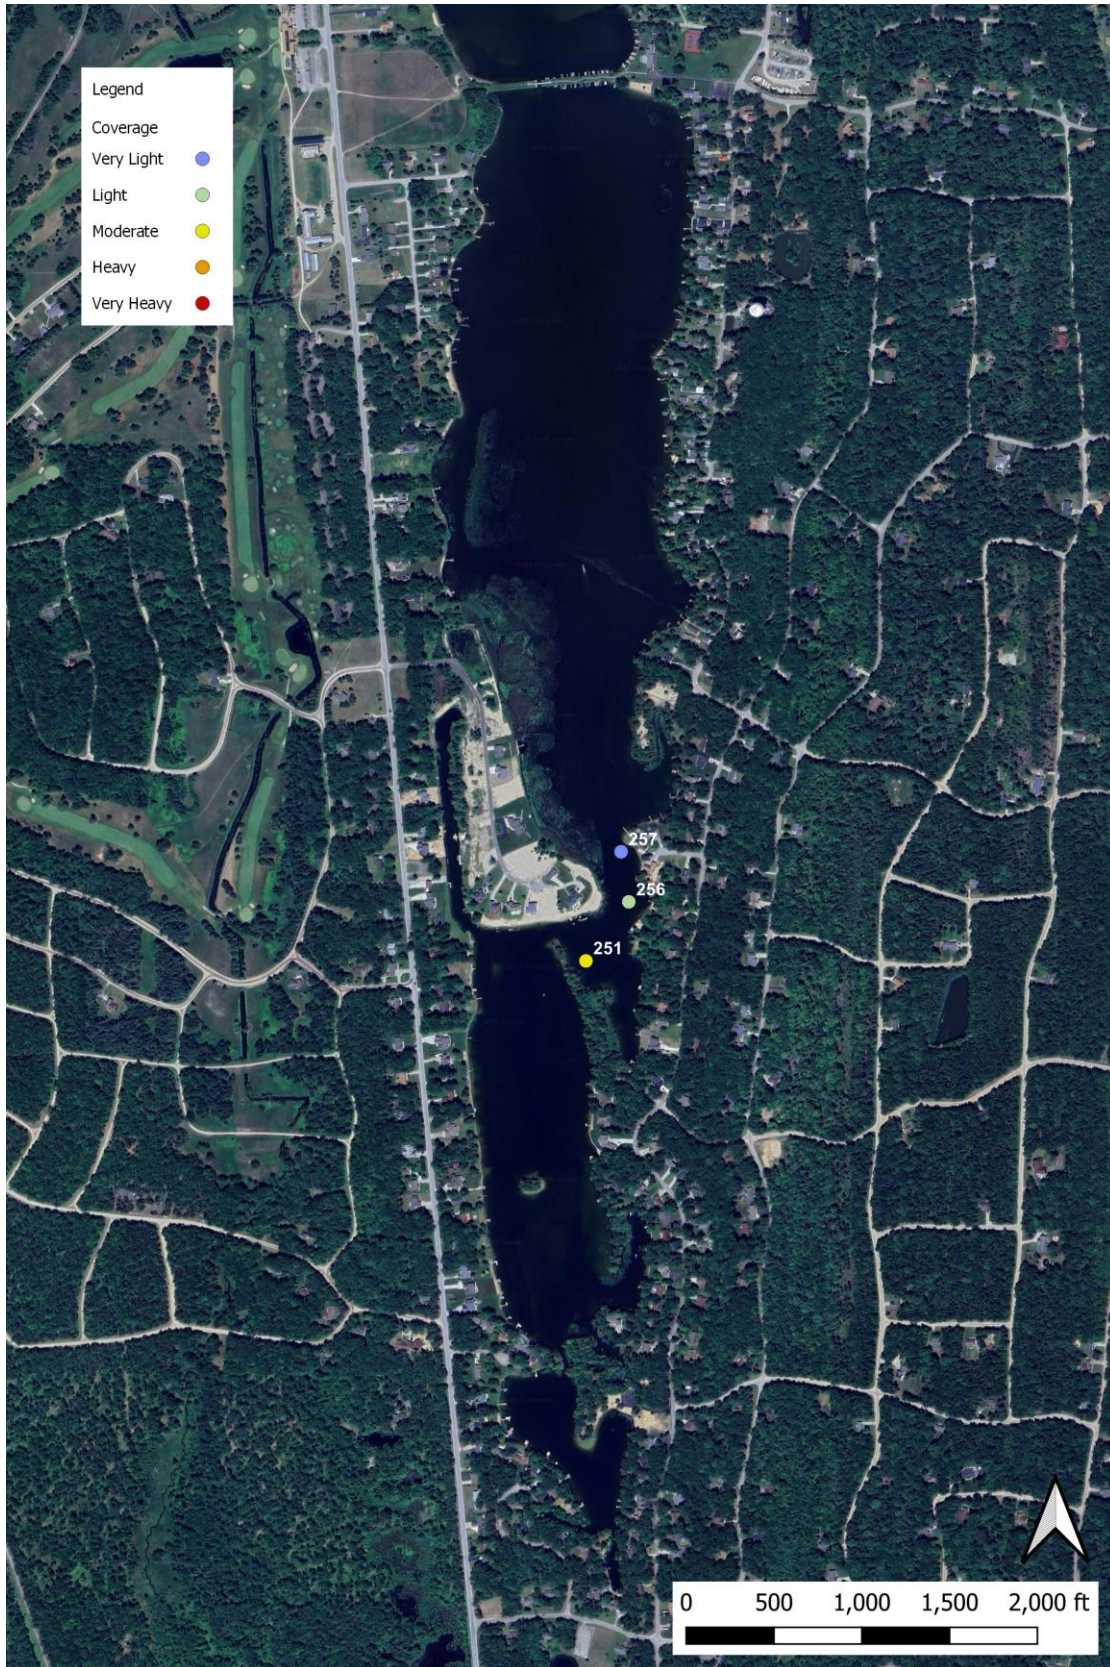
Figure 9 – Late-season (8/26/25) starry stonewort coverage.

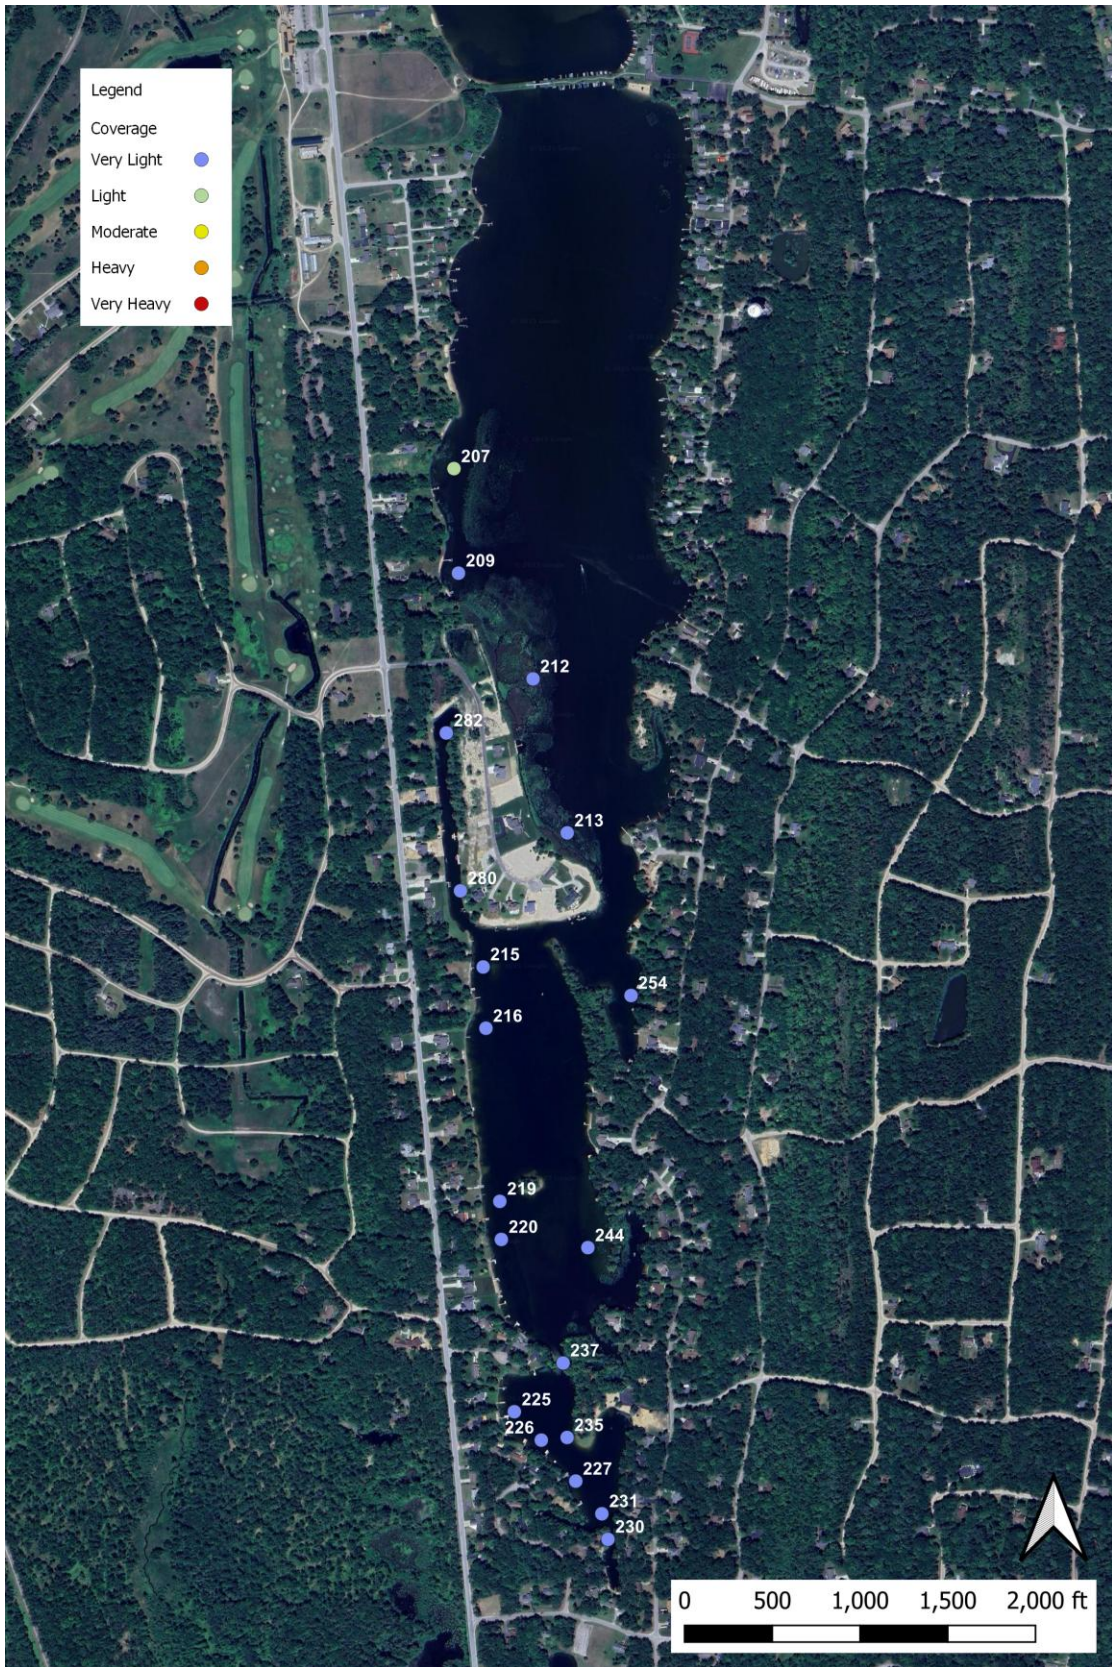
The emergent aquatic invasive species purple loosestrife was found scattered along the shoreline, not causing any management concerns during the time of the survey (Figure 10). *Phragmites* was noted in small clusters in AROS 213 at the sandy point, the eastern side of AROS 240, and at AROS 207 (Figure 11).

Figure 10 – Late-season (8/26/25) purple loosestrife coverage.

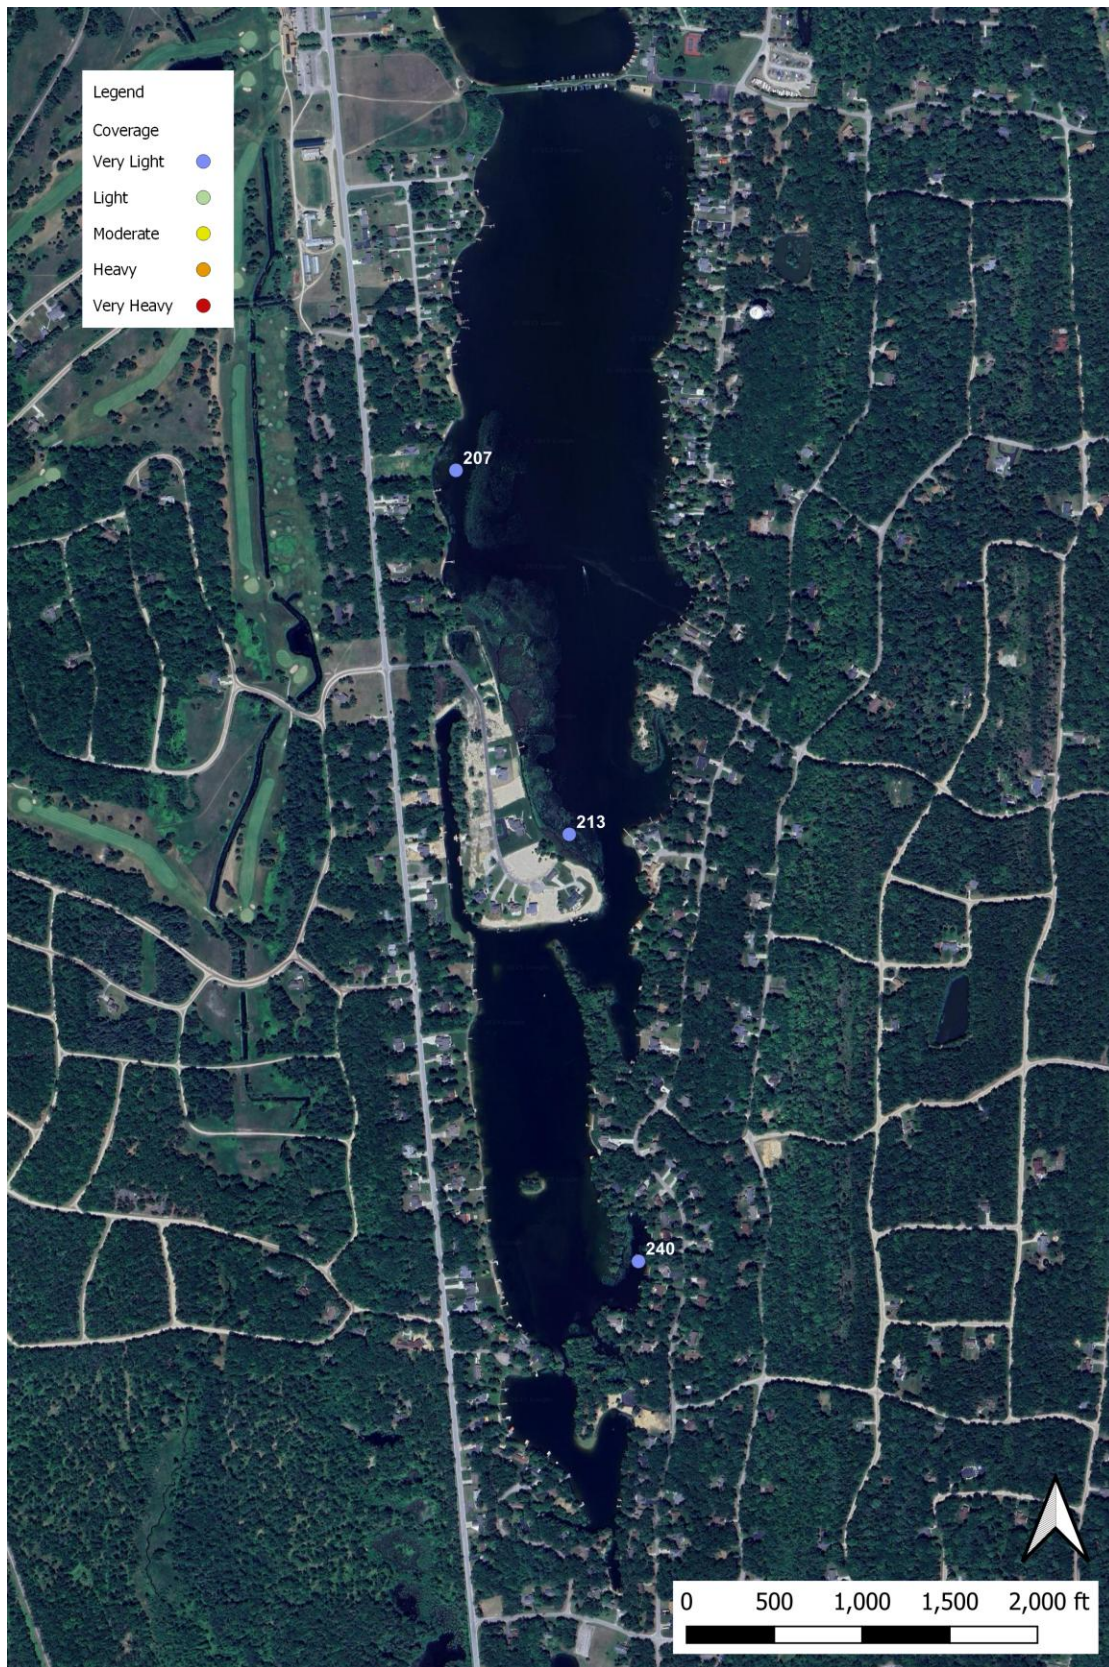
Figure 11 – Late-season (8/26/25) Phragmites coverage.

It will be crucial to monitor and document *Phragmites* coverage in Cedar Lake South following the treatment on September 18, 2025. Close monitoring will reveal the effectiveness of the treatment and inform if follow-up treatments are warranted. An additional on-the-ground survey of the treated areas might be pursued by the lake board to achieve reliable and accurate monitoring data on *Phragmites* populations across the landscape opposed to only along the shoreline. Given the increasing shoreline distribution of purple loosestrife, it is additionally recommended that the lake board consider the use of biocontrols over a few seasonal applications to manage the spread of the species pending 2026 survey findings.

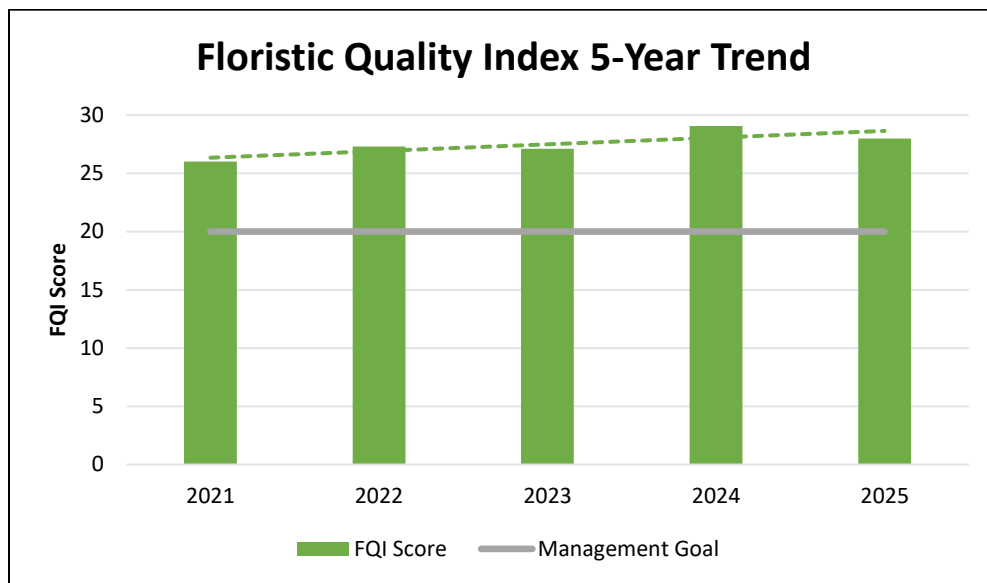
The floristic quality index score on Cedar Lake South continues to exceed the optimal management goal over the past five years (Figure 12). A slight decline in the score was observed in the past year, but 2025 findings remain higher than recorded values in 2021-2023 indicating long-term consistently improving trends. These findings represent a favorable ratio between native species and invasive species in the lake.

Figure 12 – Floristic Quality Index 5-Year Trend.

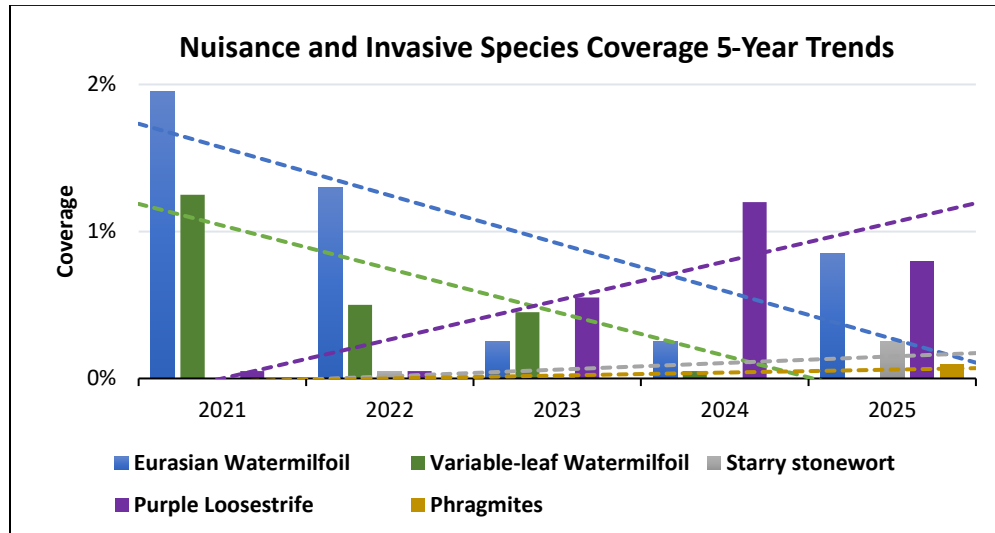
Over the past five years, coverage of Eurasian watermilfoil and variable leaf watermilfoil have exhibited declining trends while coverage of purple loosestrife, starry stonewort, and *Phragmites* have displayed increasing trends (Figure 13). Coverage of variable-leaf watermilfoil has consistently decreased since 2021, reaching 0% coverage in 2025. Invasive Eurasian watermilfoil coverage has remained consistently under 2% over the past five years, but the species increased in coverage by 0.6% in the last year. Notably, the early-season survey occurred before the first herbicide treatment, which could have influenced the increase in Eurasian watermilfoil coverage observed in 2025. Despite the slight increase in coverage trends, Eurasian watermilfoil has consistently remained under the five-year maximum of 1.95% coverage observed in 2021.

Despite increasing trendlines, purple loosestrife declined in coverage by 0.4% in the last year and *Phragmites* coverage between the two surveys was an almost negligible 0.1%. Starry stonewort was observed on the lake for the first time since 2022, and was found at its highest observed coverage since 2020, which could warrant further management intervention. Despite increasing coverages for some

Figure 13 – Nuisance and invasive species average yearly coverage 5-Year trends.

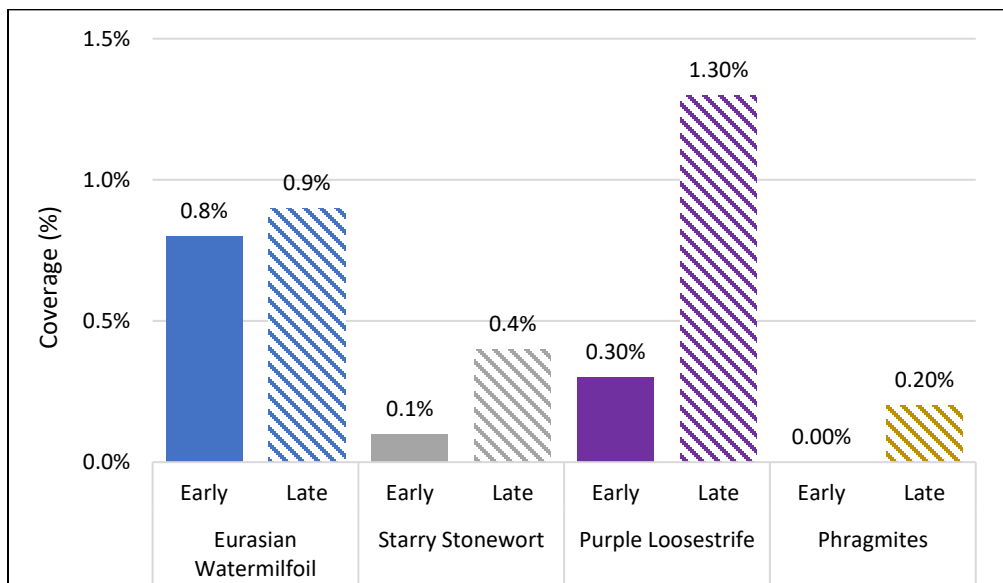
Each of the species of interest on Cedar Lake South increased in coverage from the early-season survey to the late season survey (Figure 14). The increase in Eurasian watermilfoil across the two surveys may indicate that management activities conducted on Cedar Lake in 2025 may not have had a high level of treatment efficacy. Although there was an increase in Eurasian watermilfoil coverage across the two surveys, Eurasian watermilfoil was not observed in any of the areas treated in July during the late-season survey. These findings suggest successful impact on the species where it was treated, but wider applications may be warranted in 2026 to prevent this observed increase. No management actions were taken on the starry stonewort, purple loosestrife, or phragmites prior to the late-season survey, so increases in species coverage are likely attributed to higher plant productivity later in the growing season and the species becoming more conspicuous during the late-season survey as they flower.

Figure 14 – Changes in 2025 coverage across both surveys for targeted species.

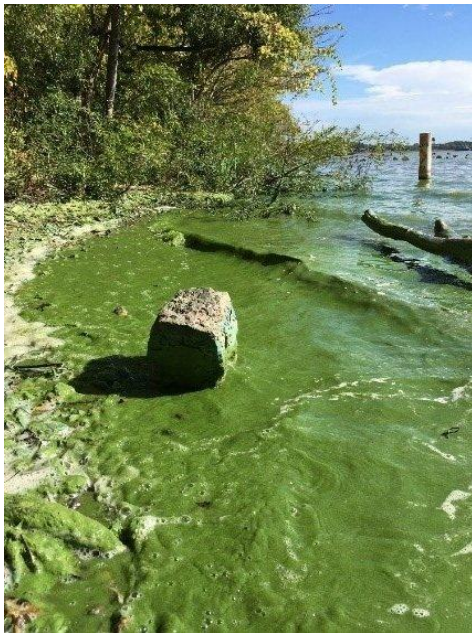
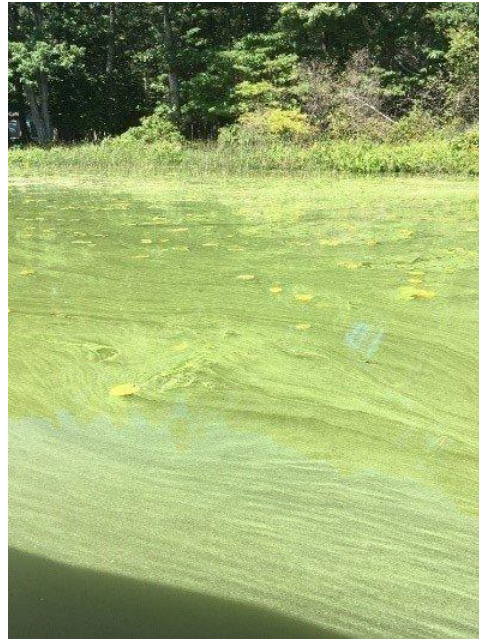
Figures A1 & A2 - Example of blue-green algal blooms taken by K&A field crews in 2020 (left) and 2019 (right).

Blue-green algae are a form of bacteria known as cyanobacteria, studies have revealed that substances made and released into the water by some of these nuisance algae can be toxic or carcinogenic. They are known to have negative impacts on aquatic ecosystems and can potentially poison and sicken pets, livestock, and wildlife. People can be exposed to the phytotoxins by ingestion or dermal absorption (through the skin). They can also be exposed via inhalation of aerosols created by overhead irrigation, strong winds, and boating activity.

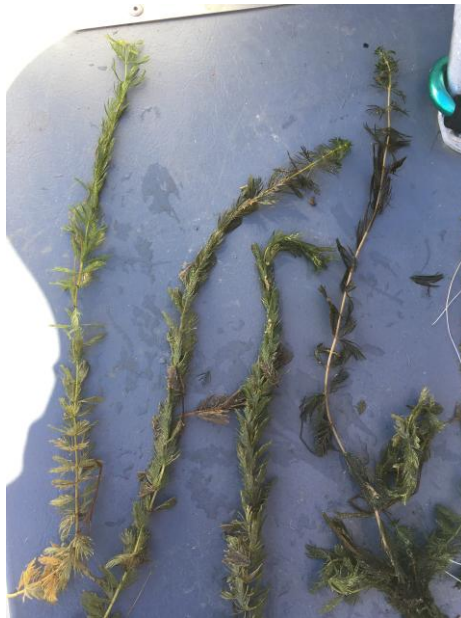
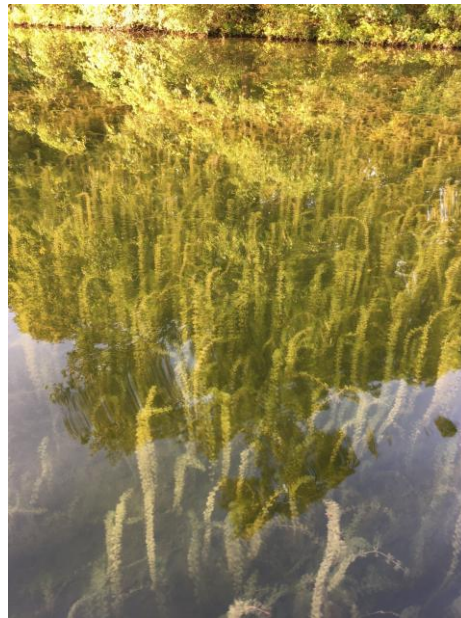
Figures A3 & A4 - Examples of Hybrid Eurasian Watermilfoil taken by K&A field staff in 2019.

Background: Anecdotal evidence suggests that hybrid milfoil has been found in Michigan inland lakes since the late 1980's. Experience has proven that it is usually not possible to determine whether the milfoil observed is either Eurasian or hybrid genotype based on phenology alone (Figures A3 and A4). However, because they play such similar roles in lake ecology, they are simply “lumped together” and referred to collectively as hybrid Eurasian watermilfoil.

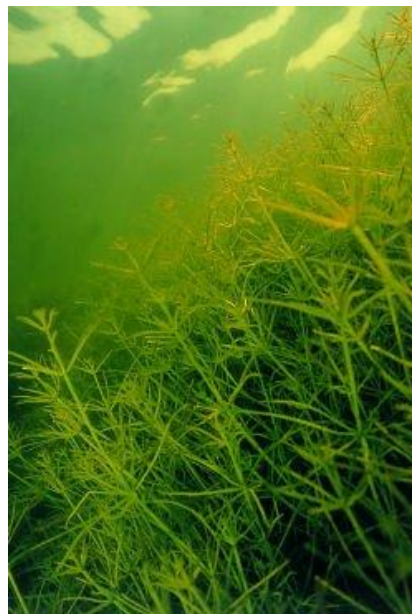
Figure A5 - Example of Starry Stonewort underwater growth, taken by K&A field crew in 2020.

Background: Starry stonewort, a macroalgae native to northern Eurasia, invaded North American inland lakes after becoming established in the St. Lawrence Seaway/Great Lakes system. Starry stonewort has likely been present in Michigan's inland lakes since the late 1990's. Since then, this invasive species has spread throughout Michigan (Figure A5). Able to spread by both fragmentation and asexual reproduction, starry stonewort has thrived in Michigan's high-quality oligotrophic and mesotrophic lakes, particularly those with marl sediments. Once established, this opportunistic species will bloom and impose a deleterious impact on many ecosystem functions. Bloom events are often unpredictable and can happen at any time of the year. In some years, starry stonewort can become a nuisance while it can be inconspicuous in others. The species can come along with other similar species and be very difficult to find when it is not blooming.

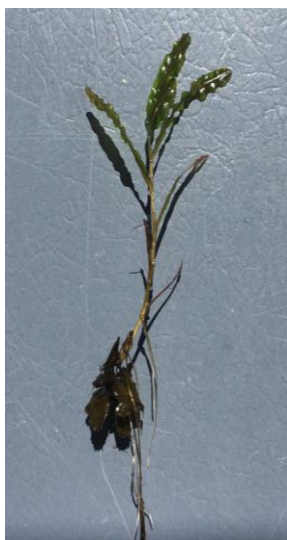
Figure A6 - Example curly leaf pondweed image from the 2021 LakeScan™ field crew.

Curly-leaf pondweed can create problems such as recreational nuisances, ecological nuisances (by outcompeting native species and reducing light availability to other plants), and degraded fish spawning habitat. Curly-leaf pondweed is easily detectable in early-spring because it is one of the few plants readily growing and often the first submersed plant to reach the surface. This gives it a competitive advantage and can grow 4 to 5 feet tall before other plants begin germinating from the bottom sediments. As water temperatures rise in late-June and early-July, curly-leaf pondweed stems begin to die, break down, and can be completely gone by mid-July.¹⁵
