Case 1:16-cr-20897-PARte Cost 12/04/2016 Page 1 of 22

Government's Exhibits in Support of the Joint Factual Statement

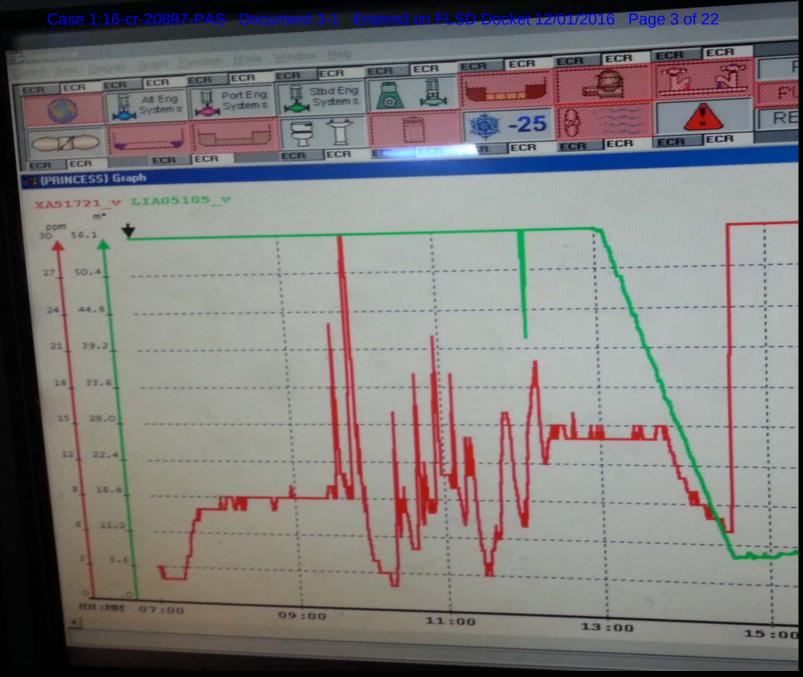
- 1. Map of Caribbean Princess voyage August 26-27, 2013.
- 2. Display of Caribbean Princess engine room computer on 08.26.13 showing a discharge in excess of the capacity of the OWS.

Graph from Caribbean Princess Engine Control Room

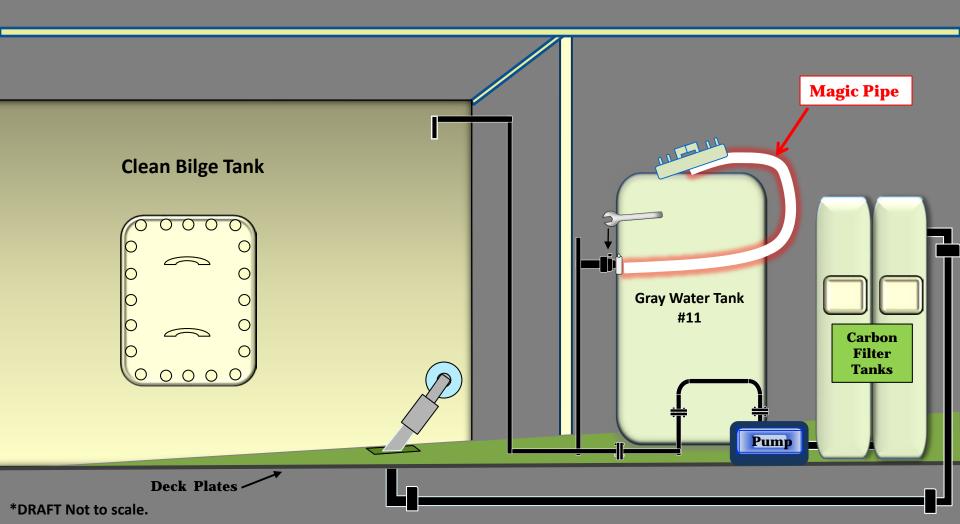
Caribbean Princess Bypass Method Used in 2013

- 3. Sounding sheets for 08-26-13 by four different crew members documenting the drop of Oilers showing drop in the Clean Bilge Tank.
- 4. Governmentt diagram of the standing pipe method of bypassing used in 2013.

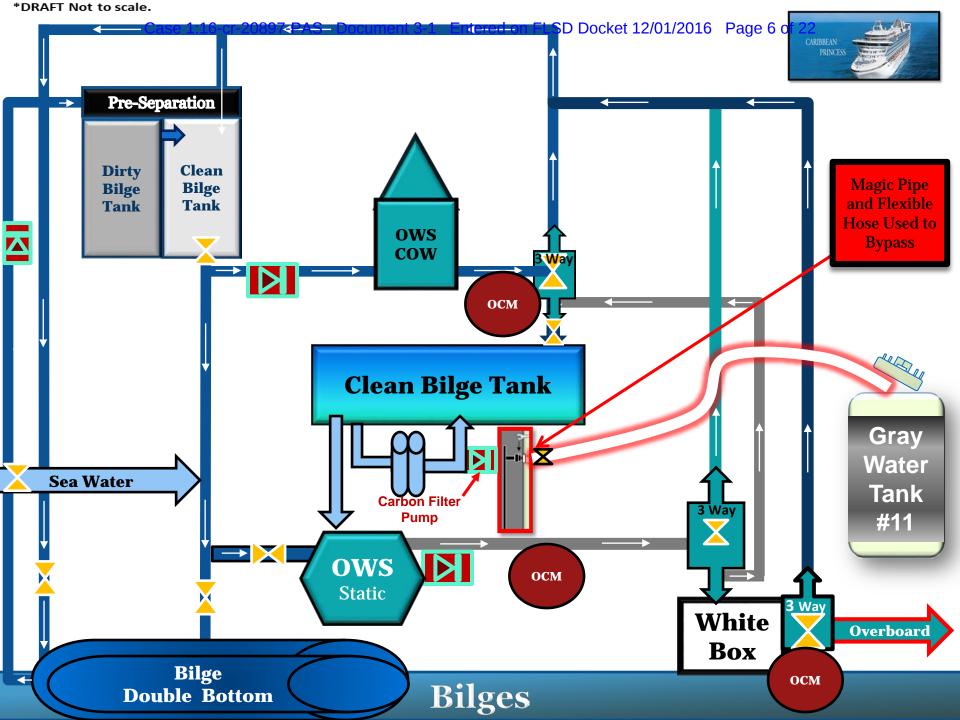
- 5. Government schematic diagram of the oily bilge system on the Caribbean Princess.
- 6. Before and after photographs of the carbon filter pump showing the bypass pipe in place on 08-26-13 and removed on 08-28-13.

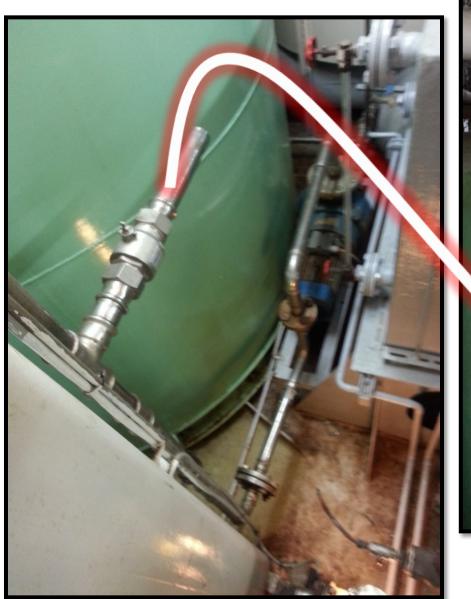
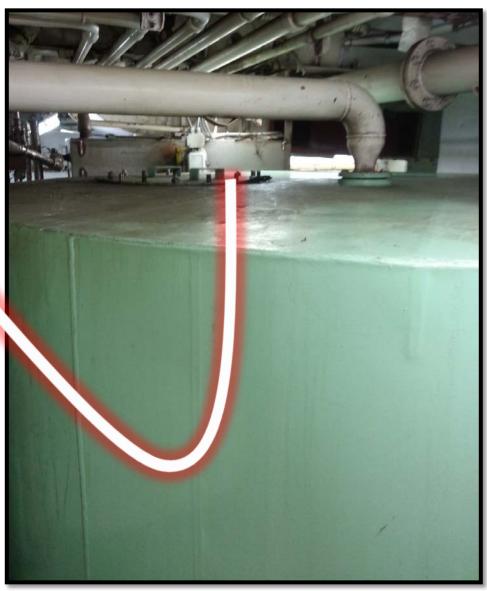
- 7. Before and after photographs of the carbon filter pump showing the bypass in place on 08-26-13 (left) and during U.S. examination on 03-08-14 (right).

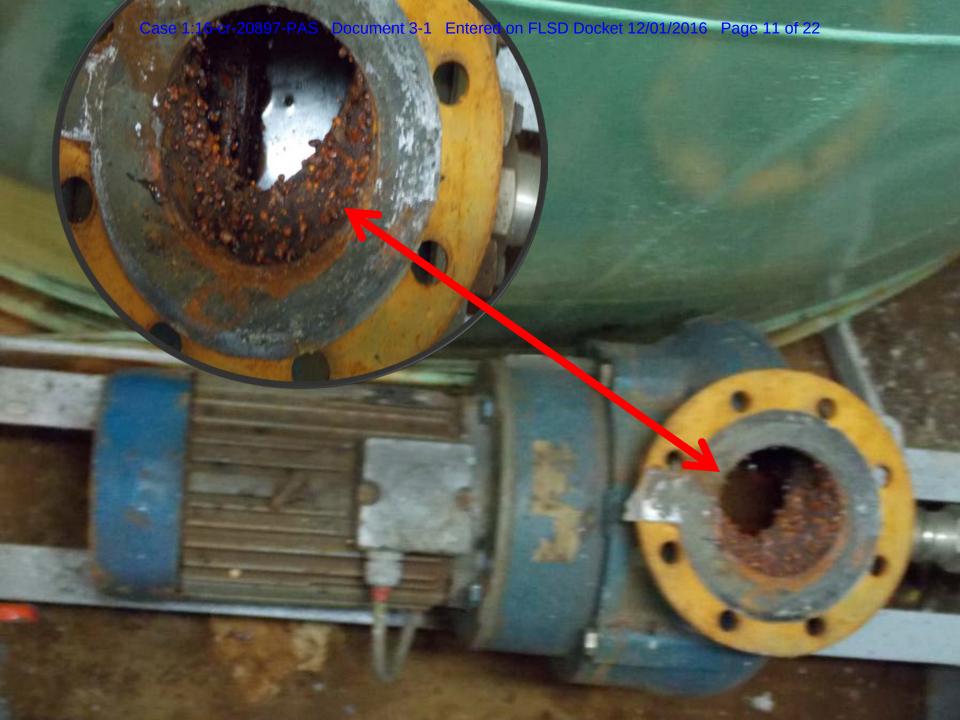
- 8. Top of graywater tank #11 adjacent to the carbon filter pump.
- 9. Depitction showing how a flexible hose was used to transfer from the standing bypass pipe to the top hatch of graywater tank #11.

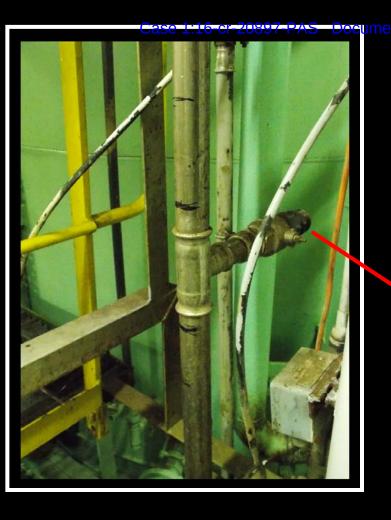
- 10. Interior of carbon filter discharge pipe when disassembled at the government's request on March 8, 2014.

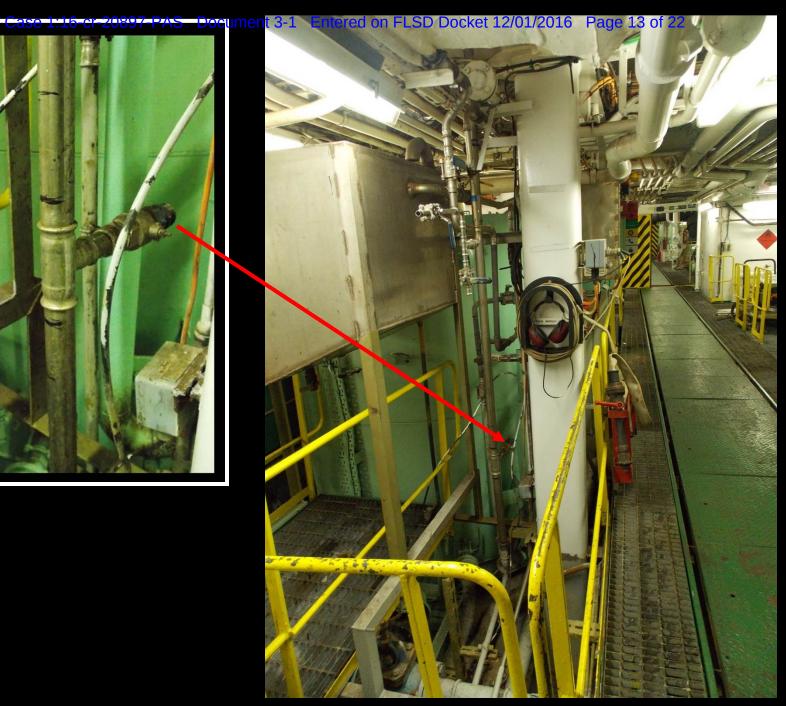
- 11. Carbon filter tanks and carbon filter pump (lower left) showing discharge pipe on top of the pump before its removal.
- 12. Threaded bypass pipe and valve used prior to the installation of the standing bypass pipe.

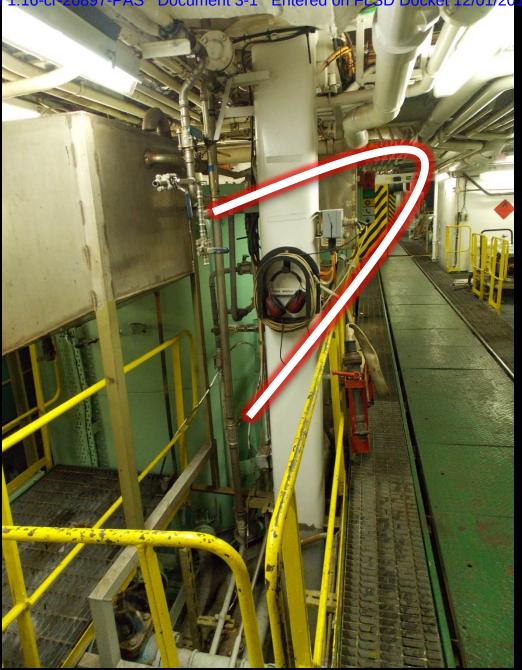
- 13. Interior of threaded bypass pipe when disassembled at the government's request on March 8, 2013.
- 14. Depiction showing how a flexible hose was used to transfer from the threaded bypass pipe to the top hatch of graywater tank #11.

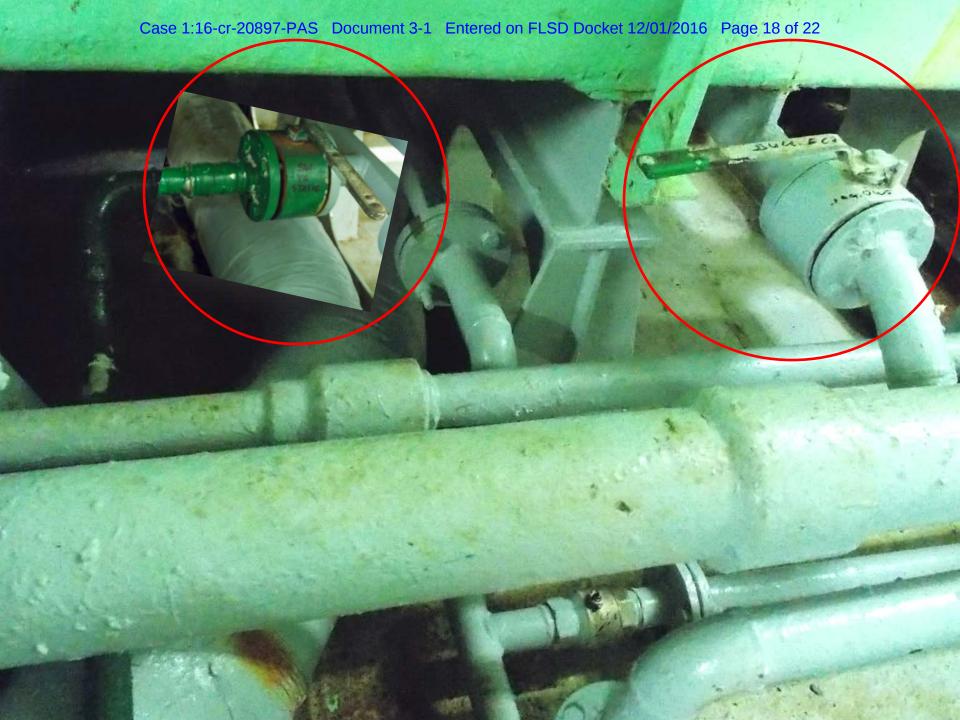
- 16. Static Oily Water Separator and pollution prevention placards.
- 17. Seawater valve opened during operation of the Static Oily Water Separator.
- 18. Pollution prevention placards mounted on the Static Oily Water Separator.
